Unnamed tributary		ok-0526-r-010		Sedimentation Risk Index 48																																																																			
<u>Common:</u> 3.4mi N of Blackman <u>Drainage:</u> Dry Branch <u>GPS:</u> 30.973309, -86.632652 <u>Land owner:</u> Donald & Janet Fugate		<u>County:</u> Okaloosa <u>PLSS(T-R-S):</u> 5N-24-03-2770 <u>Parcel No.:</u> 0000.0300 <u>Road Name:</u> Bowen Rd		<u>State:</u> Florida

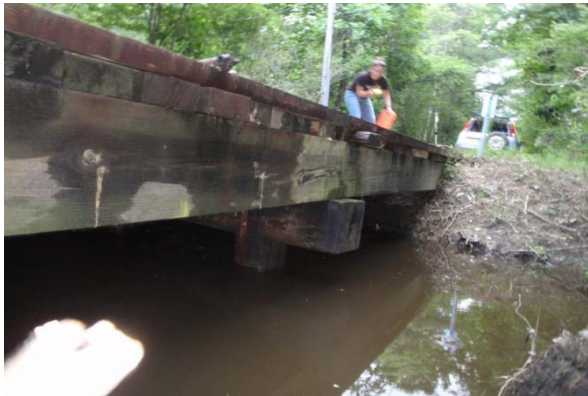
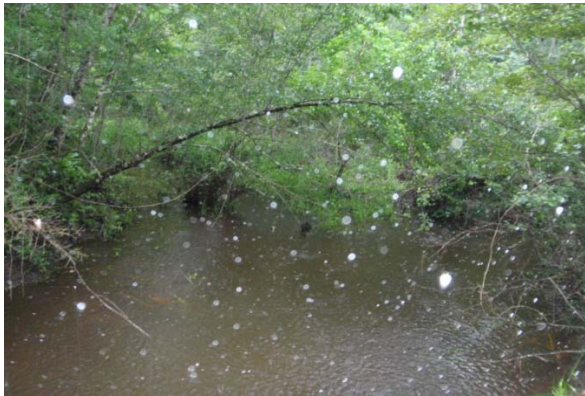
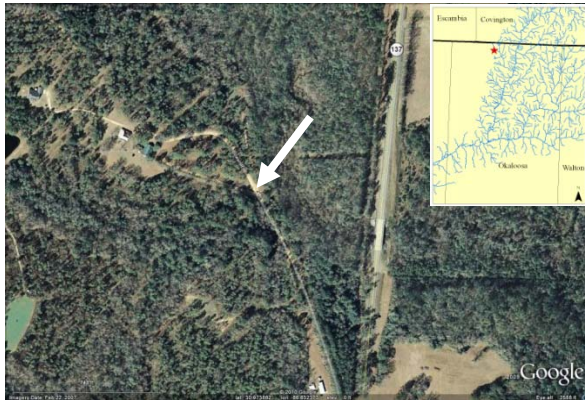
Crossing Structure: DS		DS																																																																					
<table border="1"> <thead> <tr> <th>Risk Factor</th> <th>Ranking</th> <th>Score</th> </tr> </thead> <tbody> <tr><td>US Channel Morph</td><td>DA</td><td>3</td></tr> <tr><td>DS Channel Morph</td><td>C</td><td>5</td></tr> <tr><td>DS Bank Alteration</td><td>NATURAL</td><td>5</td></tr> <tr><td>Upstream Skew Angle</td><td><5°</td><td>5</td></tr> <tr><td>Crossing fill condition</td><td>Good/Vegetated</td><td>5</td></tr> <tr><td>Inlet/Outlet Condition</td><td>No Impairment</td><td>5</td></tr> <tr><td>Road Approach Material</td><td>All Native Soil</td><td>1</td></tr> <tr><td>Potential Eroded Volume Mean</td><td><21 y³</td><td>5</td></tr> <tr><td>Approach Slope Mean</td><td><2%</td><td>5</td></tr> <tr><td>Soil K Factor</td><td>0.21-0.40</td><td>3</td></tr> <tr><td>Upstream Rt Outlet</td><td>Vegetated</td><td>1</td></tr> <tr><td>Upstream Lt Outlet</td><td>Bare soil</td><td>0</td></tr> <tr><td>Upstream Rt Ditch</td><td>Vegetated</td><td>1</td></tr> <tr><td>Upstream Lt Ditch</td><td>Bare soil</td><td>0</td></tr> <tr><td>Downstream Rt Outlet</td><td>Bare soil</td><td>0</td></tr> <tr><td>Downstream Lt Outlet</td><td>Vegetated</td><td>1</td></tr> <tr><td>Downstream Rt Ditch</td><td>Vegetated</td><td>1</td></tr> <tr><td>Downstream Lt Ditch</td><td>Bare soil</td><td>0</td></tr> <tr><td>Outlet Total</td><td>Partially Improved Outlet System</td><td>3</td></tr> <tr><td>Ditches Total</td><td>Partially Improved Drainage System</td><td>3</td></tr> <tr><td>SRI Total</td><td>Low Risk</td><td>48</td></tr> </tbody> </table>		Risk Factor	Ranking	Score	US Channel Morph	DA	3	DS Channel Morph	C	5	DS Bank Alteration	NATURAL	5	Upstream Skew Angle	<5°	5	Crossing fill condition	Good/Vegetated	5	Inlet/Outlet Condition	No Impairment	5	Road Approach Material	All Native Soil	1	Potential Eroded Volume Mean	<21 y ³	5	Approach Slope Mean	<2%	5	Soil K Factor	0.21-0.40	3	Upstream Rt Outlet	Vegetated	1	Upstream Lt Outlet	Bare soil	0	Upstream Rt Ditch	Vegetated	1	Upstream Lt Ditch	Bare soil	0	Downstream Rt Outlet	Bare soil	0	Downstream Lt Outlet	Vegetated	1	Downstream Rt Ditch	Vegetated	1	Downstream Lt Ditch	Bare soil	0	Outlet Total	Partially Improved Outlet System	3	Ditches Total	Partially Improved Drainage System	3	SRI Total	Low Risk	48

Ditches Total	Partially Improved Drainage System	3																																																																					
SRI Total	Low Risk	48																																																																					
Additional Site Features <u>Crossing Type and Quantity:</u> Bridge, 1 <u>Crossing Materials:</u> Wood <u>Soil Types:</u> 39,43,52 <u>Rt Approach Prism Fill:</u> 0.25in <u>Lt Approach Prism Fill:</u> 0.25in		<table border="1"> <thead> <tr> <th>Feature</th> <th>Within Range</th> <th>Descriptive Field</th> </tr> </thead> <tbody> <tr> <td>303(d)</td> <td>No</td> <td>N/A</td> </tr> <tr> <td>Wetland Species</td> <td>No</td> <td>N/A</td> </tr> <tr> <td>Rare and Imperiled</td> <td>Yes</td> <td>BLACKTIP SHINER, IRONCOLOR SHINER</td> </tr> <tr> <td>Land Use/ Cover</td> <td>Yes</td> <td>AGRICULTURAL/ WETLAND FORESTED MIX</td> </tr> <tr> <td>Candidate Mussels</td> <td>No</td> <td>N/A</td> </tr> <tr> <td>Sturgeon C.H.</td> <td>No</td> <td>N/A</td> </tr> </tbody> </table>				Feature	Within Range	Descriptive Field	303(d)	No	N/A	Wetland Species	No	N/A	Rare and Imperiled	Yes	BLACKTIP SHINER, IRONCOLOR SHINER	Land Use/ Cover	Yes	AGRICULTURAL/ WETLAND FORESTED MIX	Candidate Mussels	No	N/A	Sturgeon C.H.	No	N/A
