Indian Creek		co-0831-r-012		Sedimentation Risk Index 52																																																																			
<u>Common:</u> 6.9mi SW of Opp <u>Drainage:</u> Yellow River <u>GPS:</u> 31.212869, -86.340139 <u>Land owner:</u> Clidie Lee Harper LE-US, James & Barbara McCart-DS		<u>County:</u> Covington <u>PLSS (T-R-S):</u> 3N-17E-22 <u>Parcel No.:</u> 1; 6 <u>Road Name:</u> Henderson Bridge Rd		<u>State:</u> Alabama

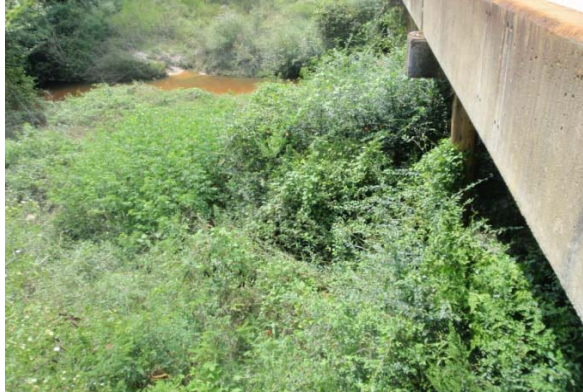
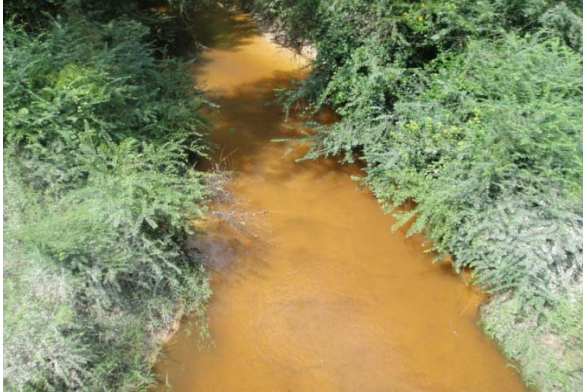
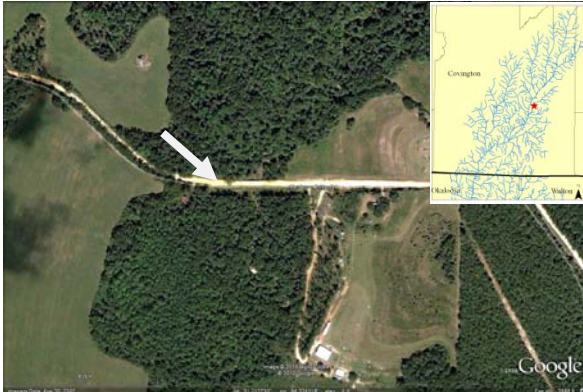
Crossing Structure: DS		US																																																																					
<table border="1"> <thead> <tr> <th>Risk Factor</th> <th>Ranking</th> <th>Score</th> </tr> </thead> <tbody> <tr><td>US Channel Morph</td><td>C</td><td>5</td></tr> <tr><td>DS Channel Morph</td><td>C</td><td>5</td></tr> <tr><td>DS Bank Alteration</td><td>MINOR/PARTIAL</td><td>3</td></tr> <tr><td>Upstream Skew Angle</td><td><5°</td><td>5</td></tr> <tr><td>Crossing fill condition</td><td>Good/Vegetated</td><td>5</td></tr> <tr><td>Inlet/Outlet Condition</td><td>No Impairment</td><td>5</td></tr> <tr><td>Road Approach Material</td><td>All Sand/Clay</td><td>3</td></tr> <tr><td>Potential Eroded Volume Mean</td><td><21 y³</td><td>5</td></tr> <tr><td>Approach Slope Mean</td><td>2.1-4%</td><td>3</td></tr> <tr><td>Soil K Factor</td><td><0.20</td><td>5</td></tr> <tr><td>Upstream Rt Outlet</td><td>Vegetated</td><td>1</td></tr> <tr><td>Upstream Lt Outlet</td><td>Vegetated</td><td>1</td></tr> <tr><td>Upstream Rt Ditch</td><td>Bare soil</td><td>0</td></tr> <tr><td>Upstream Lt Ditch</td><td>Bare soil</td><td>0</td></tr> <tr><td>Downstream Rt Outlet</td><td>Vegetated</td><td>1</td></tr> <tr><td>Downstream Lt Outlet</td><td>Vegetated</td><td>1</td></tr> <tr><td>Downstream Rt Ditch</td><td>Bare soil</td><td>0</td></tr> <tr><td>Downstream Lt Ditch</td><td>Vegetated</td><td>1</td></tr> <tr><td>Outlet Total</td><td>Improved Outlet System</td><td>5</td></tr> <tr><td>Ditches Total</td><td>Partially Improved Drainage System</td><td>3</td></tr> <tr><td>SRI Total</td><td>Low Risk</td><td>52</td></tr> </tbody> </table>		Risk Factor	Ranking	Score	US Channel Morph	C	5	DS Channel Morph	C	5	DS Bank Alteration	MINOR/PARTIAL	3	Upstream Skew Angle	<5°	5	Crossing fill condition	Good/Vegetated	5	Inlet/Outlet Condition	No Impairment	5	Road Approach Material	All Sand/Clay	3	Potential Eroded Volume Mean	<21 y ³	5	Approach Slope Mean	2.1-4%	3	Soil K Factor	<0.20	5	Upstream Rt Outlet	Vegetated	1	Upstream Lt Outlet	Vegetated	1	Upstream Rt Ditch	Bare soil	0	Upstream Lt Ditch	Bare soil	0	Downstream Rt Outlet	Vegetated	1	Downstream Lt Outlet	Vegetated	1	Downstream Rt Ditch	Bare soil	0	Downstream Lt Ditch	Vegetated	1	Outlet Total	Improved Outlet System	5	Ditches Total	Partially Improved Drainage System	3	SRI Total	Low Risk	52

Risk Factor	Ranking	Score																																																																					
US Channel Morph	C	5																																																																					
DS Channel Morph	C	5																																																																					
DS Bank Alteration	MINOR/PARTIAL	3																																																																					
Upstream Skew Angle	<5°	5																																																																					
Crossing fill condition	Good/Vegetated	5																																																																					
Inlet/Outlet Condition	No Impairment	5																																																																					
Road Approach Material	All Sand/Clay	3																																																																					
Potential Eroded Volume Mean	<21 y ³	5																																																																					
Approach Slope Mean	2.1-4%	3

Soil K Factor	<0.20	5																																																																					
Upstream Rt Outlet	Vegetated	1																																																																					
Upstream Lt Outlet	Vegetated	1																																																																					
Upstream Rt Ditch	Bare soil	0																																																																					
Upstream Lt Ditch	Bare soil	0																																																																					
Downstream Rt Outlet	Vegetated	1																																																																					
Downstream Lt Outlet	Vegetated	1																																																																					
Downstream Rt Ditch	Bare soil	0																																																																					
Downstream Lt Ditch	Vegetated	1																																																																					
Outlet Total	Improved Outlet System	5

Ditches Total	Partially Improved Drainage System	3																																																																					
SRI Total	Low Risk	52																																																																					
Additional Site Features <u>Crossing Type and Quantity:</u> Bridge, 1 <u>Crossing Materials:</u> Reinforced Concrete <u>Soil Types:</u> BnB, BnC, CdC, FoA, FuB, MBA, OrE <u>Rt Approach Prism Fill:</u> 0.25in <u>Lt Approach Prism Fill:</u> 0.1in		<table border="1"> <thead> <tr> <th>Feature</th> <th>Within Range</th> <th>Descriptive Field</th> </tr> </thead> <tbody> <tr> <td>303(d)</td> <td>No</td> <td>N/A</td> </tr> <tr> <td>Wetland Species</td> <td>No</td> <td>N/A</td> </tr> <tr> <td>Rare and Imperiled</td> <td>No</td> <td>N/A</td> </tr> <tr> <td>Land Use/ Cover</td> <td>Yes</td> <td>N/A/ PASTURE, HAY, SUCCESSIONAL SHRUB, SCRUB (CLEAR CUT)</td> </tr> <tr> <td>Candidate Mussels</td> <td>No</td> <td>N/A</td> </tr> <tr> <td>Sturgeon C.H.</td> <td>No</td> <td>N/A</td> </tr> </tbody> </table>				Feature	Within Range	Descriptive Field	303(d)	No	N/A	Wetland Species	No	N/A	Rare and Imperiled	No	N/A	Land Use/ Cover	Yes	N/A/ PASTURE, HAY, SUCCESSIONAL SHRUB, SCRUB (CLEAR CUT)	Candidate Mussels	No	N/A	Sturgeon C.H.	No	N/A
