Unnamed tributary		co-0901-r-008	Sedimentation Risk Index 44																																																																		
<u>Common:</u> 12.5mi NW of Florala <u>Drainage:</u> Spring Branch <u>GPS:</u> 31.156458123, -86.443771608 <u>Land owner:</u> Thomas & Margaret Gross US. Mrs. JM Forte – DS North, WP Bulger – DS South		<u>County:</u> Covington <u>State:</u> Alabama <u>PLSS (T-R-S):</u> 2N-16E-10 <u>Parcel No.:</u> 6; 7; 7.01 <u>Road Name:</u> Bulger Town Rd

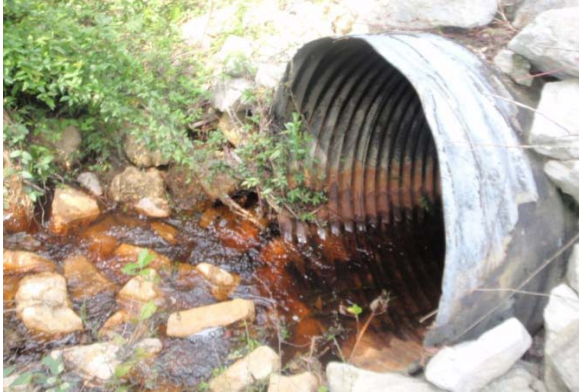
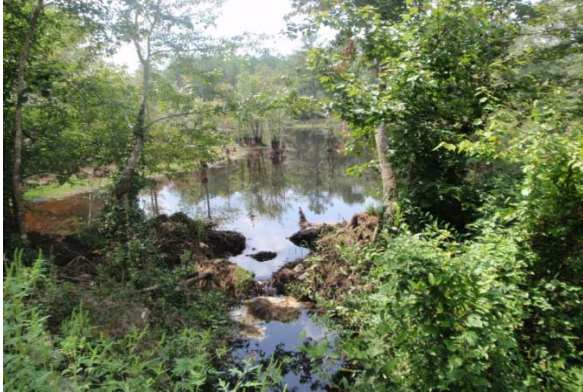
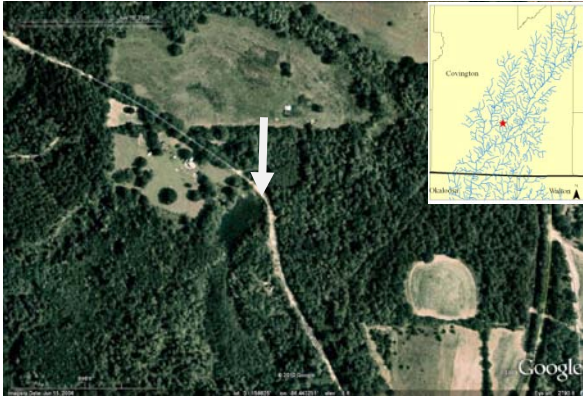
Crossing Structure: US		US																																																																			
<table border="1"> <thead> <tr> <th>Risk Factor</th> <th>Ranking</th> <th>Score</th> </tr> </thead> <tbody> <tr><td>US Channel Morph</td><td>PONDED</td><td>1</td></tr> <tr><td>DS Channel Morph</td><td>E</td><td>5</td></tr> <tr><td>DS Bank Alteration</td><td>MINOR/PARTIAL</td><td>3</td></tr> <tr><td>Upstream Skew Angle</td><td><5°</td><td>5</td></tr> <tr><td>Crossing fill condition</td><td>Fair/Rip Rap</td><td>3</td></tr> <tr><td>Inlet/Outlet Condition</td><td>No Impairment</td><td>5</td></tr> <tr><td>Road Approach Material</td><td>All Native Soil</td><td>1</td></tr> <tr><td>Potential Eroded Volume Mean</td><td><21 y³</td><td>5</td></tr> <tr><td>Approach Slope Mean</td><td>2.1-4%</td><td>3</td></tr> <tr><td>Soil K Factor</td><td><0.20</td><td>5</td></tr> <tr><td>Upstream Rt Outlet</td><td>Vegetated</td><td>1</td></tr> <tr><td>Upstream Lt Outlet</td><td>Rip Rap</td><td>1</td></tr> <tr><td>Upstream Rt Ditch</td><td>Vegetated</td><td>1</td></tr> <tr><td>Upstream Lt Ditch</td><td>Bare soil</td><td>0</td></tr> <tr><td>Downstream Rt Outlet</td><td>Vegetated</td><td>1</td></tr> <tr><td>Downstream Lt Outlet</td><td>Vegetated</td><td>1</td></tr> <tr><td>Downstream Rt Ditch</td><td>Bare soil</td><td>0</td></tr> <tr><td>Downstream Lt Ditch</td><td>Bare soil</td><td>0</td></tr> <tr><td>Outlet Total</td><td>Improved Outlet System</td><td>5</td></tr> <tr><td>Ditches Total</td><td>Partially Improved Drainage System</td><td>3</td></tr> <tr><td>SRI Total</td><td>Medium Risk</td><td>44</td></tr> </tbody> </table>		Risk Factor	Ranking	Score	US Channel Morph	PONDED	1	DS Channel Morph	E	5	DS Bank Alteration	MINOR/PARTIAL	3	Upstream Skew Angle	<5°	5	Crossing fill condition	Fair/Rip Rap	3	Inlet/Outlet Condition	No Impairment	5	Road Approach Material	All Native Soil	1	Potential Eroded Volume Mean	<21 y ³	5	Approach Slope Mean	2.1-4%	3	Soil K Factor	<0.20	5	Upstream Rt Outlet	Vegetated	1	Upstream Lt Outlet	Rip Rap	1	Upstream Rt Ditch	Vegetated	1	Upstream Lt Ditch	Bare soil	0	Downstream Rt Outlet	Vegetated	1	Downstream Lt Outlet	Vegetated	1	Downstream Rt Ditch	Bare soil	0	Downstream Lt Ditch	Bare soil	0	Outlet Total	Improved Outlet System	5	Ditches Total	Partially Improved Drainage System	3	SRI Total	Medium Risk	44

Notes: Rip rap DS stream bed
