Loon Branch		sr-0414-r-006		Sedimentation Risk Index <b>52</b>																																																																			
<u>Common:</u> 6.3mi S of Harold <u>Drainage:</u> Boiling Creek <u>GPS:</u> 30.568467, -86.867492 <u>Land owner:</u> US Government- Eglin AFB		<u>County:</u> Santa Rosa <u>PLSS(T-R-S):</u> 1N-26-29 <u>Parcel No.:</u> 1 <u>Road Name:</u> RR 211- Eglin AFB		<u>State:</u> Florida

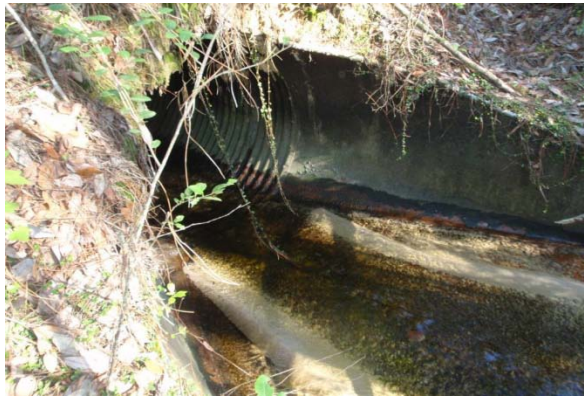
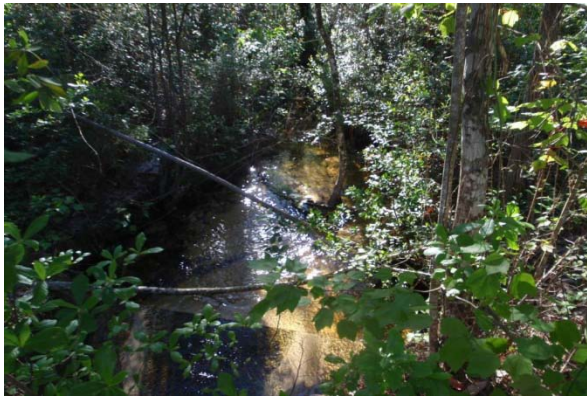
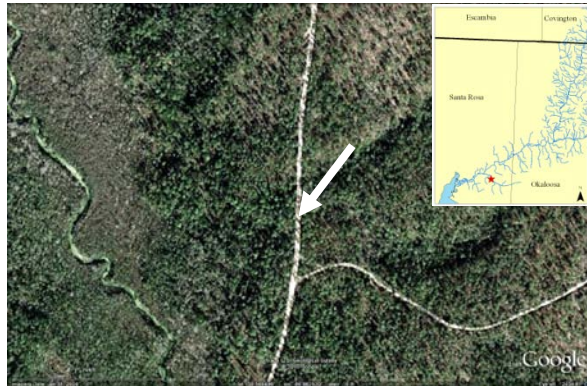
Crossing Structure: DS		DS																																																																					
<table border="1"> <thead> <tr> <th>Risk Factor</th> <th>Ranking</th> <th>Score</th> </tr> </thead> <tbody> <tr><td>US Channel Morph</td><td>C</td><td>5</td></tr> <tr><td>DS Channel Morph</td><td>E</td><td>5</td></tr> <tr><td>DS Bank Alteration</td><td>MINOR/PARTIAL</td><td>3</td></tr> <tr><td>Upstream Skew Angle</td><td>&lt;5°</td><td>5</td></tr> <tr><td>Crossing fill condition</td><td>Good/Vegetated</td><td>5</td></tr> <tr><td>Inlet/Outlet Condition</td><td>No Impairment</td><td>5</td></tr> <tr><td>Road Approach Material</td><td>All Sand/Clay</td><td>3</td></tr> <tr><td>Potential Eroded Volume Mean</td><td>&lt;21 y<sup>3</sup></td><td>5</td></tr> <tr><td>Approach Slope Mean</td><td>&lt;2%</td><td>5</td></tr> <tr><td>Soil K Factor</td><td>&lt;0.20</td><td>5</td></tr> <tr><td>Upstream Rt Outlet</td><td>Vegetated</td><td>1</td></tr> <tr><td>Upstream Lt Outlet</td><td>Vegetated</td><td>1</td></tr> <tr><td>Upstream Rt Ditch</td><td>Bare soil</td><td>0</td></tr> <tr><td>Upstream Lt Ditch</td><td>Bare soil</td><td>0</td></tr> <tr><td>Downstream Rt Outlet</td><td>Vegetated</td><td>1</td></tr> <tr><td>Downstream Lt Outlet</td><td>Vegetated</td><td>1</td></tr> <tr><td>Downstream Rt Ditch</td><td>Bare soil</td><td>0</td></tr> <tr><td>Downstream Lt Ditch</td><td>Bare soil</td><td>0</td></tr> <tr><td>Outlet Total</td><td>Improved Outlet System</td><td>5</td></tr> <tr><td>Ditches Total</td><td>Unimproved Drainage System</td><td>1</td></tr> <tr><td><b>SRI Total</b></td><td><b>Low Risk</b></td><td><b>52</b></td></tr> </tbody> </table>		Risk Factor	Ranking	Score	US Channel Morph	C	5	DS Channel Morph	E	5	DS Bank Alteration	MINOR/PARTIAL	3	Upstream Skew Angle	<5°	5	Crossing fill condition	Good/Vegetated	5	Inlet/Outlet Condition	No Impairment	5	Road Approach Material	All Sand/Clay	3	Potential Eroded Volume Mean	<21 y <sup>3</sup>	5	Approach Slope Mean	<2%	5	Soil K Factor	<0.20	5	Upstream Rt Outlet	Vegetated	1	Upstream Lt Outlet	Vegetated	1	Upstream Rt Ditch	Bare soil	0	Upstream Lt Ditch	Bare soil	0	Downstream Rt Outlet	Vegetated	1	Downstream Lt Outlet	Vegetated	1	Downstream Rt Ditch	Bare soil	0	Downstream Lt Ditch	Bare soil	0	Outlet Total	Improved Outlet System	5	Ditches Total	Unimproved Drainage System	1	<b>SRI Total</b>	<b>Low Risk</b>	<b>52</b>

Risk Factor	Ranking	Score																																																																					
US Channel Morph	C	5																																																																					
DS Channel Morph	E	5																																																																					
DS Bank Alteration	MINOR/PARTIAL	3																																																																					
Upstream Skew Angle	<5°	5																																																																					
Crossing fill condition	Good/Vegetated	5																																																																					
Inlet/Outlet Condition	No Impairment	5																																																																					
Road Approach Material	All Sand/Clay	3																																																																					
Potential Eroded Volume Mean	<21 y <sup>3</sup>	5

Approach Slope Mean	<2%	5																																																																					
Soil K Factor	<0.20	5																																																																					
Upstream Rt Outlet	Vegetated	1																																																																					
Upstream Lt Outlet	Vegetated	1																																																																					
Upstream Rt Ditch	Bare soil	0																																																																					
Upstream Lt Ditch	Bare soil	0																																																																					
Downstream Rt Outlet	Vegetated	1																																																																					
Downstream Lt Outlet	Vegetated	1																																																																					
Downstream Rt Ditch	Bare soil	0																																																																					
Downstream Lt Ditch	Bare soil	0

Outlet Total	Improved Outlet System	5																																																																					
Ditches Total	Unimproved Drainage System	1																																																																					
<b>SRI Total</b>	<b>Low Risk</b>	<b>52</b>																																																																					
<b>Additional Site Features</b> <u>Crossing Type and Quantity:</u> Culvert, 1 <u>Crossing Materials:</u> Metal <u>Soil Types:</u> 7,21,23,34,40,46,47 <u>Rt Approach Prism Fill:</u> 0.5in <u>Lt Approach Prism Fill:</u> 0.5in		<table border="1"> <thead> <tr> <th>Feature</th> <th>Within Range</th> <th>Descriptive Field</th> </tr> </thead> <tbody> <tr> <td>303(d)</td> <td>No</td> <td>N/A</td> </tr> <tr> <td>Wetland Species</td> <td>Yes</td> <td>1-3 FOCAL SPECIES IN UPLAND AREAS</td> </tr> <tr> <td>Rare and Imperiled</td> <td>Yes</td> <td>BLUENOSE SHINER, IRONCOLOR SHINER</td> </tr> <tr> <td>Land Use/Cover</td> <td>Yes</td> <td>PUBLIC/SEMI-PUBLIC/NA</td> </tr> <tr> <td>Candidate Mussels</td> <td>No</td> <td>N/A</td> </tr> <tr> <td>Sturgeon C.H.</td> <td>No</td> <td>N/A</td> </tr> </tbody> </table>				Feature	Within Range	Descriptive Field	303(d)	No	N/A	Wetland Species	Yes	1-3 FOCAL SPECIES IN UPLAND AREAS	Rare and Imperiled	Yes	BLUENOSE SHINER, IRONCOLOR SHINER	Land Use/Cover	Yes	PUBLIC/SEMI-PUBLIC/NA	Candidate Mussels	No	N/A	Sturgeon C.H.	No	N/A
