Bridge Branch		ok-1005-r-003	Sedimentation Risk Index 44																																																																		
<u>Common:</u> 6mi E of Crestview <u>Drainage:</u> Bear Creek <u>GPS:</u> 30.756197979, -86.469174761 <u>Land owner:</u> Courington Construction Inc		<u>County:</u> Okaloosa <u>State:</u> Florida <u>PLSS(T-R-S):</u> 3N-22-17 <u>Parcel No.:</u> 4.001 <u>Road Name:</u> Carousel Rd

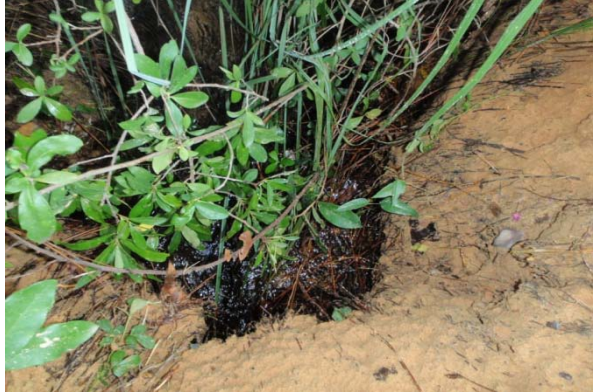
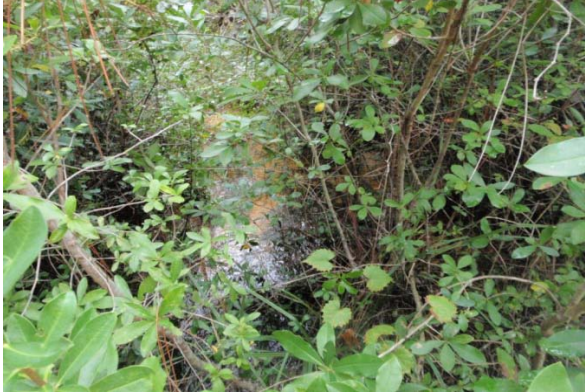
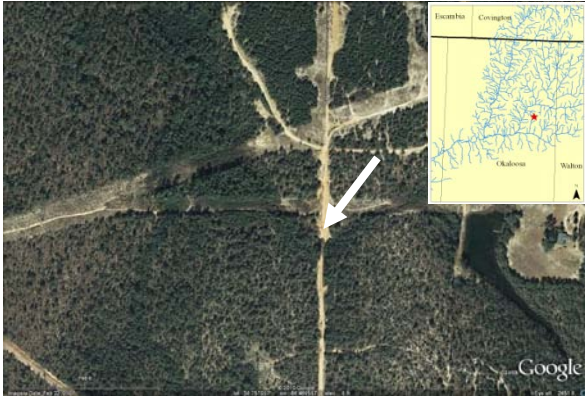
Crossing Structure: US		US																																																																			
<table border="1"> <thead> <tr> <th>Risk Factor</th> <th>Ranking</th> <th>Score</th> </tr> </thead> <tbody> <tr><td>US Channel Morph</td><td>B</td><td>5</td></tr> <tr><td>DS Channel Morph</td><td>B</td><td>5</td></tr> <tr><td>DS Bank Alteration</td><td>NATURAL</td><td>5</td></tr> <tr><td>Upstream Skew Angle</td><td><5°</td><td>5</td></tr> <tr><td>Crossing fill condition</td><td>Good/Vegetated</td><td>5</td></tr> <tr><td>Inlet/Outlet Condition</td><td>Sed Islands/Scouring</td><td>3</td></tr> <tr><td>Road Approach Material</td><td>All Sand/Clay</td><td>3</td></tr> <tr><td>Potential Eroded Volume Mean</td><td>>40 y³</td><td>1</td></tr> <tr><td>Approach Slope Mean</td><td>>4%</td><td>1</td></tr> <tr><td>Soil K Factor</td><td><0.20</td><td>5</td></tr> <tr><td>Upstream Rt Outlet</td><td>Vegetated</td><td>1</td></tr> <tr><td>Upstream Lt Outlet</td><td>Vegetated</td><td>1</td></tr> <tr><td>Upstream Rt Ditch</td><td>Bare soil</td><td>0</td></tr> <tr><td>Upstream Lt Ditch</td><td>Bare soil</td><td>0</td></tr> <tr><td>Downstream Rt Outlet</td><td>Vegetated</td><td>1</td></tr> <tr><td>Downstream Lt Outlet</td><td>Vegetated</td><td>1</td></tr> <tr><td>Downstream Rt Ditch</td><td>Bare soil</td><td>0</td></tr> <tr><td>Downstream Lt Ditch</td><td>Bare soil</td><td>0</td></tr> <tr><td>Outlet Total</td><td>Improved Outlet System</td><td>5</td></tr> <tr><td>Ditches Total</td><td>Unimproved Drainage System</td><td>1</td></tr> <tr><td>SRI Total</td><td>Medium Risk</td><td>44</td></tr> </tbody> </table>		Risk Factor	Ranking	Score	US Channel Morph	B	5	DS Channel Morph	B	5	DS Bank Alteration	NATURAL	5	Upstream Skew Angle	<5°	5	Crossing fill condition	Good/Vegetated	5	Inlet/Outlet Condition	Sed Islands/Scouring	3	Road Approach Material	All Sand/Clay	3	Potential Eroded Volume Mean	>40 y ³	1	Approach Slope Mean	>4%	1	Soil K Factor	<0.20	5	Upstream Rt Outlet	Vegetated	1	Upstream Lt Outlet	Vegetated	1	Upstream Rt Ditch	Bare soil	0	Upstream Lt Ditch	Bare soil	0	Downstream Rt Outlet	Vegetated	1	Downstream Lt Outlet	Vegetated	1	Downstream Rt Ditch	Bare soil	0	Downstream Lt Ditch	Bare soil	0	Outlet Total	Improved Outlet System	5	Ditches Total	Unimproved Drainage System	1	SRI Total	Medium Risk	44

Notes: Highly vegetated.
