Unnamed tributary		co-1103-r-013	Sedimentation Risk Index 46																																																																		
<u>Common:</u> 5.7mi NE of Opp <u>Drainage:</u> Poley Creek <u>GPS:</u> 31.356551963,-86.210525437 <u>Land owner:</u> Mary Donaldson		<u>County:</u> Covington <u>State:</u> Alabama <u>PLSS (T-R-S):</u> 5N-18E-36 <u>Parcel No.:</u> 2 <u>Road Name:</u> Piney Grove Rd

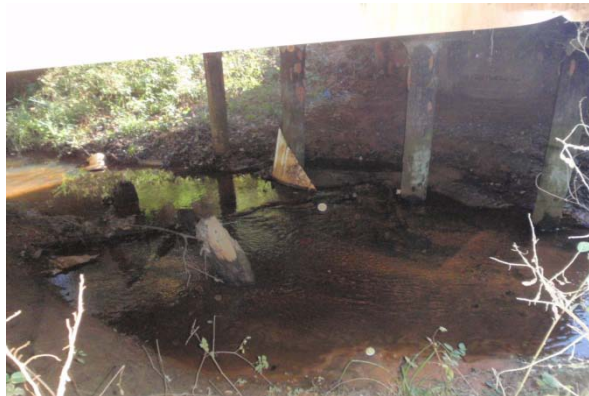
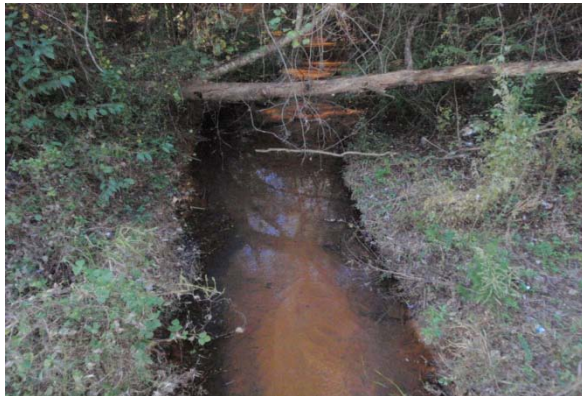
Crossing Structure: DS		DS																																																																			
<table border="1"> <thead> <tr> <th>Risk Factor</th> <th>Ranking</th> <th>Score</th> </tr> </thead> <tbody> <tr><td>US Channel Morph</td><td>C</td><td>5</td></tr> <tr><td>DS Channel Morph</td><td>C</td><td>5</td></tr> <tr><td>DS Bank Alteration</td><td>NATURAL</td><td>5</td></tr> <tr><td>Upstream Skew Angle</td><td><5°</td><td>5</td></tr> <tr><td>Crossing fill condition</td><td>Good/Vegetated</td><td>5</td></tr> <tr><td>Inlet/Outlet Condition</td><td>No Impairment</td><td>5</td></tr> <tr><td>Road Approach Material</td><td>All Sand/Clay</td><td>3</td></tr> <tr><td>Potential Eroded Volume Mean</td><td>21-40 y³</td><td>3</td></tr> <tr><td>Approach Slope Mean</td><td>>4%</td><td>1</td></tr> <tr><td>Soil K Factor</td><td>0.21-0.40</td><td>3</td></tr> <tr><td>Upstream Rt Outlet</td><td>Vegetated</td><td>1</td></tr> <tr><td>Upstream Lt Outlet</td><td>Vegetated</td><td>1</td></tr> <tr><td>Upstream Rt Ditch</td><td>Bare soil</td><td>0</td></tr> <tr><td>Upstream Lt Ditch</td><td>Bare soil</td><td>0</td></tr> <tr><td>Downstream Rt Outlet</td><td>Vegetated</td><td>1</td></tr> <tr><td>Downstream Lt Outlet</td><td>Vegetated</td><td>1</td></tr> <tr><td>Downstream Rt Ditch</td><td>Bare soil</td><td>0</td></tr> <tr><td>Downstream Lt Ditch</td><td>Bare soil</td><td>0</td></tr> <tr><td>Outlet Total</td><td>Improved Outlet System</td><td>5</td></tr> <tr><td>Ditches Total</td><td>Unimproved Drainage System</td><td>1</td></tr> <tr><td>SRI Total</td><td>Low Risk</td><td>46</td></tr> </tbody> </table>				Risk Factor	Ranking	Score	US Channel Morph	C	5	DS Channel Morph	C	5	DS Bank Alteration	NATURAL	5	Upstream Skew Angle	<5°	5	Crossing fill condition	Good/Vegetated	5	Inlet/Outlet Condition	No Impairment	5	Road Approach Material	All Sand/Clay	3	Potential Eroded Volume Mean	21-40 y ³	3	Approach Slope Mean	>4%	1	Soil K Factor	0.21-0.40	3	Upstream Rt Outlet	Vegetated	1	Upstream Lt Outlet	Vegetated	1	Upstream Rt Ditch	Bare soil	0	Upstream Lt Ditch	Bare soil	0	Downstream Rt Outlet	Vegetated	1	Downstream Lt Outlet	Vegetated	1	Downstream Rt Ditch	Bare soil	0	Downstream Lt Ditch	Bare soil	0	Outlet Total	Improved Outlet System	5	Ditches Total	Unimproved Drainage System	1	SRI Total	Low Risk	46
