Unnamed tributary		co-0810-r-009	Sedimentation Risk Index <b>40</b>																																																																		
<u>Common:</u> 8.2mi NW of Laurel Hill <u>Drainage:</u> Yellow River <i>GPS:</i> 31.072219, -86.520719 <u>Land owner:</u> R.Wayne & Dewain Bass-US, Linda Kloter-DS		<u>County:</u> Covington <u>State:</u> Alabama <u>PLSS (T-R-S):</u> 1N-15E-11 <u>Parcel No.:</u> 2; 2.02 <u>Road Name:</u> Bass Rd

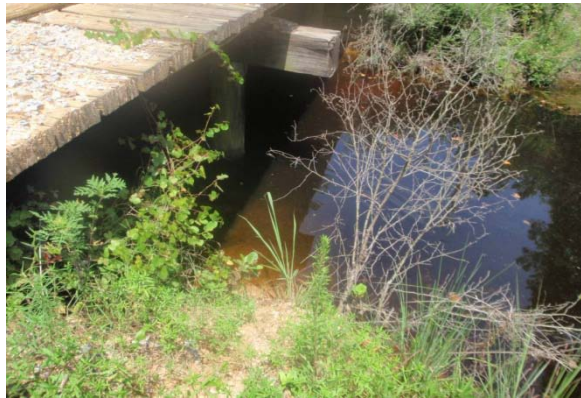
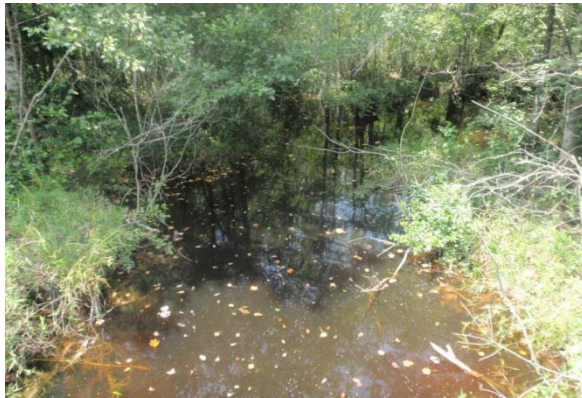
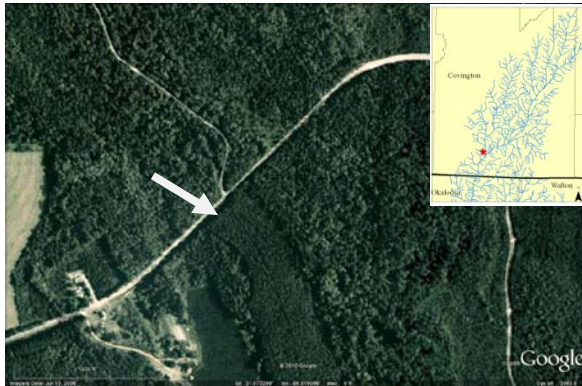
Crossing Structure: US		US																																																																			
<table border="1"> <thead> <tr> <th>Risk Factor</th> <th>Ranking</th> <th>Score</th> </tr> </thead> <tbody> <tr><td>US Channel Morph</td><td>DA</td><td>3</td></tr> <tr><td>DS Channel Morph</td><td>DA</td><td>3</td></tr> <tr><td>DS Bank Alteration</td><td>HIGH</td><td>1</td></tr> <tr><td>Upstream Skew Angle</td><td>5-30°</td><td>3</td></tr> <tr><td>Crossing fill condition</td><td>Fair/Rip Rap</td><td>3</td></tr> <tr><td>Inlet/Outlet Condition</td><td>No Impairment</td><td>5</td></tr> <tr><td>Road Approach Material</td><td>All Sand/Clay</td><td>3</td></tr> <tr><td>Potential Eroded Volume Mean</td><td>&lt;21 y<sup>3</sup></td><td>5</td></tr> <tr><td>Approach Slope Mean</td><td>2.1-4%</td><td>3</td></tr> <tr><td>Soil K Factor</td><td>&lt;0.20</td><td>5</td></tr> <tr><td>Upstream Rt Outlet</td><td>Vegetated</td><td>1</td></tr> <tr><td>Upstream Lt Outlet</td><td>Vegetated</td><td>1</td></tr> <tr><td>Upstream Rt Ditch</td><td>Bare soil</td><td>0</td></tr> <tr><td>Upstream Lt Ditch</td><td>Bare soil</td><td>0</td></tr> <tr><td>Downstream Rt Outlet</td><td>Vegetated</td><td>1</td></tr> <tr><td>Downstream Lt Outlet</td><td>Vegetated</td><td>1</td></tr> <tr><td>Downstream Rt Ditch</td><td>Bare soil</td><td>0</td></tr> <tr><td>Downstream Lt Ditch</td><td>Bare soil</td><td>0</td></tr> <tr><td>Outlet Total</td><td>Improved Outlet System</td><td>5</td></tr> <tr><td>Ditches Total</td><td>Unimproved Drainage System</td><td>1</td></tr> <tr><td><b>SRI Total</b></td><td><b>Medium Risk</b></td><td><b>40</b></td></tr> </tbody> </table>		Risk Factor	Ranking	Score	US Channel Morph	DA	3	DS Channel Morph	DA	3	DS Bank Alteration	HIGH	1	Upstream Skew Angle	5-30°	3	Crossing fill condition	Fair/Rip Rap	3	Inlet/Outlet Condition	No Impairment	5	Road Approach Material	All Sand/Clay	3	Potential Eroded Volume Mean	<21 y <sup>3</sup>	5	Approach Slope Mean	2.1-4%	3	Soil K Factor	<0.20	5	Upstream Rt Outlet	Vegetated	1	Upstream Lt Outlet	Vegetated	1	Upstream Rt Ditch	Bare soil	0	Upstream Lt Ditch	Bare soil	0	Downstream Rt Outlet	Vegetated	1	Downstream Lt Outlet	Vegetated	1	Downstream Rt Ditch	Bare soil	0	Downstream Lt Ditch	Bare soil	0	Outlet Total	Improved Outlet System	5	Ditches Total	Unimproved Drainage System	1	<b>SRI Total</b>	<b>Medium Risk</b>	<b>40</b>

Risk Factor	Ranking	Score																																																																			
US Channel Morph	DA	3																																																																			
DS Channel Morph	DA	3																																																																			
DS Bank Alteration	HIGH	1																																																																			
Upstream Skew Angle	5-30°	3																																																																			
Crossing fill condition	Fair/Rip Rap	3																																																																			
Inlet/Outlet Condition	No Impairment	5																																																																			
Road Approach Material	All Sand/Clay	3																																																																			
Potential Eroded Volume Mean	<21 y <sup>3</sup>	5																																																																			
Approach Slope Mean	2.1-4%	3

Soil K Factor	<0.20	5																																																																			
Upstream Rt Outlet	Vegetated	1																																																																			
Upstream Lt Outlet	Vegetated	1																																																																			
Upstream Rt Ditch	Bare soil	0																																																																			
Upstream Lt Ditch	Bare soil	0																																																																			
Downstream Rt Outlet	Vegetated	1																																																																			
Downstream Lt Outlet	Vegetated	1																																																																			
Downstream Rt Ditch	Bare soil	0																																																																			
Downstream Lt Ditch	Bare soil	0																																																																			
Outlet Total	Improved Outlet System	5

Ditches Total	Unimproved Drainage System	1																																																																			
<b>SRI Total</b>	<b>Medium Risk</b>	<b>40</b>																																																																			
<b>Additional Site Features</b> <u>Crossing Type and Quantity:</u> Bridge, 1 <u>Crossing Materials:</u> Wood <u>Soil Types:</u> BoB,BoC,DmB,FoA,FuB,LuB,MBA,OrB <u>Rt Approach Prism Fill:</u> 0.10in <u>Lt Approach Prism Fill:</u> 0.25in		<table border="1"> <thead> <tr> <th>Feature</th> <th>Within Range</th> <th>Descriptive Field</th> </tr> </thead> <tbody> <tr><td>303(d)</td><td>No</td><td>N/A</td></tr> <tr><td>Wetland Species</td><td>No</td><td>N/A</td></tr> <tr><td>Rare and Imperiled</td><td>No</td><td>N/A</td></tr> <tr><td>Land Use/Cover</td><td>Yes</td><td>N/A/ DEVELOPED OPEN SPACE</td></tr> <tr><td>Candidate Mussels</td><td>No</td><td>N/A</td></tr> <tr><td>Sturgeon C.H.</td><td>No</td><td>N/A</td></tr> </tbody> </table>		Feature	Within Range	Descriptive Field	303(d)	No	N/A	Wetland Species	No	N/A	Rare and Imperiled	No	N/A	Land Use/Cover	Yes	N/A/ DEVELOPED OPEN SPACE	Candidate Mussels	No	N/A	Sturgeon C.H.	No	N/A
