Larkin Creek		co-0731-r-003	Sedimentation Risk Index 44																																																																		
<u>Common:</u> 5.7mi NW of Laurel Hill <u>Drainage:</u> Yellow River <u>GPS:</u> 31.041678, -86.494814 <u>Land owner:</u> Rayonier Forest Resources		<u>County:</u> Covington <u>State:</u> Alabama <u>PLSS (T-R-S):</u> 1N-16E-19 <u>Parcel No.:</u> 1 <u>Road Name:</u> Booth Rd

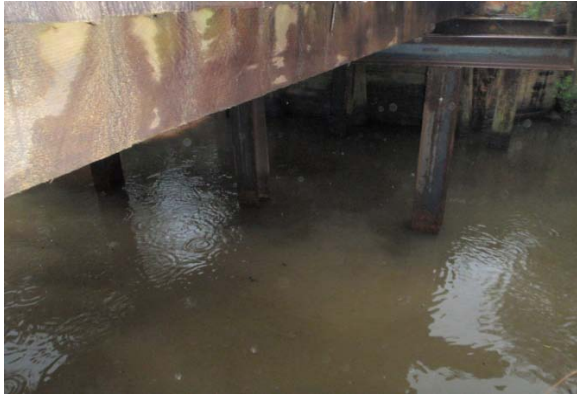
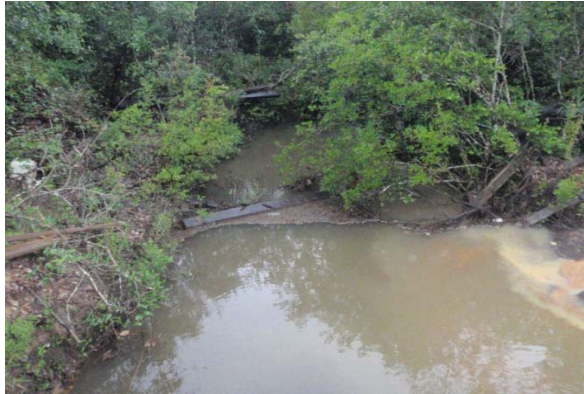
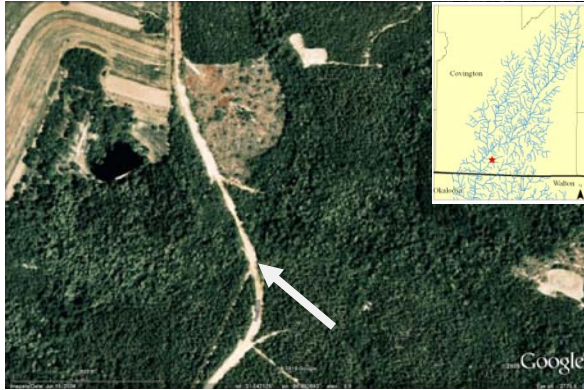
Crossing Structure: US		DS																																																																			
<table border="1"> <thead> <tr> <th>Risk Factor</th> <th>Ranking</th> <th>Score</th> </tr> </thead> <tbody> <tr><td>US Channel Morph</td><td>C</td><td>5</td></tr> <tr><td>DS Channel Morph</td><td>C</td><td>5</td></tr> <tr><td>DS Bank Alteration</td><td>MINOR/PARTIAL</td><td>3</td></tr> <tr><td>Upstream Skew Angle</td><td><5°</td><td>5</td></tr> <tr><td>Crossing fill condition</td><td>Good/Vegetated</td><td>5</td></tr> <tr><td>Inlet/Outlet Condition</td><td>No Impairment</td><td>5</td></tr> <tr><td>Road Approach Material</td><td>All Aggregate</td><td>5</td></tr> <tr><td>Potential Eroded Volume Mean</td><td>>40 y³</td><td>1</td></tr> <tr><td>Approach Slope Mean</td><td>>4%</td><td>1</td></tr> <tr><td>Soil K Factor</td><td><0.20</td><td>5</td></tr> <tr><td>Upstream Rt Outlet</td><td>Bare soil</td><td>0</td></tr> <tr><td>Upstream Lt Outlet</td><td>Bare soil</td><td>0</td></tr> <tr><td>Upstream Rt Ditch</td><td>Bare soil</td><td>0</td></tr> <tr><td>Upstream Lt Ditch</td><td>Bare soil</td><td>0</td></tr> <tr><td>Downstream Rt Outlet</td><td>Bare soil</td><td>0</td></tr> <tr><td>Downstream Lt Outlet</td><td>Vegetated</td><td>1</td></tr> <tr><td>Downstream Rt Ditch</td><td>Bare soil</td><td>0</td></tr> <tr><td>Downstream Lt Ditch</td><td>Bare soil</td><td>0</td></tr> <tr><td>Outlet Total</td><td>Partially Improved Outlet System</td><td>3</td></tr> <tr><td>Ditches Total</td><td>Unimproved Drainage System</td><td>1</td></tr> <tr><td>SRI Total</td><td>Medium Risk</td><td>44</td></tr> </tbody> </table>		Risk Factor	Ranking	Score	US Channel Morph	C	5	DS Channel Morph	C	5	DS Bank Alteration	MINOR/PARTIAL	3	Upstream Skew Angle	<5°	5	Crossing fill condition	Good/Vegetated	5	Inlet/Outlet Condition	No Impairment	5	Road Approach Material	All Aggregate	5	Potential Eroded Volume Mean	>40 y ³	1	Approach Slope Mean	>4%	1	Soil K Factor	<0.20	5	Upstream Rt Outlet	Bare soil	0	Upstream Lt Outlet	Bare soil	0	Upstream Rt Ditch	Bare soil	0	Upstream Lt Ditch	Bare soil	0	Downstream Rt Outlet	Bare soil	0	Downstream Lt Outlet	Vegetated	1	Downstream Rt Ditch	Bare soil	0	Downstream Lt Ditch	Bare soil	0	Outlet Total	Partially Improved Outlet System	3	Ditches Total	Unimproved Drainage System	1	SRI Total	Medium Risk	44

Notes: Woody debris build-up DS.
