Unnamed tributary		co-0901-r-016	Sedimentation Risk Index 46																																																																		
<u>Common:</u> 11.6mi SE of Andalusia <u>Drainage:</u> Yellow River <u>GPS:</u> 31.161090750, -86.388066995 <u>Land owner:</u> Patricia Moody		<u>County:</u> Covington <u>State:</u> Alabama <u>PLSS (T-R-S):</u> 2N-17E-7 <u>Parcel No.:</u> 2 <u>Road Name:</u> Lamar Lake Rd

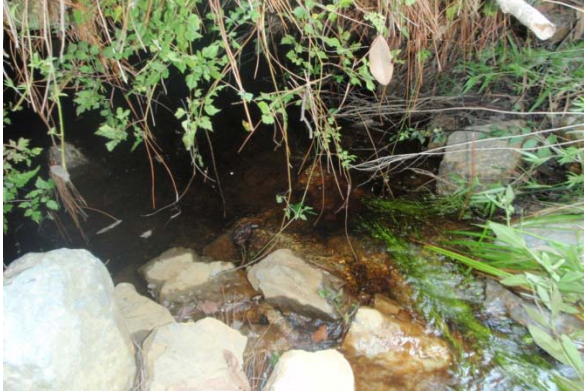
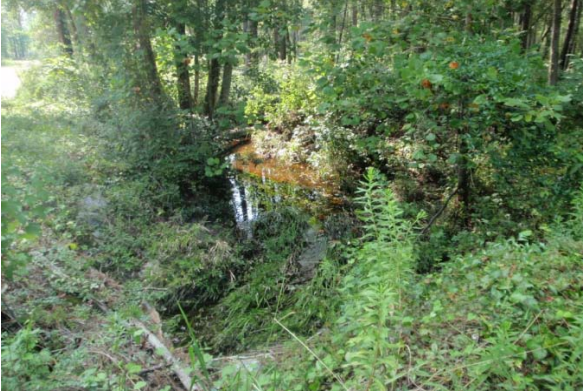
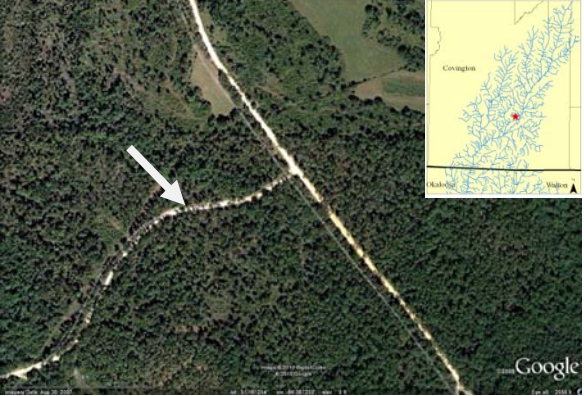
Risk Factor	Ranking	Score																																																																			
US Channel Morph	C	5																																																																			
DS Channel Morph	C	5																																																																			
DS Bank Alteration	MINOR/PARTIAL	3																																																																			
Upstream Skew Angle	>30°	1																																																																			
Crossing fill condition	Good/Vegetated	5																																																																			
Inlet/Outlet Condition	No Impairment	5																																																																			
Road Approach Material	All Sand/Clay	3																																																																			
Potential Eroded Volume Mean	>40 y ³	1																																																																			
Approach Slope Mean	<2%	5

Soil K Factor	<0.20	5																																																																			
Upstream Rt Outlet	Vegetated	1																																																																			
Upstream Lt Outlet	Vegetated	1																																																																			
Upstream Rt Ditch	Bare soil	0																																																																			
Upstream Lt Ditch	Bare soil	0																																																																			
Downstream Rt Outlet	Vegetated	1																																																																			
Downstream Lt Outlet	Vegetated	1																																																																			
Downstream Rt Ditch	Vegetated	1																																																																			
Downstream Lt Ditch	Vegetated	1																																																																			
Outlet Total	Improved Outlet System	5

Notes: Rip rap in stream bed.
