Yellow River		co-1029-r-004	Sedimentation Risk Index 52																																																																		
<u>Common:</u> 10.4mi NE of Andalusia <u>Drainage:</u> Blackwater Bay <i>GPS:</i> 31.384186700, -86.331219659 <u>Land owner:</u> Billy Henderson & Rite Odom		<u>County:</u> Covington <u>PLSS (T-R-S):</u> 5N-17E-22 <u>Parcel No.:</u> 5 <u>Road Name:</u> Lord Hill Rd

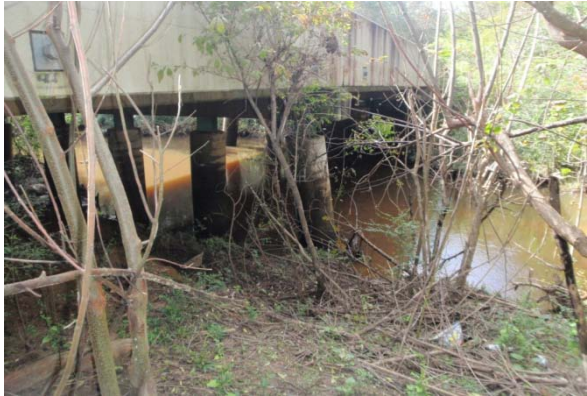
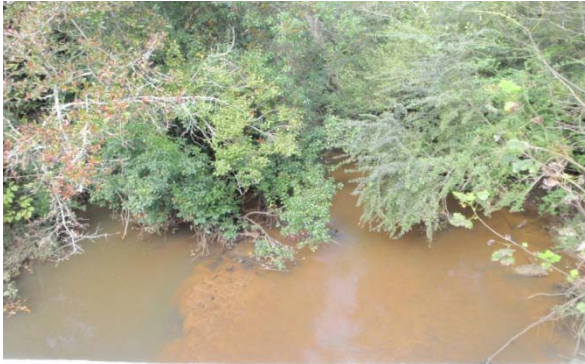
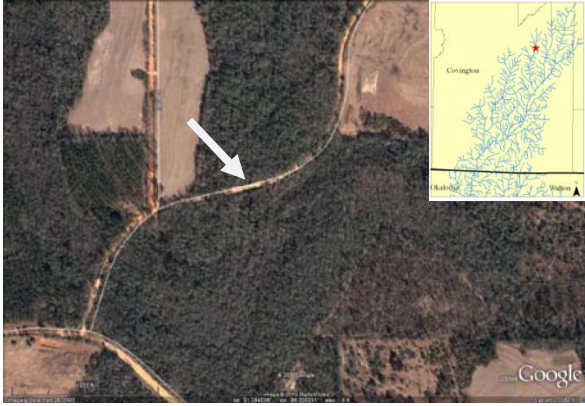
Crossing Structure: US		US																																																																			
<table border="1"> <thead> <tr> <th>Risk Factor</th> <th>Ranking</th> <th>Score</th> </tr> </thead> <tbody> <tr><td>US Channel Morph</td><td>C</td><td>5</td></tr> <tr><td>DS Channel Morph</td><td>C</td><td>5</td></tr> <tr><td>DS Bank Alteration</td><td>MINOR/PARTIAL</td><td>3</td></tr> <tr><td>Upstream Skew Angle</td><td><5°</td><td>5</td></tr> <tr><td>Crossing fill condition</td><td>Good/Vegetated</td><td>5</td></tr> <tr><td>Inlet/Outlet Condition</td><td>No Impairment</td><td>5</td></tr> <tr><td>Road Approach Material</td><td>All Sand/Clay</td><td>3</td></tr> <tr><td>Potential Eroded Volume Mean</td><td><21 y³</td><td>5</td></tr> <tr><td>Approach Slope Mean</td><td><2%</td><td>5</td></tr> <tr><td>Soil K Factor</td><td><0.20</td><td>5</td></tr> <tr><td>Upstream Rt Outlet</td><td>Vegetated</td><td>1</td></tr> <tr><td>Upstream Lt Outlet</td><td>Vegetated</td><td>1</td></tr> <tr><td>Upstream Rt Ditch</td><td>Bare soil</td><td>0</td></tr> <tr><td>Upstream Lt Ditch</td><td>Bare soil</td><td>0</td></tr> <tr><td>Downstream Rt Outlet</td><td>Vegetated</td><td>1</td></tr> <tr><td>Downstream Lt Outlet</td><td>Vegetated</td><td>1</td></tr> <tr><td>Downstream Rt Ditch</td><td>Bare soil</td><td>0</td></tr> <tr><td>Downstream Lt Ditch</td><td>Bare soil</td><td>0</td></tr> <tr><td>Outlet Total</td><td>Improved Outlet System</td><td>5</td></tr> <tr><td>Ditches Total</td><td>Unimproved Drainage System</td><td>1</td></tr> <tr><td>SRI Total</td><td>Low Risk</td><td>52</td></tr> </tbody> </table>				Risk Factor	Ranking	Score	US Channel Morph	C	5	DS Channel Morph	C	5	DS Bank Alteration	MINOR/PARTIAL	3	Upstream Skew Angle	<5°	5	Crossing fill condition	Good/Vegetated	5	Inlet/Outlet Condition	No Impairment	5	Road Approach Material	All Sand/Clay	3	Potential Eroded Volume Mean	<21 y ³	5	Approach Slope Mean	<2%	5	Soil K Factor	<0.20	5	Upstream Rt Outlet	Vegetated	1	Upstream Lt Outlet	Vegetated	1	Upstream Rt Ditch	Bare soil	0	Upstream Lt Ditch	Bare soil	0	Downstream Rt Outlet	Vegetated	1	Downstream Lt Outlet	Vegetated	1	Downstream Rt Ditch	Bare soil	0	Downstream Lt Ditch	Bare soil	0	Outlet Total	Improved Outlet System	5	Ditches Total	Unimproved Drainage System	1	SRI Total	Low Risk	52

Ditches Total	Unimproved Drainage System	1																																																																			
SRI Total	Low Risk	52																																																																			
Additional Site Features <u>Crossing Type and Quantity:</u> Bridge, 1 <u>Crossing Materials:</u> Reinforced Concrete <u>Soil Types:</u> Mba, OrC, OrE, TrD <u>Rt Approach Prism Fill:</u> 0.25in <u>Lt Approach Prism Fill:</u> 0.15in
