Unnamed tributary		co-0810-r-004		Sedimentation Risk Index 46																																																																			
<u>Common:</u> 9.5mi N of Laurel Hill <u>Drainage:</u> Yellow River <u>GPS:</u> 31.098728, -86.499981 <u>Land owner:</u> Kermit George		<u>County:</u> Covington <u>PLSS (T-R-S):</u> 2N-15E-36 <u>Parcel No.:</u> 1 <u>Road Name:</u> Bass Rd		<u>State:</u> Alabama

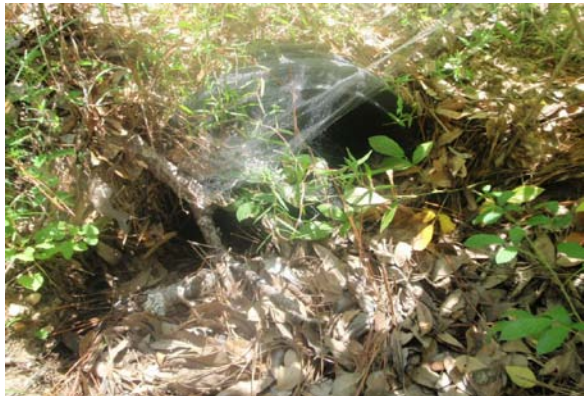
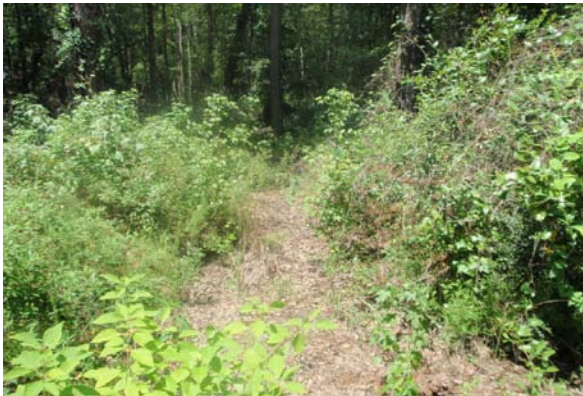
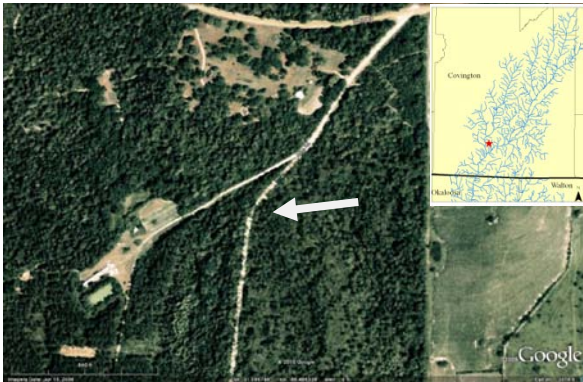
Crossing Structure: US		US																																																																					
<table border="1"> <thead> <tr> <th>Risk Factor</th> <th>Ranking</th> <th>Score</th> </tr> </thead> <tbody> <tr><td>US Channel Morph</td><td>E</td><td>5</td></tr> <tr><td>DS Channel Morph</td><td>E</td><td>5</td></tr> <tr><td>DS Bank Alteration</td><td>MINOR/PARTIAL</td><td>3</td></tr> <tr><td>Upstream Skew Angle</td><td><5°</td><td>5</td></tr> <tr><td>Crossing fill condition</td><td>Good/Vegetated</td><td>5</td></tr> <tr><td>Inlet/Outlet Condition</td><td>Blocked</td><td>1</td></tr> <tr><td>Road Approach Material</td><td>All Sand/Clay</td><td>3</td></tr> <tr><td>Potential Eroded Volume Mean</td><td><21 y³</td><td>5</td></tr> <tr><td>Approach Slope Mean</td><td><2%</td><td>5</td></tr> <tr><td>Soil K Factor</td><td><0.20</td><td>5</td></tr> <tr><td>Upstream Rt Outlet</td><td>Vegetated</td><td>1</td></tr> <tr><td>Upstream Lt Outlet</td><td>Bare soil</td><td>0</td></tr> <tr><td>Upstream Rt Ditch</td><td>Bare soil</td><td>0</td></tr> <tr><td>Upstream Lt Ditch</td><td>Bare soil</td><td>0</td></tr> <tr><td>Downstream Rt Outlet</td><td>Vegetated</td><td>1</td></tr> <tr><td>Downstream Lt Outlet</td><td>Vegetated</td><td>1</td></tr> <tr><td>Downstream Rt Ditch</td><td>Bare soil</td><td>0</td></tr> <tr><td>Downstream Lt Ditch</td><td>Bare soil</td><td>0</td></tr> <tr><td>Outlet Total</td><td>Partially Improved Outlet System</td><td>3</td></tr> <tr><td>Ditches Total</td><td>Unimproved Drainage System</td><td>1</td></tr> <tr><td>SRI Total</td><td>Low Risk</td><td>46</td></tr> </tbody> </table>		Risk Factor	Ranking	Score	US Channel Morph	E	5	DS Channel Morph	E	5	DS Bank Alteration	MINOR/PARTIAL	3	Upstream Skew Angle	<5°	5	Crossing fill condition	Good/Vegetated	5	Inlet/Outlet Condition	Blocked	1	Road Approach Material	All Sand/Clay	3	Potential Eroded Volume Mean	<21 y ³	5	Approach Slope Mean	<2%	5	Soil K Factor	<0.20	5	Upstream Rt Outlet	Vegetated	1	Upstream Lt Outlet	Bare soil	0	Upstream Rt Ditch	Bare soil	0	Upstream Lt Ditch	Bare soil	0	Downstream Rt Outlet	Vegetated	1	Downstream Lt Outlet	Vegetated	1	Downstream Rt Ditch	Bare soil	0	Downstream Lt Ditch	Bare soil	0	Outlet Total	Partially Improved Outlet System	3	Ditches Total	Unimproved Drainage System	1	SRI Total	Low Risk	46

Risk Factor	Ranking	Score																																																																					
US Channel Morph	E	5																																																																					
DS Channel Morph	E	5																																																																					
DS Bank Alteration	MINOR/PARTIAL	3																																																																					
Upstream Skew Angle	<5°	5																																																																					
Crossing fill condition	Good/Vegetated	5																																																																					
Inlet/Outlet Condition	Blocked	1																																																																					
Road Approach Material	All Sand/Clay	3																																																																					
Potential Eroded Volume Mean	<21 y ³	5																																																																					
Approach Slope Mean	<2%	5

Soil K Factor	<0.20	5																																																																					
Upstream Rt Outlet	Vegetated	1																																																																					
Upstream Lt Outlet	Bare soil	0																																																																					
Upstream Rt Ditch	Bare soil	0																																																																					
Upstream Lt Ditch	Bare soil	0																																																																					
Downstream Rt Outlet	Vegetated	1																																																																					
Downstream Lt Outlet	Vegetated	1																																																																					
Downstream Rt Ditch	Bare soil	0																																																																					
Downstream Lt Ditch	Bare soil	0																																																																					
Outlet Total	Partially Improved Outlet System	3

Ditches Total	Unimproved Drainage System	1																																																																					
SRI Total	Low Risk	46																																																																					
Additional Site Features <u>Crossing Type and Quantity:</u> Culvert, 1 <u>Crossing Materials:</u> Metal <u>Soil Types:</u> BoC, FoA, FuB <u>Rt Approach Prism Fill:</u> 0.25in <u>Lt Approach Prism Fill:</u> 0.25in		<table border="1"> <thead> <tr> <th>Feature</th> <th>Within Range</th> <th>Descriptive Field</th> </tr> </thead> <tbody> <tr> <td>303(d)</td> <td>No</td> <td>N/A</td> </tr> <tr> <td>Wetland Species</td> <td>No</td> <td>N/A</td> </tr> <tr> <td>Rare and Imperiled</td> <td>No</td> <td>N/A</td> </tr> <tr> <td>Land Use/Cover</td> <td>Yes</td> <td>N/A/ EAST GULF COASTAL PLAIN INTERIOR UPLAND LONGLEAF PINE WOODLAND- OPEN UNDERSTORY MODI</td> </tr> <tr> <td>Candidate Mussels</td> <td>No</td> <td>N/A</td> </tr> <tr> <td>Sturgeon C.H.</td> <td>No</td> <td>N/A</td> </tr> </tbody> </table>				Feature	Within Range	Descriptive Field	303(d)	No	N/A	Wetland Species	No	N/A	Rare and Imperiled	No	N/A	Land Use/Cover	Yes	N/A/ EAST GULF COASTAL PLAIN INTERIOR UPLAND LONGLEAF PINE WOODLAND- OPEN UNDERSTORY MODI	Candidate Mussels	No	N/A	Sturgeon C.H.	No	N/A
