Unnamed tributary		co-1103-r-016	Sedimentation Risk Index 52																																																																		
<u>Common:</u> 2.28 NE of Opp <u>Drainage:</u> Poley Creek <i>GPS:</i> 31.314453730,-86.245187458 <u>Land owner:</u> Palmer & Mildred Ellis East, O.J. Spurlin Heirs West		<u>County:</u> Covington <u>State:</u> Alabama <u>PLSS (T-R-S):</u> 4N-18E-15/16 <u>Parcel No.:</u> 11,8 <u>Road Name:</u> Jones Rd

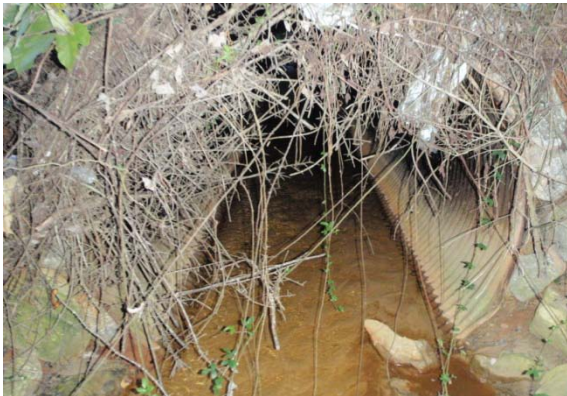
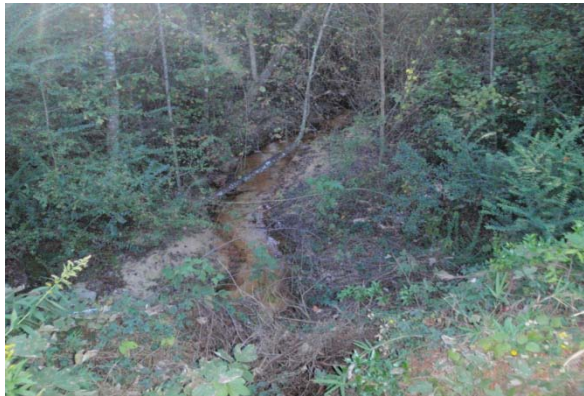
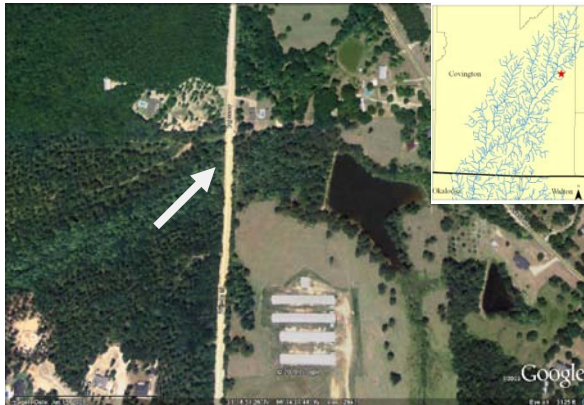
Crossing Structure: DS		DS																																																																			
<table border="1"> <thead> <tr> <th>Risk Factor</th> <th>Ranking</th> <th>Score</th> </tr> </thead> <tbody> <tr><td>US Channel Morph</td><td>E</td><td>5</td></tr> <tr><td>DS Channel Morph</td><td>E</td><td>5</td></tr> <tr><td>DS Bank Alteration</td><td>NATURAL</td><td>5</td></tr> <tr><td>Upstream Skew Angle</td><td><5°</td><td>5</td></tr> <tr><td>Crossing fill condition</td><td>Good/Vegetated</td><td>5</td></tr> <tr><td>Inlet/Outlet Condition</td><td>No Impairment</td><td>5</td></tr> <tr><td>Road Approach Material</td><td>All Aggregate</td><td>5</td></tr> <tr><td>Potential Eroded Volume Mean</td><td><21 y³</td><td>5</td></tr> <tr><td>Approach Slope Mean</td><td>2.1-4%</td><td>3</td></tr> <tr><td>Soil K Factor</td><td><0.20</td><td>5</td></tr> <tr><td>Upstream Rt Outlet</td><td>Vegetated</td><td>1</td></tr> <tr><td>Upstream Lt Outlet</td><td>Bare soil</td><td>0</td></tr> <tr><td>Upstream Rt Ditch</td><td>Bare soil</td><td>0</td></tr> <tr><td>Upstream Lt Ditch</td><td>Bare soil</td><td>0</td></tr> <tr><td>Downstream Rt Outlet</td><td>Vegetated</td><td>1</td></tr> <tr><td>Downstream Lt Outlet</td><td>Vegetated</td><td>1</td></tr> <tr><td>Downstream Rt Ditch</td><td>Bare soil</td><td>0</td></tr> <tr><td>Downstream Lt Ditch</td><td>Bare soil</td><td>0</td></tr> <tr><td>Outlet Total</td><td>Partially Improved Outlet System</td><td>3</td></tr> <tr><td>Ditches Total</td><td>Unimproved Drainage System</td><td>1</td></tr> <tr><td>SRI Total</td><td>Low Risk</td><td>52</td></tr> </tbody> </table>		Risk Factor	Ranking	Score	US Channel Morph	E	5	DS Channel Morph	E	5	DS Bank Alteration	NATURAL	5	Upstream Skew Angle	<5°	5	Crossing fill condition	Good/Vegetated	5	Inlet/Outlet Condition	No Impairment	5	Road Approach Material	All Aggregate	5	Potential Eroded Volume Mean	<21 y ³	5	Approach Slope Mean	2.1-4%	3	Soil K Factor	<0.20	5	Upstream Rt Outlet	Vegetated	1	Upstream Lt Outlet	Bare soil	0	Upstream Rt Ditch	Bare soil	0	Upstream Lt Ditch	Bare soil	0	Downstream Rt Outlet	Vegetated	1	Downstream Lt Outlet	Vegetated	1	Downstream Rt Ditch	Bare soil	0	Downstream Lt Ditch	Bare soil	0	Outlet Total	Partially Improved Outlet System	3	Ditches Total	Unimproved Drainage System	1	SRI Total	Low Risk	52

Risk Factor	Ranking	Score																																																																			
US Channel Morph	E	5																																																																			
DS Channel Morph	E	5																																																																			
DS Bank Alteration	NATURAL	5																																																																			
Upstream Skew Angle	<5°	5																																																																			
Crossing fill condition	Good/Vegetated	5																																																																			
Inlet/Outlet Condition	No Impairment	5																																																																			
Road Approach Material	All Aggregate	5																																																																			
Potential Eroded Volume Mean	<21 y ³	5																																																																			
Approach Slope Mean	2.1-4%	3

Soil K Factor	<0.20	5																																																																			
Upstream Rt Outlet	Vegetated	1																																																																			
Upstream Lt Outlet	Bare soil	0																																																																			
Upstream Rt Ditch	Bare soil	0																																																																			
Upstream Lt Ditch	Bare soil	0																																																																			
Downstream Rt Outlet	Vegetated	1																																																																			
Downstream Lt Outlet	Vegetated	1																																																																			
Downstream Rt Ditch	Bare soil	0																																																																			
Downstream Lt Ditch	Bare soil	0																																																																			
Outlet Total	Partially Improved Outlet System	3

Ditches Total	Unimproved Drainage System	1																																																																			
SRI Total	Low Risk	52																																																																			
Additional Site Features <u>Crossing Type and Quantity:</u> Culvert, 1 <u>Crossing Materials:</u> Metal <u>Soil Types:</u> BnC, CdB, CdC, MBA, OrB <u>Rt Approach Prism Fill:</u> 0.1in <u>Lt Approach Prism Fill:</u> 0.1in		<table border="1"> <thead> <tr> <th>Feature</th> <th>Within Range</th> <th>Descriptive Field</th> </tr> </thead> <tbody> <tr><td>303(d)</td><td>No</td><td>N/A</td></tr> <tr><td>Wetland Species</td><td>No</td><td>N/A</td></tr> <tr><td>Rare and Imperiled</td><td>No</td><td>N/A</td></tr> <tr><td>Land Use/ Cover</td><td>Yes</td><td>N/A/ SUCCESSIONAL SHRUB, SCRUB (OTHER)</td></tr> <tr><td>Candidate Mussels</td><td>No</td><td>N/A</td></tr> <tr><td>Sturgeon C.H.</td><td>No</td><td>N/A</td></tr> </tbody> </table>		Feature	Within Range	Descriptive Field	303(d)	No	N/A	Wetland Species	No	N/A	Rare and Imperiled	No	N/A	Land Use/ Cover	Yes	N/A/ SUCCESSIONAL SHRUB, SCRUB (OTHER)	Candidate Mussels	No	N/A	Sturgeon C.H.	No	N/A
