Pond Creek			ok-0928-001		Severity Score 9.5
<u>Common:</u> 9.8mi NE of Crestview <u>Drainage:</u> Shoal River <u>GPS:</u> 30.833902405, -86.42818011 <u>Land owner:</u> Odessa Jackson			<u>County:</u> Okaloosa <u>State:</u> Florida <u>PLSS(T-R-S):</u> 4N-22W-22 <u>Parcel No.:</u> 1

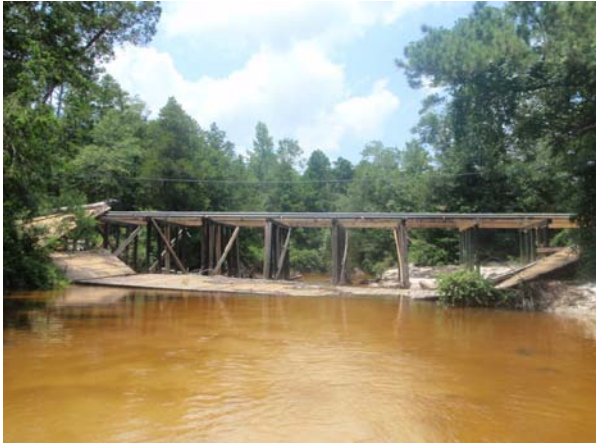
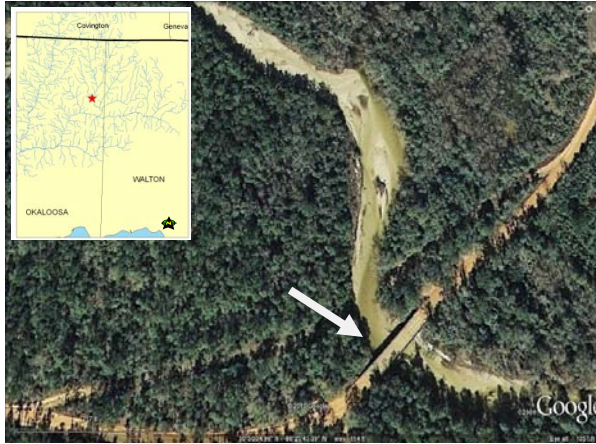
Lake Ella Rd bridge crossing- US					
Risk Factor	Ranking	Score	Feature	Within Range	Descriptive Field
Channel Stability	Good	0.5	303(d)	No	N/A
Channel Alteration	Historic	0.5	Wetland Species	No	N/A
Bank Erosion	Active	1	Rare and Imperiled	Yes	IRONCOLOR SHINER SPECKLED CHUB
BEHI	High	1	Land Use/ Cover	Yes	AGRICULTURAL/ STREAMS AND WATERWAYS
Local NPSP	Obvious Sources	1.5	Candidate Mussels	No	N/A
Shoring Structures	Present	1.5	Sturgeon C.H.	No	N/A
Pipe Discharge	Not Present	0	Additional Site Features <u>Stream Channel Woody Material:</u> Numerous <u>Impoundments:</u> Manmade (Wooden Bridge) <u>Substrate Composition:</u> Medium Sand <u>Bank Material:</u> Sand

Notes: Collapsed bridge causes a possible fish passage barrier and collects trash. Bridge blow out is likely due to high velocity flows during storm events from the widening and straightening of Pond Creek after it's confluence with Juniper Creek 0.10 miles upstream.
