Unnamed tributary		wa-0716-r-002	Sedimentation Risk Index <b>32</b>																																																																		
<u>Common:</u> 3.9mi E of Mossy Head <u>Drainage:</u> Shoal River <u>GPS:</u> 30.753471,-86.250669 <u>Land owner:</u> Claude Santer- US East, Ruth G Davenport Trust-US West, Chester & Louise Chambers-DS		<u>County:</u> Walton <u>State:</u> Florida <u>PLSS(T-R-S):</u> 3N-20-16-28060 <u>Parcel No.:</u> 24.0080; 24.0060; 25.0010 <u>Road Name:</u> W. Dogwood Rd

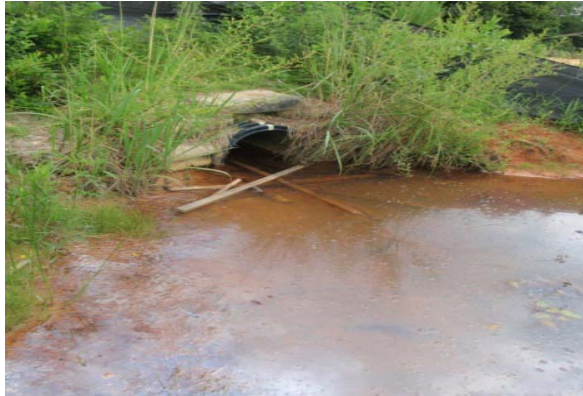
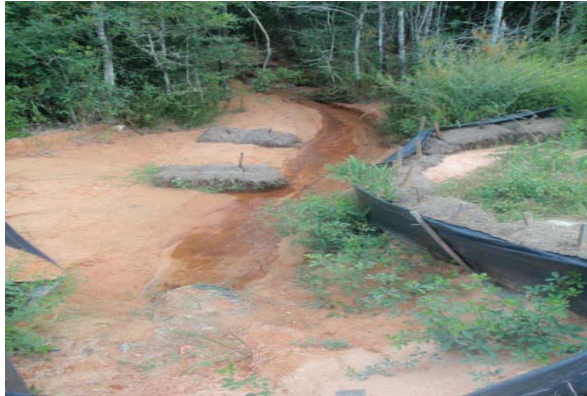
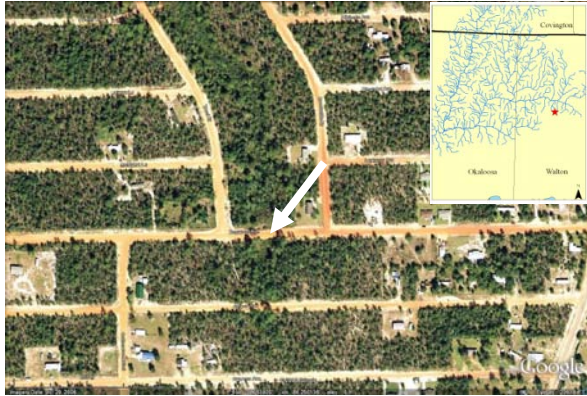
Crossing Structure: US		DS																																																																			
<table border="1"> <thead> <tr> <th>Risk Factor</th> <th>Ranking</th> <th>Score</th> </tr> </thead> <tbody> <tr><td>US Channel Morph</td><td>PONDED</td><td>1</td></tr> <tr><td>DS Channel Morph</td><td>C</td><td>5</td></tr> <tr><td>DS Bank Alteration</td><td>HIGH</td><td>1</td></tr> <tr><td>Upstream Skew Angle</td><td>5-30°</td><td>3</td></tr> <tr><td>Crossing fill condition</td><td>Fair/Rip Rap</td><td>3</td></tr> <tr><td>Inlet/Outlet Condition</td><td>Sed Islands/Scouring</td><td>3</td></tr> <tr><td>Road Approach Material</td><td>All Sand/Clay</td><td>3</td></tr> <tr><td>Potential Eroded Volume Mean</td><td>&lt;21 y<sup>3</sup></td><td>5</td></tr> <tr><td>Approach Slope Mean</td><td>2.1-4%</td><td>3</td></tr> <tr><td>Soil K Factor</td><td>0.21-0.40</td><td>3</td></tr> <tr><td>Upstream Rt Outlet</td><td>Other</td><td>0</td></tr> <tr><td>Upstream Lt Outlet</td><td>Other</td><td>0</td></tr> <tr><td>Upstream Rt Ditch</td><td>Bare soil</td><td>0</td></tr> <tr><td>Upstream Lt Ditch</td><td>Bare soil</td><td>0</td></tr> <tr><td>Downstream Rt Outlet</td><td>Other</td><td>0</td></tr> <tr><td>Downstream Lt Outlet</td><td>Other</td><td>0</td></tr> <tr><td>Downstream Rt Ditch</td><td>Bare soil</td><td>0</td></tr> <tr><td>Downstream Lt Ditch</td><td>Bare soil</td><td>0</td></tr> <tr><td>Outlet Total</td><td>Unimproved Outlet System</td><td>1</td></tr> <tr><td>Ditches Total</td><td>Unimproved Drainage System</td><td>1</td></tr> <tr><td><b>SRI Total</b></td><td><b>High Risk</b></td><td><b>32</b></td></tr> </tbody> </table>		Risk Factor	Ranking	Score	US Channel Morph	PONDED	1	DS Channel Morph	C	5	DS Bank Alteration	HIGH	1	Upstream Skew Angle	5-30°	3	Crossing fill condition	Fair/Rip Rap	3	Inlet/Outlet Condition	Sed Islands/Scouring	3	Road Approach Material	All Sand/Clay	3	Potential Eroded Volume Mean	<21 y <sup>3</sup>	5	Approach Slope Mean	2.1-4%	3	Soil K Factor	0.21-0.40	3	Upstream Rt Outlet	Other	0	Upstream Lt Outlet	Other	0	Upstream Rt Ditch	Bare soil	0	Upstream Lt Ditch	Bare soil	0	Downstream Rt Outlet	Other	0	Downstream Lt Outlet	Other	0	Downstream Rt Ditch	Bare soil	0	Downstream Lt Ditch	Bare soil	0	Outlet Total	Unimproved Outlet System	1	Ditches Total	Unimproved Drainage System	1	<b>SRI Total</b>	<b>High Risk</b>	<b>32</b>

Notes: BMPs installed
