Murder Creek		ok-1105-003		Severity Score 4.75	
<u>Common:</u> 6.2mi SW of Laurel Hill, 0.2 miles DS from Senterfitt Rd. <u>Drainage:</u> Yellow River <u>GPS:</u> 30.893281952, -86.522234328 <u>Land owner:</u> Lisa Jenkins		<u>County:</u> Okaloosa <u>State:</u> Florida <u>PLSS(T-R-S):</u> 5N-23W-35 <u>Parcel No.:</u> 1

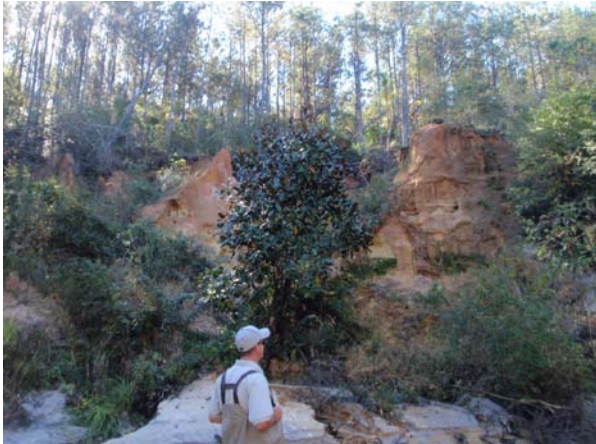
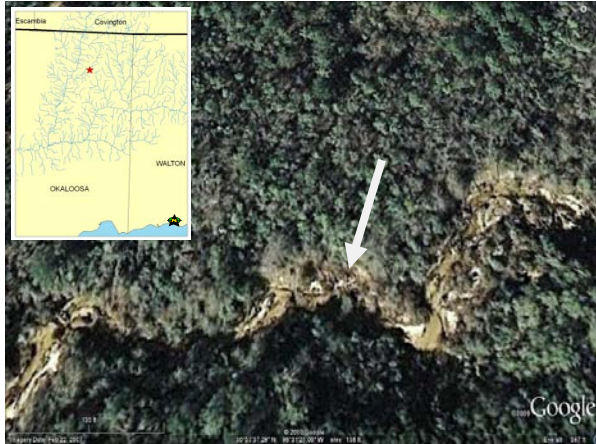
Notes: Characteristic of the banks along the reach 0.5mi below Senterfitt Rd crossing. High sediment loads within stream.
