Shoal River		ok-0616-005		Severity Score 2.5	
<u>Common:</u> 3.9mi E of Crestview <u>Drainage:</u> Yellow River <u>GPS:</u> 30.75743615, -86.50566681 <u>Land owner:</u> Rita Chimiak		<u>County:</u> Okaloosa <u>PLSS:</u> 3N-23W-11 <u>Parcel No.:</u> 2		<u>State:</u> Florida

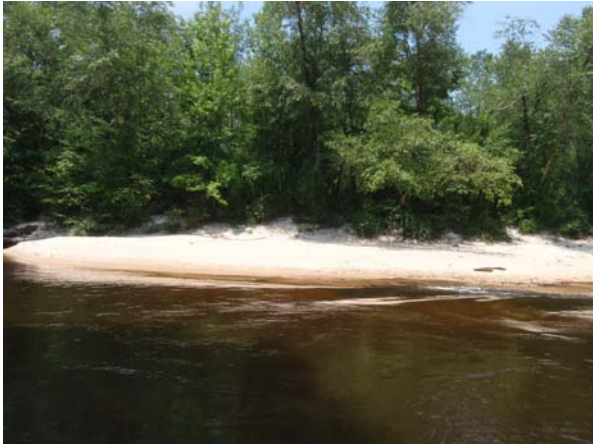
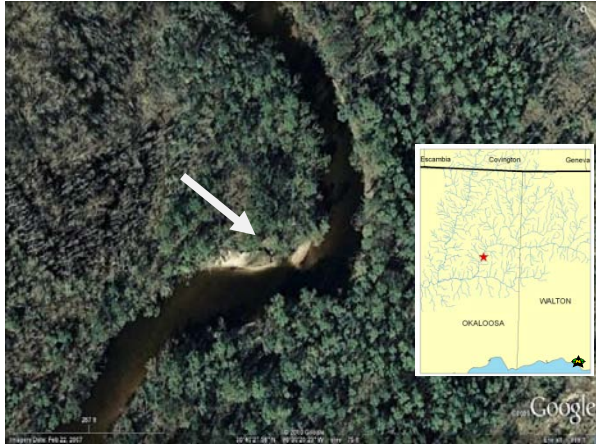
Notes: Aggradational site: Some localized deposition along top of low bank. Moderate number of deep pools. Erosion opposite depositional sites. Public access for recreation, trail leading to RB. OFW
