Shoal River		ok-0615-006		Severity Score 4.5	
<u>Common:</u> 7.7mi NE of Crestview <u>Drainage:</u> Yellow River <u>GPS:</u> 30.79211924, -86.442472064 <u>Land owner:</u> Haiseal Timber Co		<u>County:</u> Okaloosa <u>PLSS(T-R-S):</u> 3N-22W-4 <u>Parcel No.:</u> 4		<u>State:</u> Florida

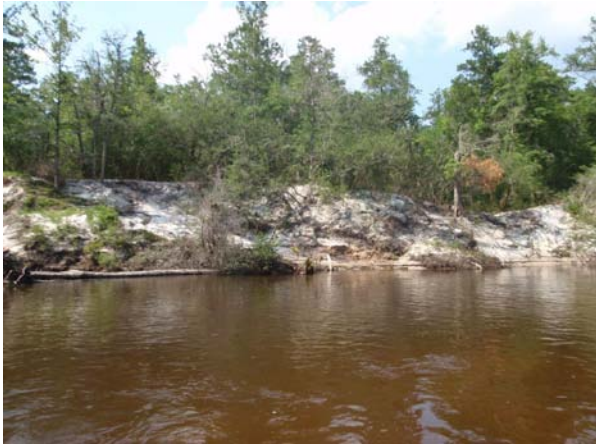
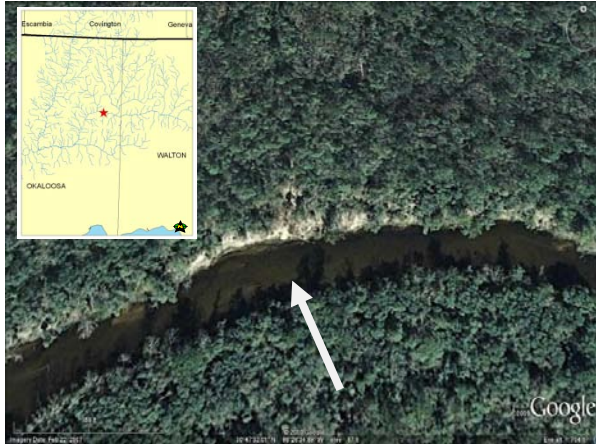
RB					
Risk Factor	Ranking	Score	Feature	Within Range	Descriptive Field
Channel Stability	Fair	1	303(d)	No	N/A
Channel Alteration	None	0	Wetland Species	Yes	1-3 FOCAL SPECIES IN WETLAND AREAS
Bank Erosion	Active	1	Rare and Imperiled	Yes	GOLDSTRIPE DARTER, IRONCOLOR SHINER
BEHI	High	1	Land Use/ Cover	Yes	N/A/ STREAMS AND WATERWAYS
Local NPSP	No Evidence	0	Candidate Mussels	No	N/A
Shoring Structures	Not Present	0	Sturgeon C.H.	No	N/A
Pipe Discharge	Not Present	0			
Water Odors	Not Present	0			
Fish Passage Barrier	Not Present	0			
RB: Riparian Buffer	0-29 ft	0.75			
LB: Riparian Buffer	100+ ft	0			
RB: Floodplain Access	None	0.75

Notes: Natural meander erosion.
