Unnamed tributary		co-0820-r-002	Sedimentation Risk Index 32																																																																		
<u>Common:</u> 4.0mi N of Florala <u>Drainage:</u> Clear Creek <u>GPS:</u> 31.061369177, -86.337699081 <u>Land owner:</u> Rayonier Forest Resources LP		<u>County:</u> Covington <u>State:</u> Alabama <u>PLSS (T-R-S):</u> 1N-17E-10 <u>Parcel No.:</u> 1 <u>Road Name:</u> Tram Rd

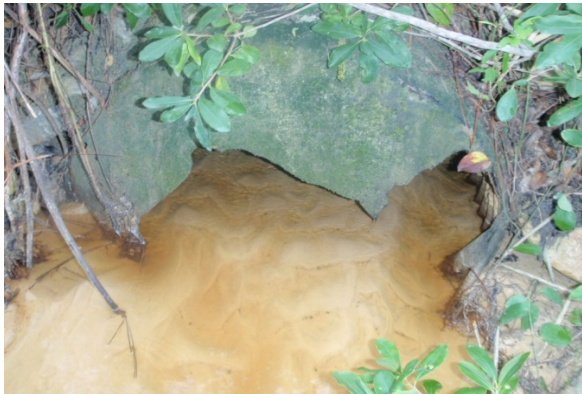
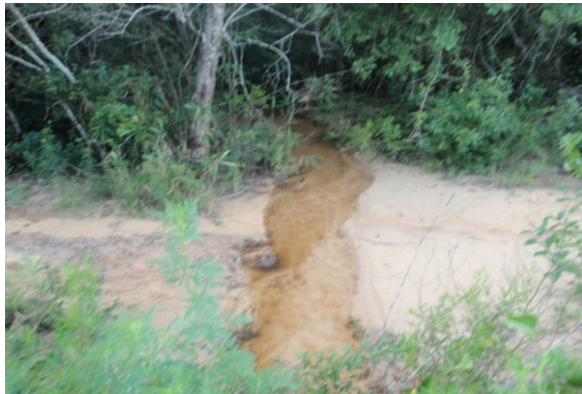
Crossing Structure: DS		DS																																																																			
<table border="1"> <thead> <tr> <th>Risk Factor</th> <th>Ranking</th> <th>Score</th> </tr> </thead> <tbody> <tr><td>US Channel Morph</td><td>E</td><td>5</td></tr> <tr><td>DS Channel Morph</td><td>E</td><td>5</td></tr> <tr><td>DS Bank Alteration</td><td>HIGH</td><td>1</td></tr> <tr><td>Upstream Skew Angle</td><td>5-30°</td><td>3</td></tr> <tr><td>Crossing fill condition</td><td>Poor/Bare soil</td><td>1</td></tr> <tr><td>Inlet/Outlet Condition</td><td>Sed Islands/Scouring</td><td>3</td></tr> <tr><td>Road Approach Material</td><td>All Sand/Clay</td><td>3</td></tr> <tr><td>Potential Eroded Volume Mean</td><td>>40 y³</td><td>1</td></tr> <tr><td>Approach Slope Mean</td><td>2.1-4%</td><td>3</td></tr> <tr><td>Soil K Factor</td><td><0.20</td><td>5</td></tr> <tr><td>Upstream Rt Outlet</td><td>Bare soil</td><td>0</td></tr> <tr><td>Upstream Lt Outlet</td><td>Bare soil</td><td>0</td></tr> <tr><td>Upstream Rt Ditch</td><td>Bare soil</td><td>0</td></tr> <tr><td>Upstream Lt Ditch</td><td>Bare soil</td><td>0</td></tr> <tr><td>Downstream Rt Outlet</td><td>Bare soil</td><td>0</td></tr> <tr><td>Downstream Lt Outlet</td><td>Bare soil</td><td>0</td></tr> <tr><td>Downstream Rt Ditch</td><td>Bare soil</td><td>0</td></tr> <tr><td>Downstream Lt Ditch</td><td>Bare soil</td><td>0</td></tr> <tr><td>Outlet Total</td><td>Unimproved Outlet System</td><td>1</td></tr> <tr><td>Ditches Total</td><td>Unimproved Drainage System</td><td>1</td></tr> <tr><td>SRI Total</td><td>High Risk</td><td>32</td></tr> </tbody> </table>		Risk Factor	Ranking	Score	US Channel Morph	E	5	DS Channel Morph	E	5	DS Bank Alteration	HIGH	1	Upstream Skew Angle	5-30°	3	Crossing fill condition	Poor/Bare soil	1	Inlet/Outlet Condition	Sed Islands/Scouring	3	Road Approach Material	All Sand/Clay	3	Potential Eroded Volume Mean	>40 y ³	1	Approach Slope Mean	2.1-4%	3	Soil K Factor	<0.20	5	Upstream Rt Outlet	Bare soil	0	Upstream Lt Outlet	Bare soil	0	Upstream Rt Ditch	Bare soil	0	Upstream Lt Ditch	Bare soil	0	Downstream Rt Outlet	Bare soil	0	Downstream Lt Outlet	Bare soil	0	Downstream Rt Ditch	Bare soil	0	Downstream Lt Ditch	Bare soil	0	Outlet Total	Unimproved Outlet System	1	Ditches Total	Unimproved Drainage System	1	SRI Total	High Risk	32

Notes: DS sediment loaded.
