Horsehead Creek		co-0731-r-012	Sedimentation Risk Index <b>46</b>																																																																		
<u>Common:</u> 4.7mi SW of Florala <u>Drainage:</u> Pond Creek <i>GPS:</i> 30.995696, -86.406183 <u>Land owner:</u> Rayonier Forest Resources LP		<u>County:</u> Covington <i>State:</i> Alabama <u>PLSS (T-R-S):</u> 6N-22W-26 <u>Parcel No.:</u> 1 <u>Road Name:</u> Davis Rd

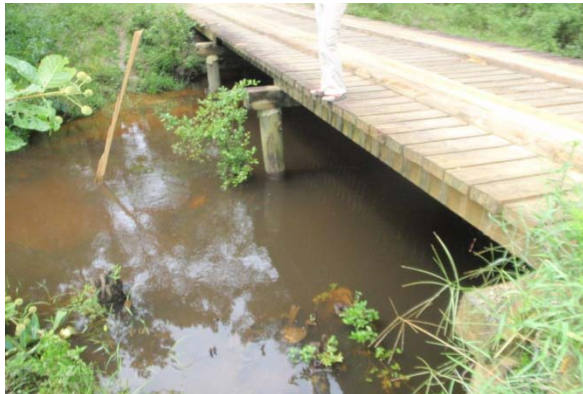
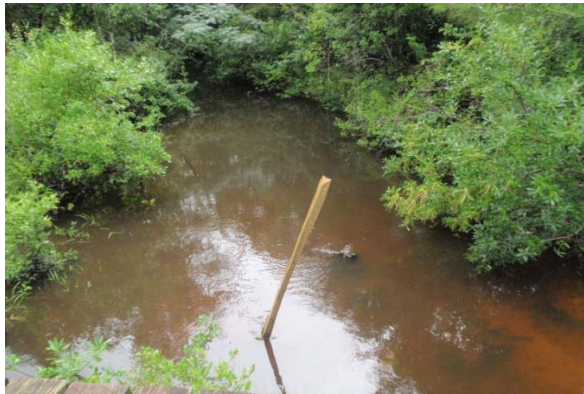
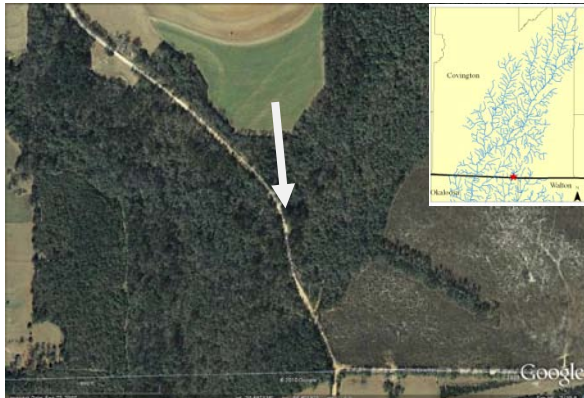
Crossing Structure: DS		DS																																																																			
<table border="1"> <thead> <tr> <th>Risk Factor</th> <th>Ranking</th> <th>Score</th> </tr> </thead> <tbody> <tr><td>US Channel Morph</td><td>DA</td><td>3</td></tr> <tr><td>DS Channel Morph</td><td>C</td><td>5</td></tr> <tr><td>DS Bank Alteration</td><td>MINOR/PARTIAL</td><td>3</td></tr> <tr><td>Upstream Skew Angle</td><td>&lt;5°</td><td>5</td></tr> <tr><td>Crossing fill condition</td><td>Fair/Rip Rap</td><td>3</td></tr> <tr><td>Inlet/Outlet Condition</td><td>No Impairment</td><td>5</td></tr> <tr><td>Road Approach Material</td><td>All Sand/Clay</td><td>3</td></tr> <tr><td>Potential Eroded Volume Mean</td><td>&lt;21 y<sup>3</sup></td><td>5</td></tr> <tr><td>Approach Slope Mean</td><td>&gt;4%</td><td>1</td></tr> <tr><td>Soil K Factor</td><td>&lt;0.20</td><td>5</td></tr> <tr><td>Upstream Rt Outlet</td><td>Vegetated</td><td>1</td></tr> <tr><td>Upstream Lt Outlet</td><td>Vegetated</td><td>1</td></tr> <tr><td>Upstream Rt Ditch</td><td>Synthetic</td><td>1</td></tr> <tr><td>Upstream Lt Ditch</td><td>Bare soil</td><td>0</td></tr> <tr><td>Downstream Rt Outlet</td><td>Vegetated</td><td>1</td></tr> <tr><td>Downstream Lt Outlet</td><td>Vegetated</td><td>1</td></tr> <tr><td>Downstream Rt Ditch</td><td>Bare soil</td><td>0</td></tr> <tr><td>Downstream Lt Ditch</td><td>Bare soil</td><td>0</td></tr> <tr><td>Outlet Total</td><td>Improved Outlet System</td><td>5</td></tr> <tr><td>Ditches Total</td><td>Partially Improved Drainage System</td><td>3</td></tr> <tr><td><b>SRI Total</b></td><td><b>Low Risk</b></td><td><b>46</b></td></tr> </tbody> </table>		Risk Factor	Ranking	Score	US Channel Morph	DA	3	DS Channel Morph	C	5	DS Bank Alteration	MINOR/PARTIAL	3	Upstream Skew Angle	<5°	5	Crossing fill condition	Fair/Rip Rap	3	Inlet/Outlet Condition	No Impairment	5	Road Approach Material	All Sand/Clay	3	Potential Eroded Volume Mean	<21 y <sup>3</sup>	5	Approach Slope Mean	>4%	1	Soil K Factor	<0.20	5	Upstream Rt Outlet	Vegetated	1	Upstream Lt Outlet	Vegetated	1	Upstream Rt Ditch	Synthetic	1	Upstream Lt Ditch	Bare soil	0	Downstream Rt Outlet	Vegetated	1	Downstream Lt Outlet	Vegetated	1	Downstream Rt Ditch	Bare soil	0	Downstream Lt Ditch	Bare soil	0	Outlet Total	Improved Outlet System	5	Ditches Total	Partially Improved Drainage System	3	<b>SRI Total</b>	<b>Low Risk</b>	<b>46</b>

Risk Factor	Ranking	Score																																																																			
US Channel Morph	DA	3																																																																			
DS Channel Morph	C	5																																																																			
DS Bank Alteration	MINOR/PARTIAL	3																																																																			
Upstream Skew Angle	<5°	5																																																																			
Crossing fill condition	Fair/Rip Rap	3																																																																			
Inlet/Outlet Condition	No Impairment	5																																																																			
Road Approach Material	All Sand/Clay	3																																																																			
Potential Eroded Volume Mean	<21 y <sup>3</sup>	5																																																																			
Approach Slope Mean	>4%	1

Soil K Factor	<0.20	5																																																																			
Upstream Rt Outlet	Vegetated	1																																																																			
Upstream Lt Outlet	Vegetated	1																																																																			
Upstream Rt Ditch	Synthetic	1																																																																			
Upstream Lt Ditch	Bare soil	0																																																																			
Downstream Rt Outlet	Vegetated	1																																																																			
Downstream Lt Outlet	Vegetated	1																																																																			
Downstream Rt Ditch	Bare soil	0																																																																			
Downstream Lt Ditch	Bare soil	0																																																																			
Outlet Total	Improved Outlet System	5

Ditches Total	Partially Improved Drainage System	3																																																																			
<b>SRI Total</b>	<b>Low Risk</b>	<b>46</b>																																																																			
<b>Additional Site Features</b> <u>Crossing Type and Quantity:</u> Bridge, 1 <u>Crossing Materials:</u> Wood <u>Soil Types:</u> BoC,DmB,EuA,FuB,MBA,TrD <u>Rt Approach Prism Fill:</u> 0.25in <u>Lt Approach Prism Fill:</u> 0.1in		<table border="1"> <thead> <tr> <th>Feature</th> <th>Within Range</th> <th>Descriptive Field</th> </tr> </thead> <tbody> <tr><td>303(d)</td><td>No</td><td>N/A</td></tr> <tr><td>Wetland Species</td><td>No</td><td>N/A</td></tr> <tr><td>Rare and Imperiled</td><td>No</td><td>N/A</td></tr> <tr><td>Land Use/Cover</td><td>No</td><td>N/A</td></tr> <tr><td>Candidate Mussels</td><td>No</td><td>N/A</td></tr> <tr><td>Sturgeon C.H.</td><td>No</td><td>N/A</td></tr> </tbody> </table>		Feature	Within Range	Descriptive Field	303(d)	No	N/A	Wetland Species	No	N/A	Rare and Imperiled	No	N/A	Land Use/Cover	No	N/A	Candidate Mussels	No	N/A	Sturgeon C.H.	No	N/A
