Unnamed tributary		co-0901-r-009	Sedimentation Risk Index <b>44</b>																																																																		
<u>Common:</u> 12.0mi NW of Florala <u>Drainage:</u> Poplar Creek <u>GPS:</u> 31.151824411, -86.435759804 <u>Land owner:</u> Mildred Bulger -US, Paul & Sara Mixson -DS		<u>County:</u> Covington <u>State:</u> Alabama <u>PLSS (T-R-S):</u> 2N-16E-10 <u>Parcel No.:</u> 14; 14.03 <u>Road Name:</u> Bulger Town Rd

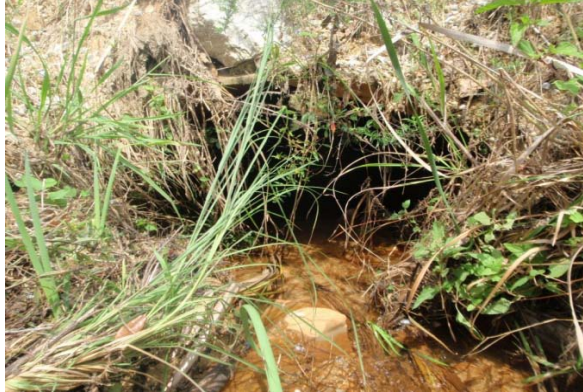
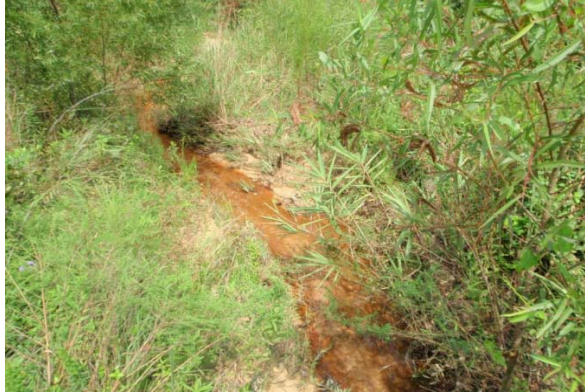
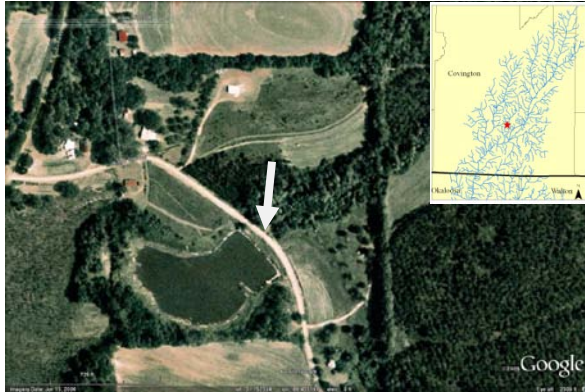
Crossing Structure: US		DS																																																																			
<table border="1"> <thead> <tr> <th>Risk Factor</th> <th>Ranking</th> <th>Score</th> </tr> </thead> <tbody> <tr><td>US Channel Morph</td><td>PONDED</td><td>1</td></tr> <tr><td>DS Channel Morph</td><td>E</td><td>5</td></tr> <tr><td>DS Bank Alteration</td><td>MINOR/PARTIAL</td><td>3</td></tr> <tr><td>Upstream Skew Angle</td><td>&lt;5°</td><td>5</td></tr> <tr><td>Crossing fill condition</td><td>Fair/Rip Rap</td><td>3</td></tr> <tr><td>Inlet/Outlet Condition</td><td>Sed Islands/Scouring</td><td>3</td></tr> <tr><td>Road Approach Material</td><td>All Aggregate</td><td>5</td></tr> <tr><td>Potential Eroded Volume Mean</td><td>&lt;21 y<sup>3</sup></td><td>5</td></tr> <tr><td>Approach Slope Mean</td><td>&lt;2%</td><td>5</td></tr> <tr><td>Soil K Factor</td><td>0.21-0.40</td><td>3</td></tr> <tr><td>Upstream Rt Outlet</td><td>Vegetated</td><td>1</td></tr> <tr><td>Upstream Lt Outlet</td><td>Vegetated</td><td>1</td></tr> <tr><td>Upstream Rt Ditch</td><td>Bare soil</td><td>0</td></tr> <tr><td>Upstream Lt Ditch</td><td>Bare soil</td><td>0</td></tr> <tr><td>Downstream Rt Outlet</td><td>Vegetated</td><td>1</td></tr> <tr><td>Downstream Lt Outlet</td><td>Vegetated</td><td>1</td></tr> <tr><td>Downstream Rt Ditch</td><td>Bare soil</td><td>0</td></tr> <tr><td>Downstream Lt Ditch</td><td>Bare soil</td><td>0</td></tr> <tr><td>Outlet Total</td><td>Improved Outlet System</td><td>5</td></tr> <tr><td>Ditches Total</td><td>Unimproved Drainage System</td><td>1</td></tr> <tr><td><b>SRI Total</b></td><td><b>Medium Risk</b></td><td><b>44</b></td></tr> </tbody> </table>		Risk Factor	Ranking	Score	US Channel Morph	PONDED	1	DS Channel Morph	E	5	DS Bank Alteration	MINOR/PARTIAL	3	Upstream Skew Angle	<5°	5	Crossing fill condition	Fair/Rip Rap	3	Inlet/Outlet Condition	Sed Islands/Scouring	3	Road Approach Material	All Aggregate	5	Potential Eroded Volume Mean	<21 y <sup>3</sup>	5	Approach Slope Mean	<2%	5	Soil K Factor	0.21-0.40	3	Upstream Rt Outlet	Vegetated	1	Upstream Lt Outlet	Vegetated	1	Upstream Rt Ditch	Bare soil	0	Upstream Lt Ditch	Bare soil	0	Downstream Rt Outlet	Vegetated	1	Downstream Lt Outlet	Vegetated	1	Downstream Rt Ditch	Bare soil	0	Downstream Lt Ditch	Bare soil	0	Outlet Total	Improved Outlet System	5	Ditches Total	Unimproved Drainage System	1	<b>SRI Total</b>	<b>Medium Risk</b>	<b>44</b>
