Unnamed tributary		co-0901-r-006		Sedimentation Risk Index 46																																																																			
<u>Common:</u> 9.5mi S of Andalusia <u>Drainage:</u> Poplar Creek <u>GPS:</u> 31.174115807, -86.444146358 <u>Land owner:</u> RTG1 LP (Dixon)		<u>County:</u> Covington <u>PLSS (T-R-S):</u> 2N-16E-3 <u>Parcel No.:</u> 2.01 <u>Road Name:</u> Braswell Rd		<u>State:</u> Alabama

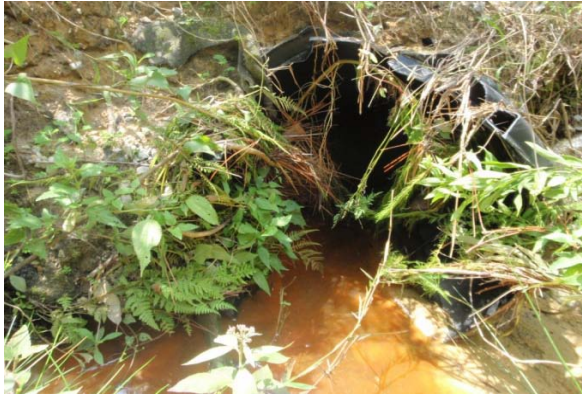
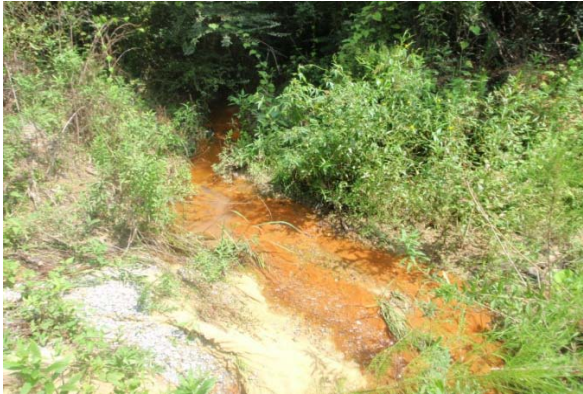
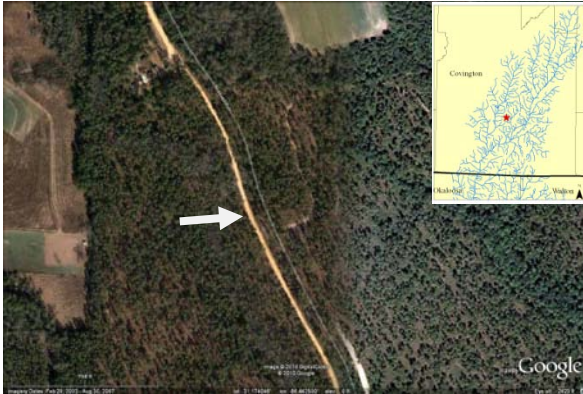
Crossing Structure: US		US																																																																					
<table border="1"> <thead> <tr> <th>Risk Factor</th> <th>Ranking</th> <th>Score</th> </tr> </thead> <tbody> <tr><td>US Channel Morph</td><td>E</td><td>5</td></tr> <tr><td>DS Channel Morph</td><td>E</td><td>5</td></tr> <tr><td>DS Bank Alteration</td><td>MINOR/PARTIAL</td><td>3</td></tr> <tr><td>Upstream Skew Angle</td><td><5°</td><td>5</td></tr> <tr><td>Crossing fill condition</td><td>Fair/Rip Rap</td><td>3</td></tr> <tr><td>Inlet/Outlet Condition</td><td>Sed Islands/Scouring</td><td>3</td></tr> <tr><td>Road Approach Material</td><td>All Sand/Clay</td><td>3</td></tr> <tr><td>Potential Eroded Volume Mean</td><td><21 y³</td><td>5</td></tr> <tr><td>Approach Slope Mean</td><td><2%</td><td>5</td></tr> <tr><td>Soil K Factor</td><td><0.20</td><td>5</td></tr> <tr><td>Upstream Rt Outlet</td><td>Bare soil</td><td>0</td></tr> <tr><td>Upstream Lt Outlet</td><td>Bare soil</td><td>0</td></tr> <tr><td>Upstream Rt Ditch</td><td>Bare soil</td><td>0</td></tr> <tr><td>Upstream Lt Ditch</td><td>Bare soil</td><td>0</td></tr> <tr><td>Downstream Rt Outlet</td><td>Rip Rap</td><td>1</td></tr> <tr><td>Downstream Lt Outlet</td><td>Vegetated</td><td>1</td></tr> <tr><td>Downstream Rt Ditch</td><td>Bare soil</td><td>0</td></tr> <tr><td>Downstream Lt Ditch</td><td>Bare soil</td><td>0</td></tr> <tr><td>Outlet Total</td><td>Partially Improved Outlet System</td><td>3</td></tr> <tr><td>Ditches Total</td><td>Unimproved Drainage System</td><td>1</td></tr> <tr><td>SRI Total</td><td>Low Risk</td><td>46</td></tr> </tbody> </table>		Risk Factor	Ranking	Score	US Channel Morph	E	5	DS Channel Morph	E	5	DS Bank Alteration	MINOR/PARTIAL	3	Upstream Skew Angle	<5°	5	Crossing fill condition	Fair/Rip Rap	3	Inlet/Outlet Condition	Sed Islands/Scouring	3	Road Approach Material	All Sand/Clay	3	Potential Eroded Volume Mean	<21 y ³	5	Approach Slope Mean	<2%	5	Soil K Factor	<0.20	5	Upstream Rt Outlet	Bare soil	0	Upstream Lt Outlet	Bare soil	0	Upstream Rt Ditch	Bare soil	0	Upstream Lt Ditch	Bare soil	0	Downstream Rt Outlet	Rip Rap	1	Downstream Lt Outlet	Vegetated	1	Downstream Rt Ditch	Bare soil	0	Downstream Lt Ditch	Bare soil	0	Outlet Total	Partially Improved Outlet System	3	Ditches Total	Unimproved Drainage System	1	SRI Total	Low Risk	46

Notes: Old aggregate washed into outlets
