Unnamed tributary		wa-0716-r-003b	Sedimentation Risk Index <b>34</b>																																																																		
<u>Common:</u> 3.8mi NE of Mossy Head <u>Drainage:</u> Shoal River <u>GPS:</u> 30.756684, -86.252618 <u>Land owner:</u> Helen Bright-US, Unknown DS		<u>County:</u> Walton <u>State:</u> Florida <u>PLSS(T-R-S):</u> 3N-20-16-28060 <u>Parcel No.:</u> 9.0150 <u>Road Name:</u> Trout Rd

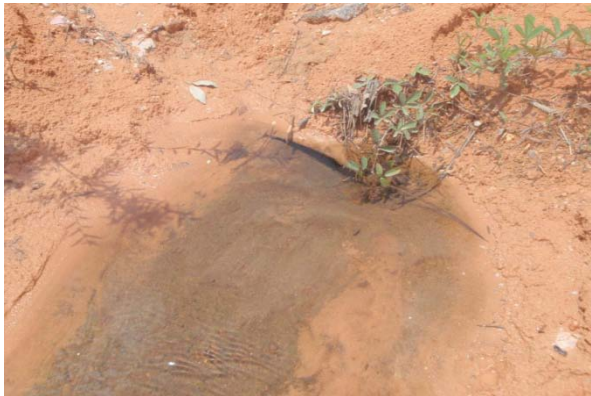
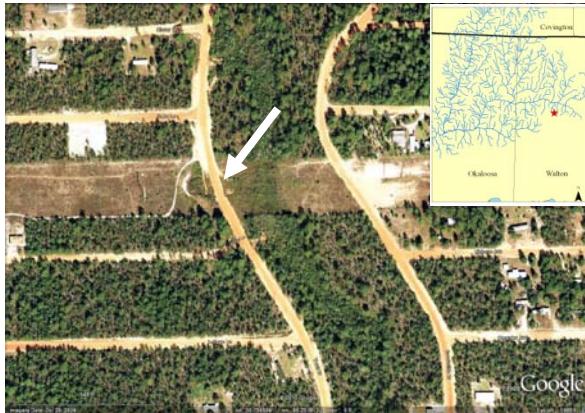
Crossing Structure: DS		DS																																																																			
<table border="1"> <thead> <tr> <th>Risk Factor</th> <th>Ranking</th> <th>Score</th> </tr> </thead> <tbody> <tr><td>US Channel Morph</td><td>DA</td><td>3</td></tr> <tr><td>DS Channel Morph</td><td>DA</td><td>3</td></tr> <tr><td>DS Bank Alteration</td><td>HIGH</td><td>1</td></tr> <tr><td>Upstream Skew Angle</td><td>&lt;5°</td><td>5</td></tr> <tr><td>Crossing fill condition</td><td>Poor/Bare soil</td><td>1</td></tr> <tr><td>Inlet/Outlet Condition</td><td>Sed Islands/Scouring</td><td>3</td></tr> <tr><td>Road Approach Material</td><td>All Sand/Clay</td><td>3</td></tr> <tr><td>Potential Eroded Volume Mean</td><td>&lt;21 y<sup>3</sup></td><td>5</td></tr> <tr><td>Approach Slope Mean</td><td>2.1-4%</td><td>3</td></tr> <tr><td>Soil K Factor</td><td>&lt;0.20</td><td>5</td></tr> <tr><td>Upstream Rt Outlet</td><td>Bare soil</td><td>0</td></tr> <tr><td>Upstream Lt Outlet</td><td>Bare soil</td><td>0</td></tr> <tr><td>Upstream Rt Ditch</td><td>Bare soil</td><td>0</td></tr> <tr><td>Upstream Lt Ditch</td><td>Bare soil</td><td>0</td></tr> <tr><td>Downstream Rt Outlet</td><td>Bare soil</td><td>0</td></tr> <tr><td>Downstream Lt Outlet</td><td>Bare soil</td><td>0</td></tr> <tr><td>Downstream Rt Ditch</td><td>Bare soil</td><td>0</td></tr> <tr><td>Downstream Lt Ditch</td><td>Bare soil</td><td>0</td></tr> <tr><td>Outlet Total</td><td>Unimproved Outlet System</td><td>1</td></tr> <tr><td>Ditches Total</td><td>Unimproved Drainage System</td><td>1</td></tr> <tr><td><b>SRI Total</b></td><td><b>High Risk</b></td><td><b>34</b></td></tr> </tbody> </table>		Risk Factor	Ranking	Score	US Channel Morph	DA	3	DS Channel Morph	DA	3	DS Bank Alteration	HIGH	1	Upstream Skew Angle	<5°	5	Crossing fill condition	Poor/Bare soil	1	Inlet/Outlet Condition	Sed Islands/Scouring	3	Road Approach Material	All Sand/Clay	3	Potential Eroded Volume Mean	<21 y <sup>3</sup>	5	Approach Slope Mean	2.1-4%	3	Soil K Factor	<0.20	5	Upstream Rt Outlet	Bare soil	0	Upstream Lt Outlet	Bare soil	0	Upstream Rt Ditch	Bare soil	0	Upstream Lt Ditch	Bare soil	0	Downstream Rt Outlet	Bare soil	0	Downstream Lt Outlet	Bare soil	0	Downstream Rt Ditch	Bare soil	0	Downstream Lt Ditch	Bare soil	0	Outlet Total	Unimproved Outlet System	1	Ditches Total	Unimproved Drainage System	1	<b>SRI Total</b>	<b>High Risk</b>	<b>34</b>

Notes: Culvert barely visible
