Little Creek		wa-0626-r-002	Sedimentation Risk Index 44																																																																		
<u>Common:</u> 6.8mi SE of Florala <u>Drainage:</u> Long Creek GPS: 30.911752, -86.287466 <u>Land owner:</u> Ronald & Joan Earley-US, Mary Prater McLean-DS		<u>County:</u> Walton <u>PLSS(T-R-S):</u> 5N-20-19/30 <u>Parcel No.:</u> 6.001, 5 <u>Road Name:</u> Campground Rd

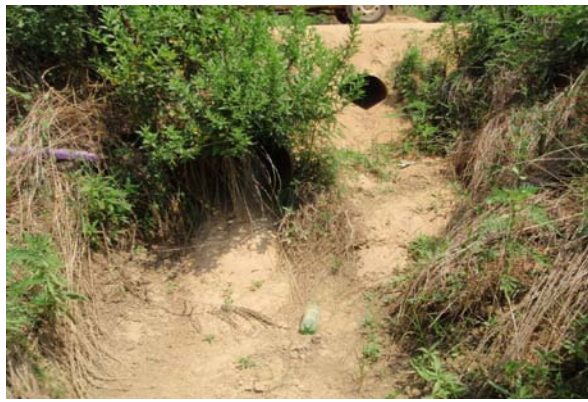
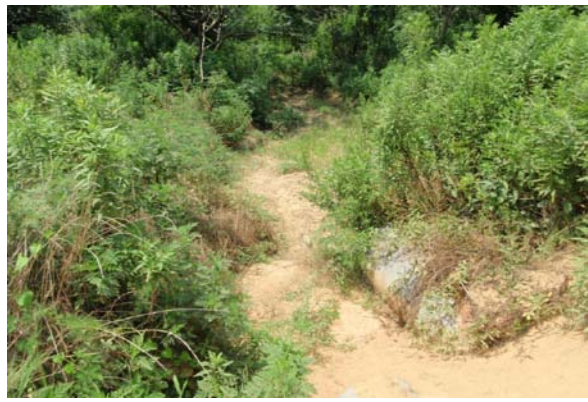
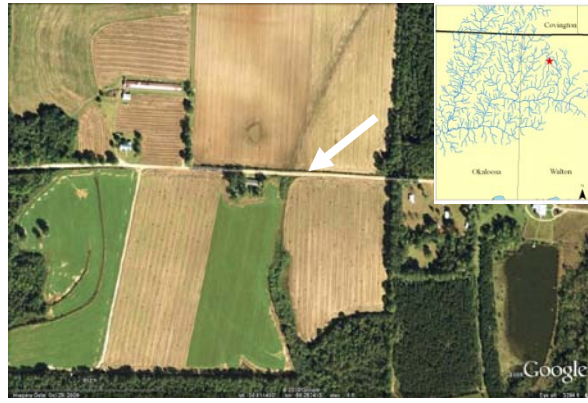
Crossing Structure: DS		DS																																																																			
<table border="1"> <thead> <tr> <th>Risk Factor</th> <th>Ranking</th> <th>Score</th> </tr> </thead> <tbody> <tr><td>US Channel Morph</td><td>C</td><td>5</td></tr> <tr><td>DS Channel Morph</td><td>C</td><td>5</td></tr> <tr><td>DS Bank Alteration</td><td>MINOR/PARTIAL</td><td>3</td></tr> <tr><td>Upstream Skew Angle</td><td><5°</td><td>5</td></tr> <tr><td>Crossing fill condition</td><td>Poor/Bare soil</td><td>1</td></tr> <tr><td>Inlet/Outlet Condition</td><td>No Impairment</td><td>5</td></tr> <tr><td>Road Approach Material</td><td>All Sand/Clay</td><td>3</td></tr> <tr><td>Potential Eroded Volume Mean</td><td>21-40 y³</td><td>3</td></tr> <tr><td>Approach Slope Mean</td><td><2%</td><td>5</td></tr> <tr><td>Soil K Factor</td><td>0.21-0.40</td><td>3</td></tr> <tr><td>Upstream Rt Outlet</td><td>Vegetated</td><td>1</td></tr> <tr><td>Upstream Lt Outlet</td><td>Vegetated</td><td>1</td></tr> <tr><td>Upstream Rt Ditch</td><td>Bare soil</td><td>0</td></tr> <tr><td>Upstream Lt Ditch</td><td>Bare soil</td><td>0</td></tr> <tr><td>Downstream Rt Outlet</td><td>Vegetated</td><td>1</td></tr> <tr><td>Downstream Lt Outlet</td><td>Vegetated</td><td>1</td></tr> <tr><td>Downstream Rt Ditch</td><td>Bare soil</td><td>0</td></tr> <tr><td>Downstream Lt Ditch</td><td>Bare soil</td><td>0</td></tr> <tr><td>Outlet Total</td><td>Improved Outlet System</td><td>5</td></tr> <tr><td>Ditches Total</td><td>Unimproved Drainage System</td><td>1</td></tr> <tr><td>SRI Total</td><td>Medium Risk</td><td>44</td></tr> </tbody> </table>		Risk Factor	Ranking	Score	US Channel Morph	C	5	DS Channel Morph	C	5	DS Bank Alteration	MINOR/PARTIAL	3	Upstream Skew Angle	<5°	5	Crossing fill condition	Poor/Bare soil	1	Inlet/Outlet Condition	No Impairment	5	Road Approach Material	All Sand/Clay	3	Potential Eroded Volume Mean	21-40 y ³	3	Approach Slope Mean	<2%	5	Soil K Factor	0.21-0.40	3	Upstream Rt Outlet	Vegetated	1	Upstream Lt Outlet	Vegetated	1	Upstream Rt Ditch	Bare soil	0	Upstream Lt Ditch	Bare soil	0	Downstream Rt Outlet	Vegetated	1	Downstream Lt Outlet	Vegetated	1	Downstream Rt Ditch	Bare soil	0	Downstream Lt Ditch	Bare soil	0	Outlet Total	Improved Outlet System	5	Ditches Total	Unimproved Drainage System	1	SRI Total	Medium Risk	44

Notes: Dry at time of survey. 2 culverts of different diameter
