Unnamed tributary		ok-0429-r-008	Sedimentation Risk Index <b>30</b>																																																																		
<u>Common:</u> 5.0mi W of Crestview <u>Drainage:</u> Yellow River <u>GPS:</u> 30.735068394, -86.649976145 <u>Land owner:</u> James A. Gillman- US, Jake & Julia Phillips- DS		<u>County:</u> Okaloosa <u>State:</u> Florida <u>PLSS(T-R-S):</u> 3N-24-28 <u>Parcel No.:</u> 2, 6 <u>Road Name:</u> Al Gillman Rd

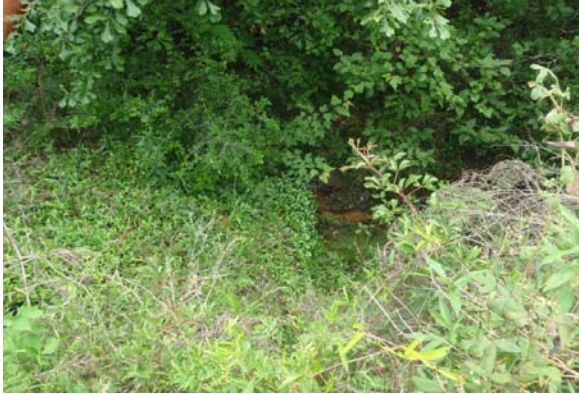
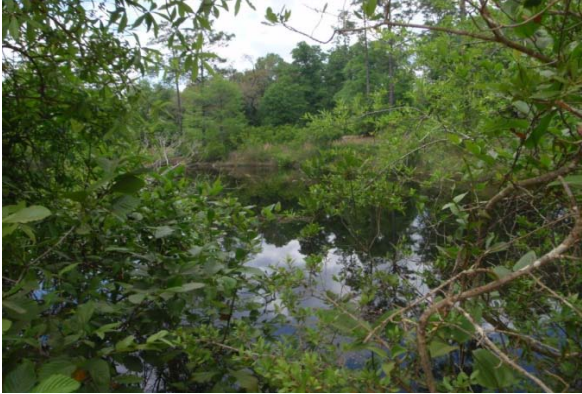
Crossing Structure: DS		US																																																																			
<table border="1"> <thead> <tr> <th>Risk Factor</th> <th>Ranking</th> <th>Score</th> </tr> </thead> <tbody> <tr><td>US Channel Morph</td><td>PONDED</td><td>1</td></tr> <tr><td>DS Channel Morph</td><td>PONDED</td><td>1</td></tr> <tr><td>DS Bank Alteration</td><td>HIGH</td><td>1</td></tr> <tr><td>Upstream Skew Angle</td><td>&gt;30°</td><td>1</td></tr> <tr><td>Crossing fill condition</td><td>Good/Vegetated</td><td>5</td></tr> <tr><td>Inlet/Outlet Condition</td><td>Sed Islands/Scouring</td><td>3</td></tr> <tr><td>Road Approach Material</td><td>All Sand/Clay</td><td>3</td></tr> <tr><td>Potential Eroded Volume Mean</td><td>&gt;40 y<sup>3</sup></td><td>1</td></tr> <tr><td>Approach Slope Mean</td><td>2.1-4%</td><td>3</td></tr> <tr><td>Soil K Factor</td><td>&lt;0.20</td><td>5</td></tr> <tr><td>Upstream Rt Outlet</td><td>Vegetated</td><td>1</td></tr> <tr><td>Upstream Lt Outlet</td><td>Vegetated</td><td>1</td></tr> <tr><td>Upstream Rt Ditch</td><td>Bare soil</td><td>0</td></tr> <tr><td>Upstream Lt Ditch</td><td>Bare soil</td><td>0</td></tr> <tr><td>Downstream Rt Outlet</td><td>Vegetated</td><td>1</td></tr> <tr><td>Downstream Lt Outlet</td><td>Vegetated</td><td>1</td></tr> <tr><td>Downstream Rt Ditch</td><td>Bare soil</td><td>0</td></tr> <tr><td>Downstream Lt Ditch</td><td>Bare soil</td><td>0</td></tr> <tr><td>Outlet Total</td><td>Improved Outlet System</td><td>5</td></tr> <tr><td>Ditches Total</td><td>Unimproved Drainage System</td><td>1</td></tr> <tr><td><b>SRI Total</b></td><td><b>High Risk</b></td><td><b>30</b></td></tr> </tbody> </table>		Risk Factor	Ranking	Score	US Channel Morph	PONDED	1	DS Channel Morph	PONDED	1	DS Bank Alteration	HIGH	1	Upstream Skew Angle	>30°	1	Crossing fill condition	Good/Vegetated	5	Inlet/Outlet Condition	Sed Islands/Scouring	3	Road Approach Material	All Sand/Clay	3	Potential Eroded Volume Mean	>40 y <sup>3</sup>	1	Approach Slope Mean	2.1-4%	3	Soil K Factor	<0.20	5	Upstream Rt Outlet	Vegetated	1	Upstream Lt Outlet	Vegetated	1	Upstream Rt Ditch	Bare soil	0	Upstream Lt Ditch	Bare soil	0	Downstream Rt Outlet	Vegetated	1	Downstream Lt Outlet	Vegetated	1	Downstream Rt Ditch	Bare soil	0	Downstream Lt Ditch	Bare soil	0	Outlet Total	Improved Outlet System	5	Ditches Total	Unimproved Drainage System	1	<b>SRI Total</b>	<b>High Risk</b>	<b>30</b>

Notes: Crossing structure unknown- inaccessible due to fenced off private property.
