Unnamed tributary		co-1029-r-010	Sedimentation Risk Index 24																																																																		
<u>Common:</u> 12.4mi NE of Andalusia <u>Drainage:</u> Yellow River <u>GPS:</u> 31.417385034, -86.315982289 <u>Land owner:</u> JJ & Agnes Guy -US, Clayton Floyd -DS		<u>County:</u> Covington <u>State:</u> Alabama <u>PLSS (T-R-S):</u> 5N-17E-11 <u>Parcel No.:</u> 15; 14 <u>Road Name:</u> Oliver Rd

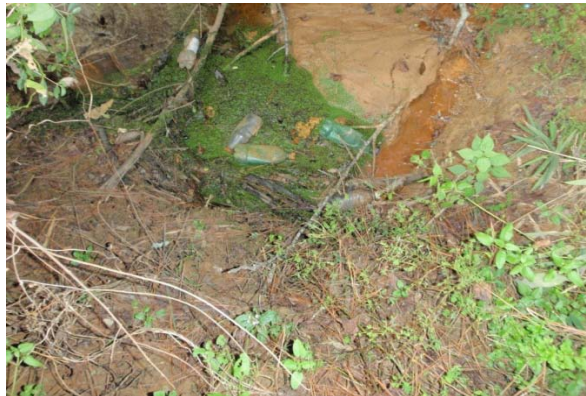
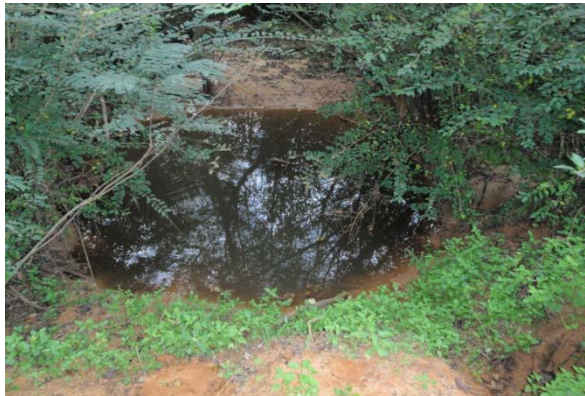
Crossing Structure: US		DS																																																																			
<table border="1"> <thead> <tr> <th>Risk Factor</th> <th>Ranking</th> <th>Score</th> </tr> </thead> <tbody> <tr><td>US Channel Morph</td><td>PONDED</td><td>1</td></tr> <tr><td>DS Channel Morph</td><td>E</td><td>5</td></tr> <tr><td>DS Bank Alteration</td><td>HIGH</td><td>1</td></tr> <tr><td>Upstream Skew Angle</td><td>>30°</td><td>1</td></tr> <tr><td>Crossing fill condition</td><td>Poor/Bare soil</td><td>1</td></tr> <tr><td>Inlet/Outlet Condition</td><td>Blocked</td><td>1</td></tr> <tr><td>Road Approach Material</td><td>All Sand/Clay</td><td>3</td></tr> <tr><td>Potential Eroded Volume Mean</td><td><21 y³</td><td>5</td></tr> <tr><td>Approach Slope Mean</td><td>>4%</td><td>1</td></tr> <tr><td>Soil K Factor</td><td>0.21-0.40</td><td>3</td></tr> <tr><td>Upstream Rt Outlet</td><td>Bare soil</td><td>0</td></tr> <tr><td>Upstream Lt Outlet</td><td>Bare soil</td><td>0</td></tr> <tr><td>Upstream Rt Ditch</td><td>Bare soil</td><td>0</td></tr> <tr><td>Upstream Lt Ditch</td><td>Bare soil</td><td>0</td></tr> <tr><td>Downstream Rt Outlet</td><td>Bare soil</td><td>0</td></tr> <tr><td>Downstream Lt Outlet</td><td>Bare soil</td><td>0</td></tr> <tr><td>Downstream Rt Ditch</td><td>Bare soil</td><td>0</td></tr> <tr><td>Downstream Lt Ditch</td><td>Bare soil</td><td>0</td></tr> <tr><td>Outlet Total</td><td>Unimproved Outlet System</td><td>1</td></tr> <tr><td>Ditches Total</td><td>Unimproved Drainage System</td><td>1</td></tr> <tr><td>SRI Total</td><td>High Risk</td><td>24</td></tr> </tbody> </table>				Risk Factor	Ranking	Score	US Channel Morph	PONDED	1	DS Channel Morph	E	5	DS Bank Alteration	HIGH	1	Upstream Skew Angle	>30°	1	Crossing fill condition	Poor/Bare soil	1	Inlet/Outlet Condition	Blocked	1	Road Approach Material	All Sand/Clay	3	Potential Eroded Volume Mean	<21 y ³	5	Approach Slope Mean	>4%	1	Soil K Factor	0.21-0.40	3	Upstream Rt Outlet	Bare soil	0	Upstream Lt Outlet	Bare soil	0	Upstream Rt Ditch	Bare soil	0	Upstream Lt Ditch	Bare soil	0	Downstream Rt Outlet	Bare soil	0	Downstream Lt Outlet	Bare soil	0	Downstream Rt Ditch	Bare soil	0	Downstream Lt Ditch	Bare soil	0	Outlet Total	Unimproved Outlet System	1	Ditches Total	Unimproved Drainage System	1	SRI Total	High Risk	24

Notes: Buried culvert. Drainage from US pond, runs down ditch then crosses under the road.
