Unnamed tributary		co-0731-r-010	Sedimentation Risk Index 42																																																																		
<u>Common:</u> 4.8mi NW of Florala <u>Drainage:</u> Horsehead Creek <u>GPS:</u> 31.039100, -86.396897 <u>Land owner:</u> Rayonier Forest Resources LP		<u>County:</u> Covington <u>State:</u> Alabama <u>PLSS (T-R-S):</u> 1N-16E-24 <u>Parcel No.:</u> 1 <u>Road Name:</u> Big Farm Rd

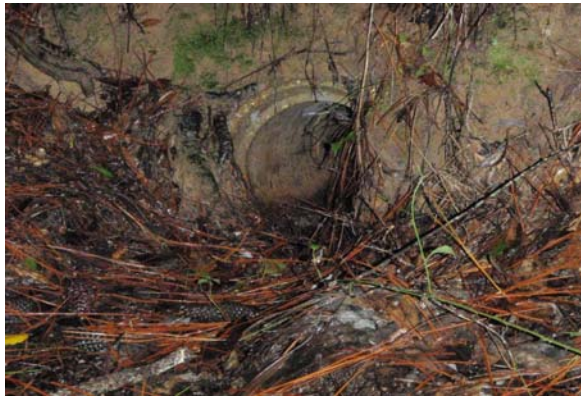
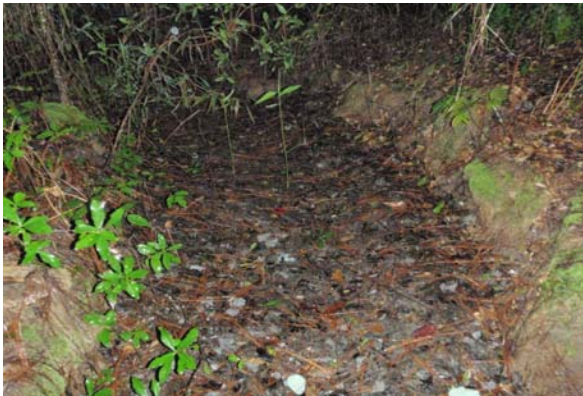
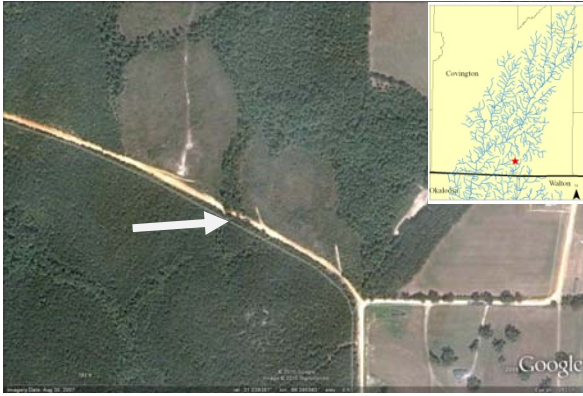
Crossing Structure: US		US																																																																			
<table border="1"> <thead> <tr> <th>Risk Factor</th> <th>Ranking</th> <th>Score</th> </tr> </thead> <tbody> <tr><td>US Channel Morph</td><td>DA</td><td>3</td></tr> <tr><td>DS Channel Morph</td><td>E</td><td>5</td></tr> <tr><td>DS Bank Alteration</td><td>MINOR/PARTIAL</td><td>3</td></tr> <tr><td>Upstream Skew Angle</td><td>5-30°</td><td>3</td></tr> <tr><td>Crossing fill condition</td><td>Good/Vegetated</td><td>5</td></tr> <tr><td>Inlet/Outlet Condition</td><td>Sed Islands/Scouring</td><td>3</td></tr> <tr><td>Road Approach Material</td><td>All Sand/Clay</td><td>3</td></tr> <tr><td>Potential Eroded Volume Mean</td><td>>40 y³</td><td>1</td></tr> <tr><td>Approach Slope Mean</td><td>2.1-4%</td><td>3</td></tr> <tr><td>Soil K Factor</td><td><0.20</td><td>5</td></tr> <tr><td>Upstream Rt Outlet</td><td>Vegetated</td><td>1</td></tr> <tr><td>Upstream Lt Outlet</td><td>Vegetated</td><td>1</td></tr> <tr><td>Upstream Rt Ditch</td><td>Bare soil</td><td>0</td></tr> <tr><td>Upstream Lt Ditch</td><td>Bare soil</td><td>0</td></tr> <tr><td>Downstream Rt Outlet</td><td>Vegetated</td><td>1</td></tr> <tr><td>Downstream Lt Outlet</td><td>Vegetated</td><td>1</td></tr> <tr><td>Downstream Rt Ditch</td><td>Vegetated</td><td>1</td></tr> <tr><td>Downstream Lt Ditch</td><td>Vegetated</td><td>1</td></tr> <tr><td>Outlet Total</td><td>Improved Outlet System</td><td>5</td></tr> <tr><td>Ditches Total</td><td>Partially Improved Drainage System</td><td>3</td></tr> <tr><td>SRI Total</td><td>Medium Risk</td><td>42</td></tr> </tbody> </table>		Risk Factor	Ranking	Score	US Channel Morph	DA	3	DS Channel Morph	E	5	DS Bank Alteration	MINOR/PARTIAL	3	Upstream Skew Angle	5-30°	3	Crossing fill condition	Good/Vegetated	5	Inlet/Outlet Condition	Sed Islands/Scouring	3	Road Approach Material	All Sand/Clay	3	Potential Eroded Volume Mean	>40 y ³	1	Approach Slope Mean	2.1-4%	3	Soil K Factor	<0.20	5	Upstream Rt Outlet	Vegetated	1	Upstream Lt Outlet	Vegetated	1	Upstream Rt Ditch	Bare soil	0	Upstream Lt Ditch	Bare soil	0	Downstream Rt Outlet	Vegetated	1	Downstream Lt Outlet	Vegetated	1	Downstream Rt Ditch	Vegetated	1	Downstream Lt Ditch	Vegetated	1	Outlet Total	Improved Outlet System	5	Ditches Total	Partially Improved Drainage System	3	SRI Total	Medium Risk	42

Notes: Possibly historically channelized
