Shoal River		ok-0616-006		Severity Score 4.5	
<u>Common:</u> 3.8mi E of Crestview <u>Drainage:</u> Yellow River <u>GPS:</u> 30.756023161, -86.507366581 <u>Land owner:</u> Rita Chimiak		<u>County:</u> Okaloosa <u>State:</u> Florida <u>PLSS(T-R-S):</u> 3N-23W-13 <u>Parcel No.:</u> 1

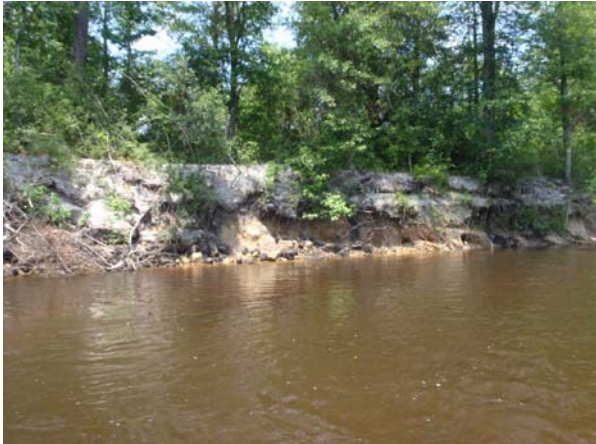
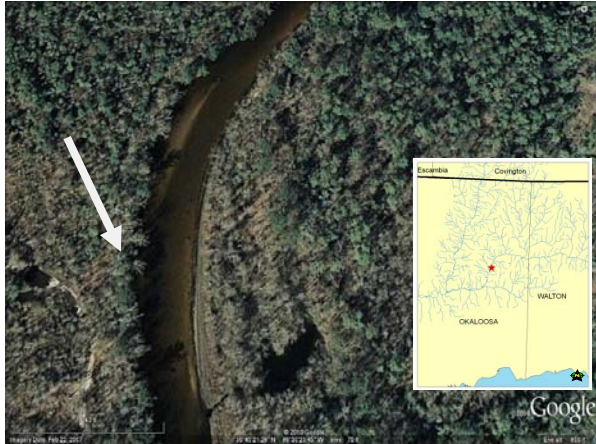
RB					
<b>Risk Factor</b>	<b>Ranking</b>	<b>Score</b>	<b>Feature</b>	<b>Within Range</b>	<b>Descriptive Field</b>
Channel Stability	Poor	1.5	303(d)	No	N/A
Channel Alteration	None	0	Wetland Species	Yes	1-3 FOCAL SPECIES IN UPLAND AREAS
Bank Erosion	Mass Wasting	1.5	Rare and Imperiled	Yes	GOLDSTRIPE DARTER, SPECKLED CHUB IRONCOLOR SHINER
BEHI	High	1	Land Use/ Cover	Yes	N/A/ STREAMS AND WATERWAYS
Local NPSP	No Evidence	0	Candidate Mussels	Yes	SOUTHERN SANDSHELL
Shoring Structures	Not Present	0	Sturgeon C.H.	No	N/A
Pipe Discharge	Not Present	0			
Water Odors	Not Present	0			
Fish Passage Barrier	Not Present	0			
RB: Riparian Buffer	100+ ft	0

LB: Riparian Buffer	100 + ft	0			
RB: Floodplain Access	Partial	0.25	<b>Additional Site Features</b>		
LB: Floodplain Access	Partial	0.25	<u>Stream Channel Woody Material:</u> Moderate		
			<u>Impoundments:</u> None		
			<u>Substrate Composition:</u> Medium Sand		
			<u>Bank Material:</u> Sand and Clay		
<b>River Threat Index:</b>		<b>4.5</b>

Notes: Foot path along top of bank for public access to sand bars.
