Unnamed tributary		wa-0707-r-007	Sedimentation Risk Index <b>30</b>																																																																		
<u>Common:</u> 3.1mi NE of Mossy Head <u>Drainage:</u> Adams Mill Creek <u>GPS:</u> 30.784610 <u>Land owner:</u> Donald & Sharon Richardson-US, William & Amaryliss Tinsley-DS		<u>County:</u> Walton <u>State:</u> Florida <u>PLSS(T-R-S):</u> 3N-21-01 <u>Parcel No.:</u> 2.002, 1.002 <u>Road Name:</u> Adams Branch Rd

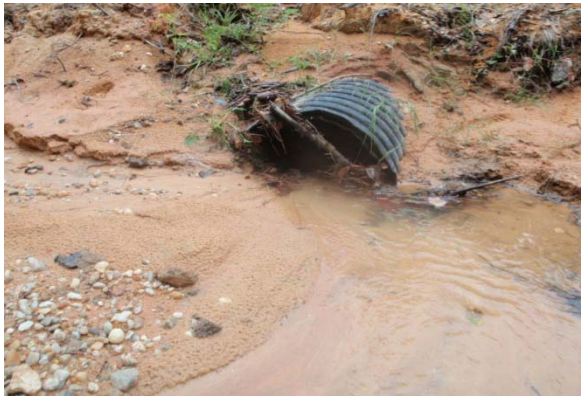
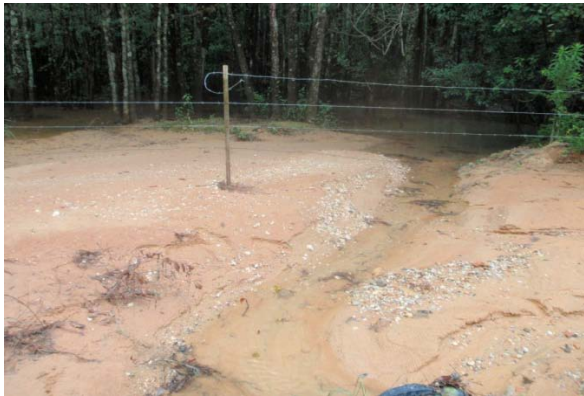
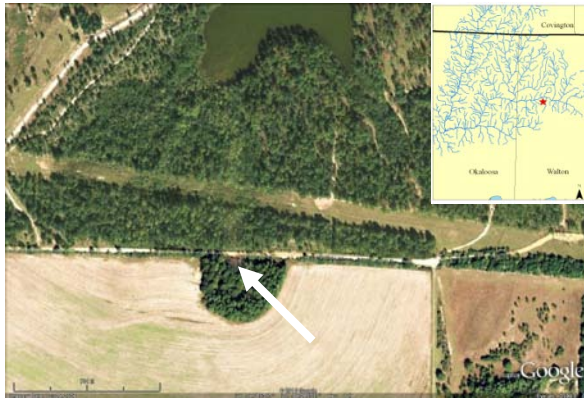
Risk Factor	Ranking	Score																																																																			
US Channel Morph	WETLAND	5																																																																			
DS Channel Morph	DA	3																																																																			
DS Bank Alteration	MINOR/PARTIAL	3																																																																			
Upstream Skew Angle	<5°	5																																																																			
Crossing fill condition	Poor/Bare soil	1																																																																			
Inlet/Outlet Condition	Blocked	1																																																																			
Road Approach Material	All Native Soil	1																																																																			
Potential Eroded Volume Mean	>40 y <sup>3</sup>	1																																																																			
Approach Slope Mean	>4%	1

Soil K Factor	<0.20	5																																																																			
Upstream Rt Outlet	Bare soil	0																																																																			
Upstream Lt Outlet	Bare soil	0																																																																			
Upstream Rt Ditch	Bare soil	0																																																																			
Upstream Lt Ditch	Bare soil	0																																																																			
Downstream Rt Outlet	Vegetated	1																																																																			
Downstream Lt Outlet	Vegetated	1																																																																			
Downstream Rt Ditch	Bare soil	0																																																																			
Downstream Lt Ditch	Bare soil	0																																																																			
Outlet Total	Partially Improved Outlet System	3

Ditches Total	Unimproved Drainage System	1																																																																			
<b>SRI Total</b>	<b>High Risk</b>	<b>30</b>																																																																			
<b>Additional Site Features</b> <u>Crossing Type and Quantity:</u> Culvert, 1 <u>Crossing Materials:</u> PVC <u>Soil Types:</u> 13,14,15,31 <u>Rt Approach Prism Fill:</u> 1.0in <u>Lt Approach Prism Fill:</u> 1.0in		<table border="1"> <thead> <tr> <th>Feature</th> <th>Within Range</th> <th>Descriptive Field</th> </tr> </thead> <tbody> <tr> <td>303(d)</td> <td>No</td> <td>N/A</td> </tr> <tr> <td>Wetland Species</td> <td>No</td> <td>N/A</td> </tr> <tr> <td>Rare and Imperiled</td> <td>Yes</td> <td>SPECKLED CHUB, IRONCOLOR SHINER, GOLDSTRIPE DARTER</td> </tr> <tr> <td>Land Use/ Cover</td> <td>Yes</td> <td>PARCELS WITH NO VALUES/ WETLAND FORESTED MIX</td> </tr> <tr> <td>Candidate Mussels</td> <td>No</td> <td>N/A</td> </tr> <tr> <td>Sturgeon C.H.</td> <td>No</td> <td>N/A</td> </tr> </tbody> </table>		Feature	Within Range	Descriptive Field	303(d)	No	N/A	Wetland Species	No	N/A	Rare and Imperiled	Yes	SPECKLED CHUB, IRONCOLOR SHINER, GOLDSTRIPE DARTER	Land Use/ Cover	Yes	PARCELS WITH NO VALUES/ WETLAND FORESTED MIX	Candidate Mussels	No	N/A	Sturgeon C.H.	No	N/A

Notes: Fencing across US.
