Boiling Creek		sr-1006-001	Severity Score 4.25																																																																																
<u>Common:</u> 6.2mi SE of Milton <u>Drainage:</u> Yellow River <u>GPS:</u> 30.57882639, -86.900219682 <u>Land owner:</u> LB: USA- Eglin AFB/ RB: NFWFMD		<u>County:</u> Santa Rosa <u>State:</u> Florida <u>PLSS(T-R-S):</u> 1N-27W-24 <u>Parcel No.:</u> 2/1

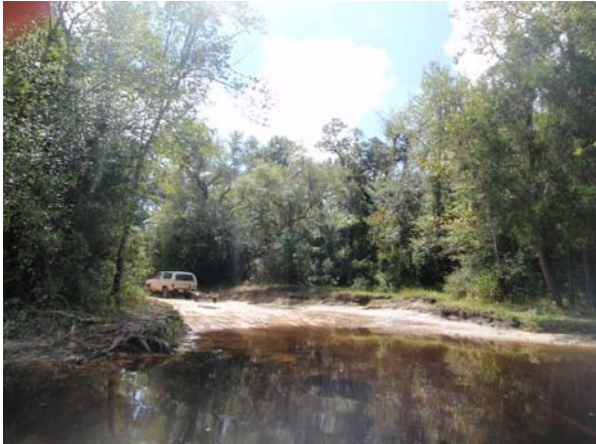
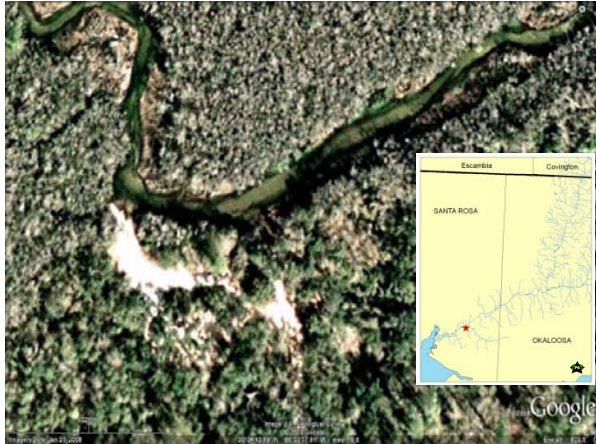
Notes: The public boat launch is frequented for AFB training. Team observed multiple Hummers at launch as well as witnessed closing of the road for the final mission for Ranger School. Boat launch is composed of about five percent concrete. Road leading to boat launch is within the flood plain and frequently flooded. Difficult to drive.
