Unnamed tributary		co-1027-r-002	Sedimentation Risk Index 42																																																																		
<u>Common:</u> 5.9mi NW of Opp <u>Drainage:</u> Yellow River GPS: 31.318371094, -86.346232084 <u>Land owner:</u> Kenneth & Martha Ward -DS, J&C Hawkins -US		<u>County:</u> Covington <u>State:</u> Alabama <u>PLSS (T-R-S):</u> 4N-17E-16/15 <u>Parcel No.:</u> 1; 4.01 <u>Road Name:</u> Homer Smith Rd

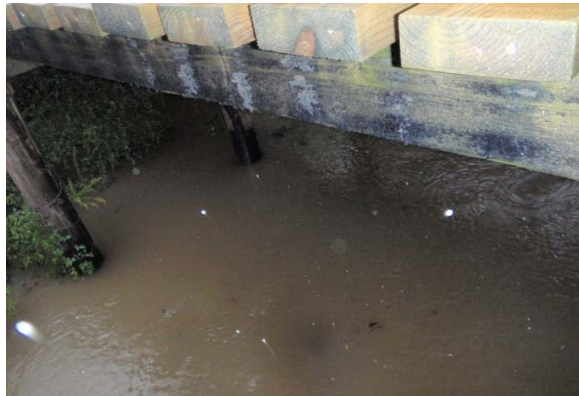
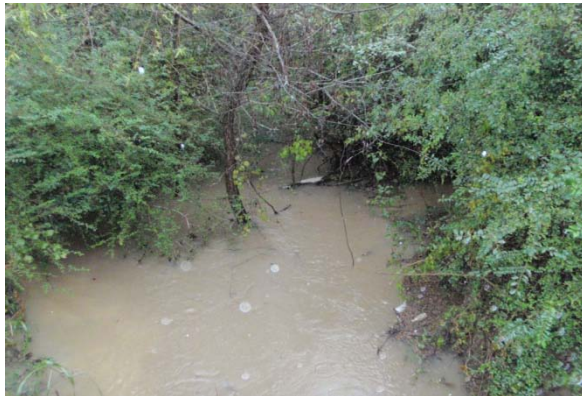
Crossing Structure: DS		US																																																																			
<table border="1"> <thead> <tr> <th>Risk Factor</th> <th>Ranking</th> <th>Score</th> </tr> </thead> <tbody> <tr><td>US Channel Morph</td><td>E</td><td>5</td></tr> <tr><td>DS Channel Morph</td><td>E</td><td>5</td></tr> <tr><td>DS Bank Alteration</td><td>MINOR/PARTIAL</td><td>3</td></tr> <tr><td>Upstream Skew Angle</td><td><5°</td><td>5</td></tr> <tr><td>Crossing fill condition</td><td>Good/Vegetated</td><td>5</td></tr> <tr><td>Inlet/Outlet Condition</td><td>No Impairment</td><td>5</td></tr> <tr><td>Road Approach Material</td><td>All Sand/Clay</td><td>3</td></tr> <tr><td>Potential Eroded Volume Mean</td><td>>40 y³</td><td>1</td></tr> <tr><td>Approach Slope Mean</td><td>>4%</td><td>1</td></tr> <tr><td>Soil K Factor</td><td><0.20</td><td>5</td></tr> <tr><td>Upstream Rt Outlet</td><td>Bare soil</td><td>0</td></tr> <tr><td>Upstream Lt Outlet</td><td>Vegetated</td><td>1</td></tr> <tr><td>Upstream Rt Ditch</td><td>Bare soil</td><td>0</td></tr> <tr><td>Upstream Lt Ditch</td><td>Bare soil</td><td>0</td></tr> <tr><td>Downstream Rt Outlet</td><td>Bare soil</td><td>0</td></tr> <tr><td>Downstream Lt Outlet</td><td>Vegetated</td><td>1</td></tr> <tr><td>Downstream Rt Ditch</td><td>Bare soil</td><td>0</td></tr> <tr><td>Downstream Lt Ditch</td><td>Bare soil</td><td>0</td></tr> <tr><td>Outlet Total</td><td>Partially Improved Outlet System</td><td>3</td></tr> <tr><td>Ditches Total</td><td>Unimproved Drainage System</td><td>1</td></tr> <tr><td>SRI Total</td><td>Medium Risk</td><td>42</td></tr> </tbody> </table>		Risk Factor	Ranking	Score	US Channel Morph	E	5	DS Channel Morph	E	5	DS Bank Alteration	MINOR/PARTIAL	3	Upstream Skew Angle	<5°	5	Crossing fill condition	Good/Vegetated	5	Inlet/Outlet Condition	No Impairment	5	Road Approach Material	All Sand/Clay	3	Potential Eroded Volume Mean	>40 y ³	1	Approach Slope Mean	>4%	1	Soil K Factor	<0.20	5	Upstream Rt Outlet	Bare soil	0	Upstream Lt Outlet	Vegetated	1	Upstream Rt Ditch	Bare soil	0	Upstream Lt Ditch	Bare soil	0	Downstream Rt Outlet	Bare soil	0	Downstream Lt Outlet	Vegetated	1	Downstream Rt Ditch	Bare soil	0	Downstream Lt Ditch	Bare soil	0	Outlet Total	Partially Improved Outlet System	3	Ditches Total	Unimproved Drainage System	1	SRI Total	Medium Risk	42
