Fleming Creek		wa-0625-r-003	Sedimentation Risk Index 36																																																																		
<u>Common:</u> 3.7 SW of Florala <u>Drainage:</u> Pond Creek <u>GPS:</u> 30.976764, -86.380619 <u>Land owner:</u> John R Cox-US, Newton Busbee-DS		<u>County:</u> Walton <u>State:</u> Florida <u>PLSS(T-R-S):</u> 6N-21-31 <u>Parcel No.:</u> 4; 2 <u>Road Name:</u> Varnum Rd

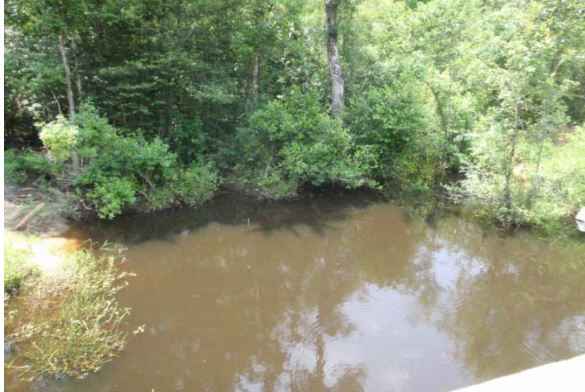
<p>Crossing Structure: DS</p>

Ditches Total	Unimproved Drainage System	1																																																																			
SRI Total	High Risk	36																																																																			
Additional Site Features <u>Crossing Type and Quantity:</u> Bridge, 1 <u>Crossing Materials:</u> Wood <u>Soil Types:</u> 2,3,10,15,22,25,26,31,32,60 <u>Rt Approach Prism Fill:</u> 1.0in <u>Lt Approach Prism Fill:</u> 1.0in		<table border="1"> <thead> <tr> <th>Feature</th> <th>Within Range</th> <th>Descriptive Field</th> </tr> </thead> <tbody> <tr> <td>303(d)</td> <td>No</td> <td>N/A</td> </tr> <tr> <td>Wetland Species</td> <td>No</td> <td>N/A</td> </tr> <tr> <td>Rare and Imperiled</td> <td>Yes</td> <td>SPECKLED CHUB, IRONCOLOR SHINER</td> </tr> <tr> <td>Land Use/ Cover</td> <td>Yes</td> <td>VACANT RESIDENTIAL, AGRICULTURAL/ MIXED WETLAND HARDWOODS</td> </tr> <tr> <td>Candidate Mussels</td> <td>No</td> <td>N/A</td> </tr> <tr> <td>Sturgeon C.H.</td> <td>No</td> <td>N/A</td> </tr> </tbody> </table>		Feature	Within Range	Descriptive Field	303(d)	No	N/A	Wetland Species	No	N/A	Rare and Imperiled	Yes	SPECKLED CHUB, IRONCOLOR SHINER	Land Use/ Cover	Yes	VACANT RESIDENTIAL, AGRICULTURAL/ MIXED WETLAND HARDWOODS	Candidate Mussels	No	N/A	Sturgeon C.H.	No	N/A

Notes: Need to stabilize prism fill on approaches.
