Blaze Branch		cr-1103-r-003	Sedimentation Risk Index 38																																																																		
<u>Common:</u> .92mi SW of Pine Level <u>Drainage:</u> Lightwood Knot <u>GPS:</u> 31.469495863,-86.2003131158 <u>Land owner:</u> Bryan Hubery Ray Jr & William Payne -US, Robert Jr. Kilcrease -DS		<u>County:</u> Crenshaw <u>State:</u> Alabama <u>PLSS (T-R-S):</u> 6N-18E-25 <u>Parcel No.:</u> 1.01, 1 <u>Road Name:</u> Kilcrease Rd

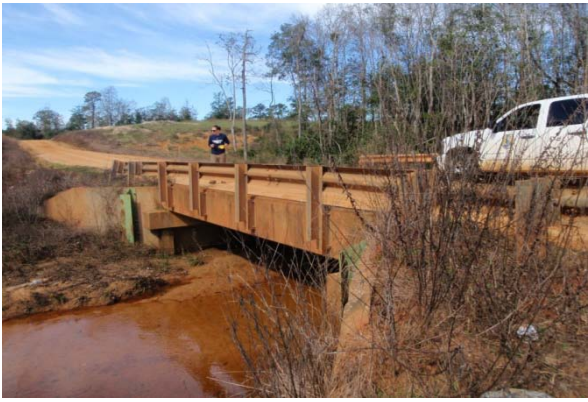
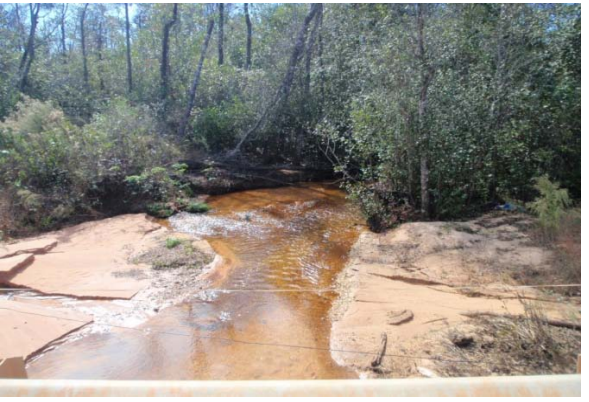
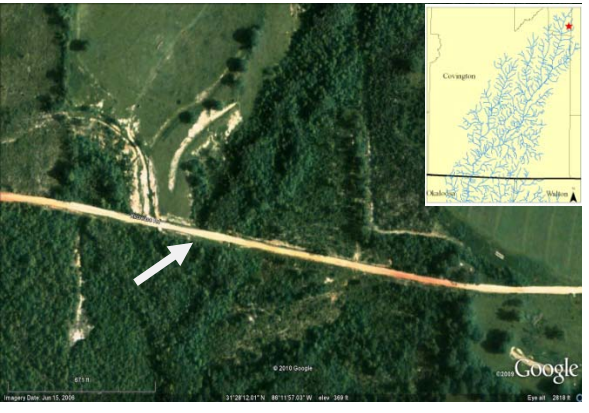
Crossing Structure: US		DS																																																																			
<table border="1"> <thead> <tr> <th>Risk Factor</th> <th>Ranking</th> <th>Score</th> </tr> </thead> <tbody> <tr><td>US Channel Morph</td><td>DA</td><td>3</td></tr> <tr><td>DS Channel Morph</td><td>E</td><td>5</td></tr> <tr><td>DS Bank Alteration</td><td>MINOR/PARTIAL</td><td>3</td></tr> <tr><td>Upstream Skew Angle</td><td>5-30°</td><td>3</td></tr> <tr><td>Crossing fill condition</td><td>Poor/Bare soil</td><td>1</td></tr> <tr><td>Inlet/Outlet Condition</td><td>Sed Islands/Scouring</td><td>3</td></tr> <tr><td>Road Approach Material</td><td>All Sand/Clay</td><td>3</td></tr> <tr><td>Potential Eroded Volume Mean</td><td><21 y³</td><td>5</td></tr> <tr><td>Approach Slope Mean</td><td>2.1-4%</td><td>3</td></tr> <tr><td>Soil K Factor</td><td>0.21-0.40</td><td>3</td></tr> <tr><td>Upstream Rt Outlet</td><td>Bare soil</td><td>0</td></tr> <tr><td>Upstream Lt Outlet</td><td>Rip Rap</td><td>1</td></tr> <tr><td>Upstream Rt Ditch</td><td>Rip Rap</td><td>1</td></tr> <tr><td>Upstream Lt Ditch</td><td>Bare soil</td><td>0</td></tr> <tr><td>Downstream Rt Outlet</td><td>Bare soil</td><td>0</td></tr> <tr><td>Downstream Lt Outlet</td><td>Rip Rap</td><td>1</td></tr> <tr><td>Downstream Rt Ditch</td><td>Bare soil</td><td>0</td></tr> <tr><td>Downstream Lt Ditch</td><td>Rip Rap</td><td>1</td></tr> <tr><td>Outlet Total</td><td>Partially Improved Outlet System</td><td>3</td></tr> <tr><td>Ditches Total</td><td>Partially Improved Drainage System</td><td>3</td></tr> <tr><td>SRI Total</td><td>Medium Risk</td><td>38</td></tr> </tbody> </table>		Risk Factor	Ranking	Score	US Channel Morph	DA	3	DS Channel Morph	E	5	DS Bank Alteration	MINOR/PARTIAL	3	Upstream Skew Angle	5-30°	3	Crossing fill condition	Poor/Bare soil	1	Inlet/Outlet Condition	Sed Islands/Scouring	3	Road Approach Material	All Sand/Clay	3	Potential Eroded Volume Mean	<21 y ³	5	Approach Slope Mean	2.1-4%	3	Soil K Factor	0.21-0.40	3	Upstream Rt Outlet	Bare soil	0	Upstream Lt Outlet	Rip Rap	1	Upstream Rt Ditch	Rip Rap	1	Upstream Lt Ditch	Bare soil	0	Downstream Rt Outlet	Bare soil	0	Downstream Lt Outlet	Rip Rap	1	Downstream Rt Ditch	Bare soil	0	Downstream Lt Ditch	Rip Rap	1	Outlet Total	Partially Improved Outlet System	3	Ditches Total	Partially Improved Drainage System	3	SRI Total	Medium Risk	38

Notes: High sediment loading from DS outlets.
