Unnamed tributary		ok-0429-r-003	Sedimentation Risk Index 40																																																																		
<u>Common:</u> 4.2mi W of Crestview <u>Drainage:</u> Yellow River <u>GPS:</u> 30.745881514, -86.637365798 <u>Land owner:</u> Tim & Nelda Flemming		<u>County:</u> Okaloosa <u>State:</u> Florida <u>PLSS(T-R-S):</u> 3N-24-22 <u>Parcel No.:</u> 3 <u>Road Name:</u> Al Gillman Rd

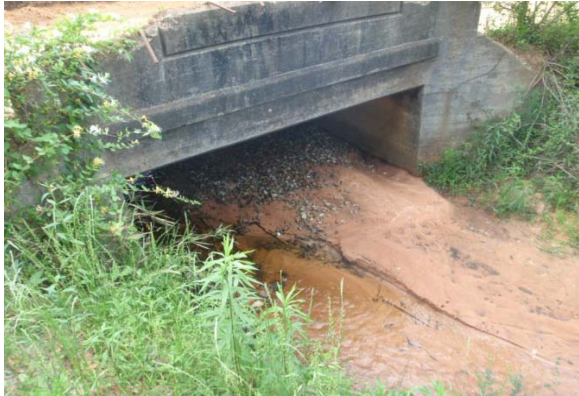
Crossing Structure: US		US																																																																			
<table border="1"> <thead> <tr> <th>Risk Factor</th> <th>Ranking</th> <th>Score</th> </tr> </thead> <tbody> <tr><td>US Channel Morph</td><td>B</td><td>5</td></tr> <tr><td>DS Channel Morph</td><td>B</td><td>5</td></tr> <tr><td>DS Bank Alteration</td><td>MINOR/PARTIAL</td><td>3</td></tr> <tr><td>Upstream Skew Angle</td><td>5-30°</td><td>3</td></tr> <tr><td>Crossing fill condition</td><td>Poor/Bare soil</td><td>1</td></tr> <tr><td>Inlet/Outlet Condition</td><td>Blocked</td><td>1</td></tr> <tr><td>Road Approach Material</td><td>All Sand/Clay</td><td>3</td></tr> <tr><td>Potential Eroded Volume Mean</td><td><21 y³</td><td>5</td></tr> <tr><td>Approach Slope Mean</td><td><2%</td><td>5</td></tr> <tr><td>Soil K Factor</td><td><0.20</td><td>5</td></tr> <tr><td>Upstream Rt Outlet</td><td>Vegetated</td><td>1</td></tr> <tr><td>Upstream Lt Outlet</td><td>Bare soil</td><td>0</td></tr> <tr><td>Upstream Rt Ditch</td><td>Bare soil</td><td>0</td></tr> <tr><td>Upstream Lt Ditch</td><td>Bare soil</td><td>0</td></tr> <tr><td>Downstream Rt Outlet</td><td>Vegetated</td><td>1</td></tr> <tr><td>Downstream Lt Outlet</td><td>Vegetated</td><td>1</td></tr> <tr><td>Downstream Rt Ditch</td><td>Bare soil</td><td>0</td></tr> <tr><td>Downstream Lt Ditch</td><td>Bare soil</td><td>0</td></tr> <tr><td>Outlet Total</td><td>Partially Improved Outlet System</td><td>3</td></tr> <tr><td>Ditches Total</td><td>Unimproved Drainage System</td><td>1</td></tr> <tr><td>SRI Total</td><td>Medium Risk</td><td>40</td></tr> </tbody> </table>		Risk Factor	Ranking	Score	US Channel Morph	B	5	DS Channel Morph	B	5	DS Bank Alteration	MINOR/PARTIAL	3	Upstream Skew Angle	5-30°	3	Crossing fill condition	Poor/Bare soil	1	Inlet/Outlet Condition	Blocked	1	Road Approach Material	All Sand/Clay	3	Potential Eroded Volume Mean	<21 y ³	5	Approach Slope Mean	<2%	5	Soil K Factor	<0.20	5	Upstream Rt Outlet	Vegetated	1	Upstream Lt Outlet	Bare soil	0	Upstream Rt Ditch	Bare soil	0	Upstream Lt Ditch	Bare soil	0	Downstream Rt Outlet	Vegetated	1	Downstream Lt Outlet	Vegetated	1	Downstream Rt Ditch	Bare soil	0	Downstream Lt Ditch	Bare soil	0	Outlet Total	Partially Improved Outlet System	3	Ditches Total	Unimproved Drainage System	1	SRI Total	Medium Risk	40

Ditches Total	Unimproved Drainage System	1																																																																			
SRI Total	Medium Risk	40																																																																			
Additional Site Features <u>Crossing Type and Quantity:</u> Bridge, 1 <u>Crossing Materials:</u> Reinforced Concrete <u>Soil Types:</u> 4,6,12,13,27,34,36,43,49,50,51,52 <u>Rt Approach Prism Fill:</u> 0.2in <u>Lt Approach Prism Fill:</u> 0.25in		<table border="1"> <thead> <tr> <th>Feature</th> <th>Within Range</th> <th>Descriptive Field</th> </tr> </thead> <tbody> <tr> <td>303(d)</td> <td>Yes</td> <td>COLIFORMS, TURBIDITY, MERCURY</td> </tr> <tr> <td>Wetland Species</td> <td>No</td> <td>N/A</td> </tr> <tr> <td>Rare and Imperiled</td> <td>Yes</td> <td>ALABAMA SHAD, ALLIGATOR GAR, BLUENOSE SHINER, GULF STURGEON, SPECKLED CHUB, IRONCOLOR SHINER, SPOTTED BULLHEAD, SPECKLED DARTER</td> </tr> <tr> <td>Land Use/Cover</td> <td>Yes</td> <td>AGRICULTURAL/ WETLAND FORESTED MIX</td> </tr> <tr> <td>Candidate Mussels</td> <td>No</td> <td>N/A</td> </tr> <tr> <td>Sturgeon C.H.</td> <td>No</td> <td>N/A</td> </tr> </tbody> </table>		Feature	Within Range	Descriptive Field	303(d)	Yes	COLIFORMS, TURBIDITY, MERCURY	Wetland Species	No	N/A	Rare and Imperiled	Yes	ALABAMA SHAD, ALLIGATOR GAR, BLUENOSE SHINER, GULF STURGEON, SPECKLED CHUB, IRONCOLOR SHINER, SPOTTED BULLHEAD, SPECKLED DARTER	Land Use/Cover	Yes	AGRICULTURAL/ WETLAND FORESTED MIX	Candidate Mussels	No	N/A	Sturgeon C.H.	No	N/A

Notes: Railroad crossing approx 100ft US.
