Unnamed tributary		co-0812-r-006	Sedimentation Risk Index 50																																																																		
<u>Common:</u> 8.6mi N of Florala <u>Drainage:</u> Clear Creek <u>GPS:</u> 31.121189, -86.375328 <u>Land owner:</u> Rayonier Forest Resources LP		<u>County:</u> Covington <u>State:</u> Alabama <u>PLSS (T-R-S):</u> 2N-17E-20 <u>Parcel No.:</u> 6 <u>Road Name:</u> Swimming Hole Rd

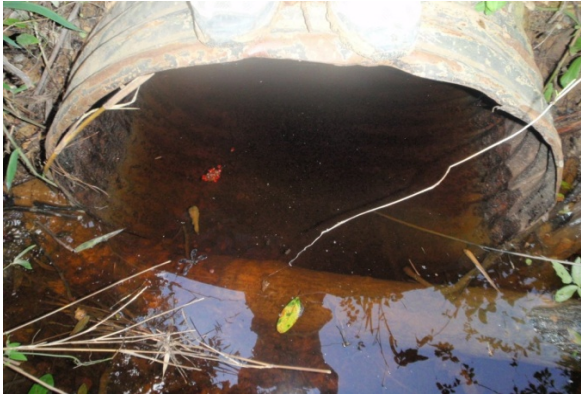
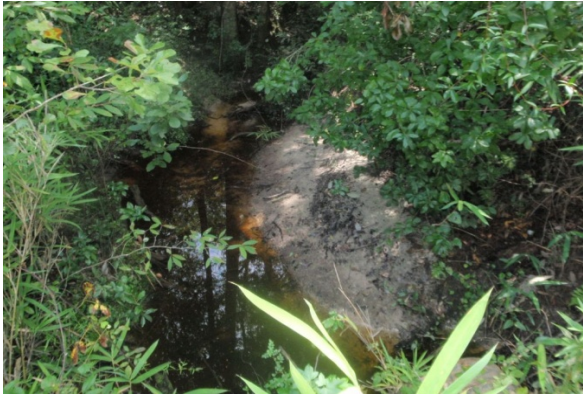
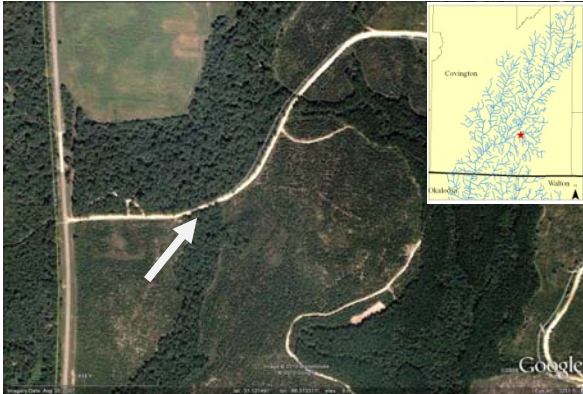
Risk Factor	Ranking	Score																																																																			
US Channel Morph	A	5																																																																			
DS Channel Morph	C	5																																																																			
DS Bank Alteration	MINOR/PARTIAL	3																																																																			
Upstream Skew Angle	5-30°	3																																																																			
Crossing fill condition	Good/Vegetated	5																																																																			
Inlet/Outlet Condition	Sed Islands/Scouring	3																																																																			
Road Approach Material	All Sand/Clay	3																																																																			
Potential Eroded Volume Mean	<21 y ³	5																																																																			
Approach Slope Mean	<2%	5

Soil K Factor	<0.20	5																																																																			
Upstream Rt Outlet	Vegetated	1																																																																			
Upstream Lt Outlet	Vegetated	1																																																																			
Upstream Rt Ditch	Bare soil	0																																																																			
Upstream Lt Ditch	Vegetated	1																																																																			
Downstream Rt Outlet	Vegetated	1																																																																			
Downstream Lt Outlet	Vegetated	1																																																																			
Downstream Rt Ditch	Bare soil	0																																																																			
Downstream Lt Ditch	Vegetated	1																																																																			
Outlet Total	Improved Outlet System	5

Ditches Total	Partially Improved Drainage System	3																																																																			
SRI Total	Low Risk	50																																																																			
Additional Site Features <u>Crossing Type and Quantity:</u> Culvert, 1 <u>Crossing Materials:</u> Metal <u>Soil Types:</u> BgA, FoA, IbA, MBA, TrB, TrD <u>Rt Approach Prism Fill:</u> 0.5in <u>Lt Approach Prism Fill:</u> 0.1in		<table border="1"> <thead> <tr> <th>Feature</th> <th>Within Range</th> <th>Descriptive Field</th> </tr> </thead> <tbody> <tr><td>303(d)</td><td>No</td><td>N/A</td></tr> <tr><td>Wetland Species</td><td>No</td><td>N/A</td></tr> <tr><td>Rare and Imperiled</td><td>No</td><td>N/A</td></tr> <tr><td>Land Use/Cover</td><td>No</td><td>N/A</td></tr> <tr><td>Candidate Mussels</td><td>No</td><td>N/A</td></tr> <tr><td>Sturgeon C.H.</td><td>No</td><td>N/A</td></tr> </tbody> </table>		Feature	Within Range	Descriptive Field	303(d)	No	N/A	Wetland Species	No	N/A	Rare and Imperiled	No	N/A	Land Use/Cover	No	N/A	Candidate Mussels	No	N/A	Sturgeon C.H.	No	N/A
