Unnamed tributary		ok-0617-r-007	Sedimentation Risk Index 40																																																																		
<u>Common:</u> 4.7mi SE of Laurel Hill <u>Drainage:</u> Pond Creek <u>GPS:</u> 30.922968, -86.397368 <u>Land owner:</u> Sonya Webb		<u>County:</u> Okaloosa <u>State:</u> Florida <u>PLSS(T-R-S):</u> 5N-22-24 <u>Parcel No.:</u> 2.005 <u>Road Name:</u> County Line Rd

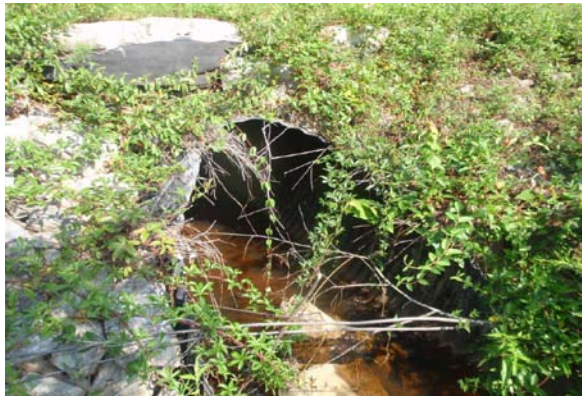
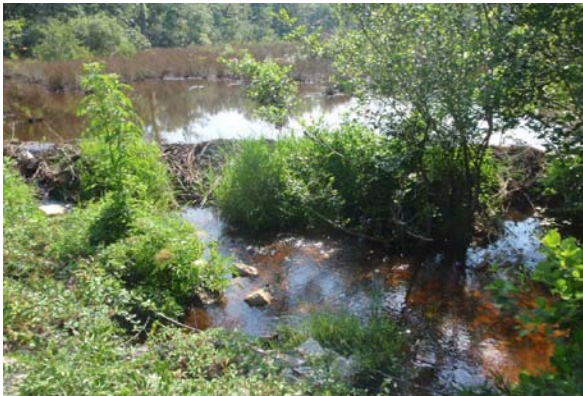
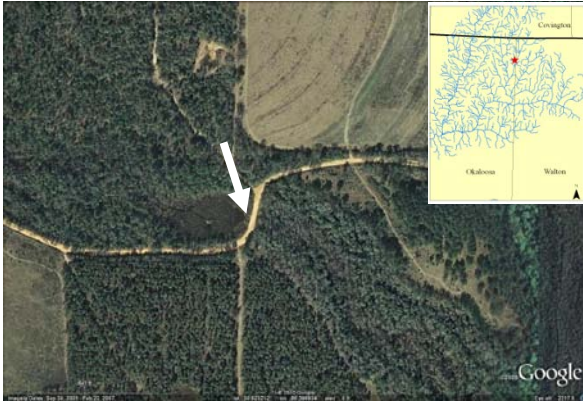
Crossing Structure: US		US																																																																			
<table border="1"> <thead> <tr> <th>Risk Factor</th> <th>Ranking</th> <th>Score</th> </tr> </thead> <tbody> <tr><td>US Channel Morph</td><td>BEAVER DAM</td><td>3</td></tr> <tr><td>DS Channel Morph</td><td>DA</td><td>3</td></tr> <tr><td>DS Bank Alteration</td><td>HIGH</td><td>1</td></tr> <tr><td>Upstream Skew Angle</td><td>5-30°</td><td>3</td></tr> <tr><td>Crossing fill condition</td><td>Good/Vegetated</td><td>5</td></tr> <tr><td>Inlet/Outlet Condition</td><td>No Impairment</td><td>5</td></tr> <tr><td>Road Approach Material</td><td>All Sand/Clay</td><td>3</td></tr> <tr><td>Potential Eroded Volume Mean</td><td>>40 y³</td><td>1</td></tr> <tr><td>Approach Slope Mean</td><td><2%</td><td>5</td></tr> <tr><td>Soil K Factor</td><td><0.20</td><td>5</td></tr> <tr><td>Upstream Rt Outlet</td><td>Vegetated</td><td>1</td></tr> <tr><td>Upstream Lt Outlet</td><td>Vegetated</td><td>1</td></tr> <tr><td>Upstream Rt Ditch</td><td>Bare soil</td><td>0</td></tr> <tr><td>Upstream Lt Ditch</td><td>Bare soil</td><td>0</td></tr> <tr><td>Downstream Rt Outlet</td><td>Vegetated</td><td>1</td></tr> <tr><td>Downstream Lt Outlet</td><td>Vegetated</td><td>1</td></tr> <tr><td>Downstream Rt Ditch</td><td>Bare soil</td><td>0</td></tr> <tr><td>Downstream Lt Ditch</td><td>Bare soil</td><td>0</td></tr> <tr><td>Outlet Total</td><td>Improved Outlet System</td><td>5</td></tr> <tr><td>Ditches Total</td><td>Unimproved Drainage System</td><td>1</td></tr> <tr><td>SRI Total</td><td>Medium Risk</td><td>40</td></tr> </tbody> </table>		Risk Factor	Ranking	Score	US Channel Morph	BEAVER DAM	3	DS Channel Morph	DA	3	DS Bank Alteration	HIGH	1	Upstream Skew Angle	5-30°	3	Crossing fill condition	Good/Vegetated	5	Inlet/Outlet Condition	No Impairment	5	Road Approach Material	All Sand/Clay	3	Potential Eroded Volume Mean	>40 y ³	1	Approach Slope Mean	<2%	5	Soil K Factor	<0.20	5	Upstream Rt Outlet	Vegetated	1	Upstream Lt Outlet	Vegetated	1	Upstream Rt Ditch	Bare soil	0	Upstream Lt Ditch	Bare soil	0	Downstream Rt Outlet	Vegetated	1	Downstream Lt Outlet	Vegetated	1	Downstream Rt Ditch	Bare soil	0	Downstream Lt Ditch	Bare soil	0	Outlet Total	Improved Outlet System	5	Ditches Total	Unimproved Drainage System	1	SRI Total	Medium Risk	40

Risk Factor	Ranking	Score																																																																			
US Channel Morph	BEAVER DAM	3																																																																			
DS Channel Morph	DA	3																																																																			
DS Bank Alteration	HIGH	1																																																																			
Upstream Skew Angle	5-30°	3																																																																			
Crossing fill condition	Good/Vegetated	5																																																																			
Inlet/Outlet Condition	No Impairment	5																																																																			
Road Approach Material	All Sand/Clay	3																																																																			
Potential Eroded Volume Mean	>40 y ³	1																																																																			
Approach Slope Mean	<2%	5

Soil K Factor	<0.20	5																																																																			
Upstream Rt Outlet	Vegetated	1																																																																			
Upstream Lt Outlet	Vegetated	1																																																																			
Upstream Rt Ditch	Bare soil	0																																																																			
Upstream Lt Ditch	Bare soil	0																																																																			
Downstream Rt Outlet	Vegetated	1																																																																			
Downstream Lt Outlet	Vegetated	1																																																																			
Downstream Rt Ditch	Bare soil	0																																																																			
Downstream Lt Ditch	Bare soil	0																																																																			
Outlet Total	Improved Outlet System	5

Ditches Total	Unimproved Drainage System	1																																																																			
SRI Total	Medium Risk	40																																																																			
Additional Site Features <u>Crossing Type and Quantity:</u> Culvert, 2 <u>Crossing Materials:</u> Metal <u>Soil Types:</u> 36,37,41,43,46 <u>Rt Approach Prism Fill:</u> 1.0in <u>Lt Approach Prism Fill:</u> 0.5in		<table border="1"> <thead> <tr> <th>Feature</th> <th>Within Range</th> <th>Descriptive Field</th> </tr> </thead> <tbody> <tr> <td>303(d)</td> <td>No</td> <td>N/A</td> </tr> <tr> <td>Wetland Species</td> <td>No</td> <td>N/A</td> </tr> <tr> <td>Rare and Imperiled</td> <td>Yes</td> <td>SPECKLED CHUB, IRONCOLOR SHINER</td> </tr> <tr> <td>Land Use/Cover</td> <td>Yes</td> <td>AGRICULTURAL/WETLAND FORESTED MIX</td> </tr> <tr> <td>Candidate Mussels</td> <td>No</td> <td>N/A</td> </tr> <tr> <td>Sturgeon C.H.</td> <td>No</td> <td>N/A</td> </tr> </tbody> </table>		Feature	Within Range	Descriptive Field	303(d)	No	N/A	Wetland Species	No	N/A	Rare and Imperiled	Yes	SPECKLED CHUB, IRONCOLOR SHINER	Land Use/Cover	Yes	AGRICULTURAL/WETLAND FORESTED MIX	Candidate Mussels	No	N/A	Sturgeon C.H.	No	N/A
