Clear Creek		co-0812-r-012		Sedimentation Risk Index 42																																																																			
<u>Common:</u> 7.6mi N of Florala <u>Drainage:</u> Yellow River <u>GPS:</u> 31.116353, -86.318125 <u>Land owner:</u> Ronnie & Cindy Moates		<u>County:</u> Covington <u>PLSS (T-R-S):</u> 2N-17E-26 <u>Parcel No.:</u> 1 <u>Road Name:</u> Tram Rd		<u>State:</u> Alabama

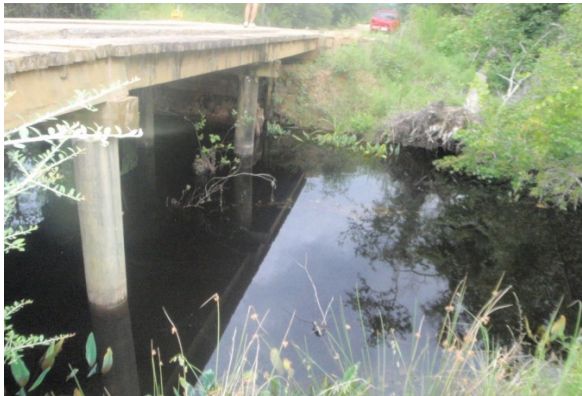
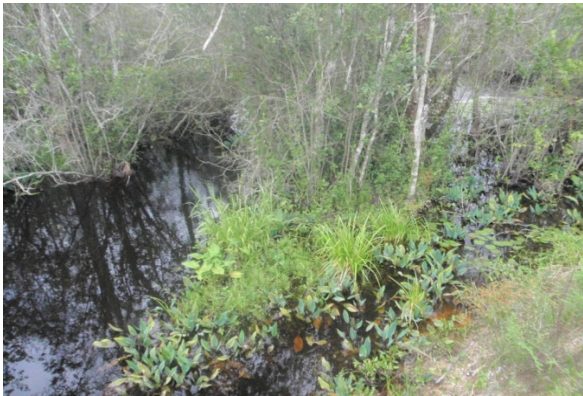
Crossing Structure: DS		US																																																																					
<table border="1"> <thead> <tr> <th>Risk Factor</th> <th>Ranking</th> <th>Score</th> </tr> </thead> <tbody> <tr><td>US Channel Morph</td><td>WETLAND</td><td>5</td></tr> <tr><td>DS Channel Morph</td><td>DA</td><td>3</td></tr> <tr><td>DS Bank Alteration</td><td>NATURAL</td><td>5</td></tr> <tr><td>Upstream Skew Angle</td><td>5-30°</td><td>3</td></tr> <tr><td>Crossing fill condition</td><td>Good/Vegetated</td><td>5</td></tr> <tr><td>Inlet/Outlet Condition</td><td>No Impairment</td><td>5</td></tr> <tr><td>Road Approach Material</td><td>All Sand/Clay</td><td>3</td></tr> <tr><td>Potential Eroded Volume Mean</td><td>>40 y³</td><td>1</td></tr> <tr><td>Approach Slope Mean</td><td>2.1-4%</td><td>3</td></tr> <tr><td>Soil K Factor</td><td><0.20</td><td>5</td></tr> <tr><td>Upstream Rt Outlet</td><td>Vegetated</td><td>1</td></tr> <tr><td>Upstream Lt Outlet</td><td>Vegetated</td><td>1</td></tr> <tr><td>Upstream Rt Ditch</td><td>Bare soil</td><td>0</td></tr> <tr><td>Upstream Lt Ditch</td><td>Bare soil</td><td>0</td></tr> <tr><td>Downstream Rt Outlet</td><td>Vegetated</td><td>1</td></tr> <tr><td>Downstream Lt Outlet</td><td>Bare soil</td><td>0</td></tr> <tr><td>Downstream Rt Ditch</td><td>Bare soil</td><td>0</td></tr> <tr><td>Downstream Lt Ditch</td><td>Bare soil</td><td>0</td></tr> <tr><td>Outlet Total</td><td>Partially Improved Outlet System</td><td>3</td></tr> <tr><td>Ditches Total</td><td>Unimproved Drainage System</td><td>1</td></tr> <tr><td>SRI Total</td><td>Medium Risk</td><td>42</td></tr> </tbody> </table>		Risk Factor	Ranking	Score	US Channel Morph	WETLAND	5	DS Channel Morph	DA	3	DS Bank Alteration	NATURAL	5	Upstream Skew Angle	5-30°	3	Crossing fill condition	Good/Vegetated	5	Inlet/Outlet Condition	No Impairment	5	Road Approach Material	All Sand/Clay	3	Potential Eroded Volume Mean	>40 y ³	1	Approach Slope Mean	2.1-4%	3	Soil K Factor	<0.20	5	Upstream Rt Outlet	Vegetated	1	Upstream Lt Outlet	Vegetated	1	Upstream Rt Ditch	Bare soil	0	Upstream Lt Ditch	Bare soil	0	Downstream Rt Outlet	Vegetated	1	Downstream Lt Outlet	Bare soil	0	Downstream Rt Ditch	Bare soil	0	Downstream Lt Ditch	Bare soil	0	Outlet Total	Partially Improved Outlet System	3	Ditches Total	Unimproved Drainage System	1	SRI Total	Medium Risk	42
