Faegins Creek		co-1029-r-003	Sedimentation Risk Index 42																																																																		
<u>Common:</u> 10.1mi NE of Andalusia <u>Drainage:</u> Yellow River <u>GPS:</u> 31.382492870, -86.334532485 <u>Land owner:</u> Tray Creane & Brett Riley		<u>County:</u> Covington <u>State:</u> Alabama <u>PLSS (T-R-S):</u> 5N-17E-22 <u>Parcel No.:</u> 4 <u>Road Name:</u> Lord Hill Rd

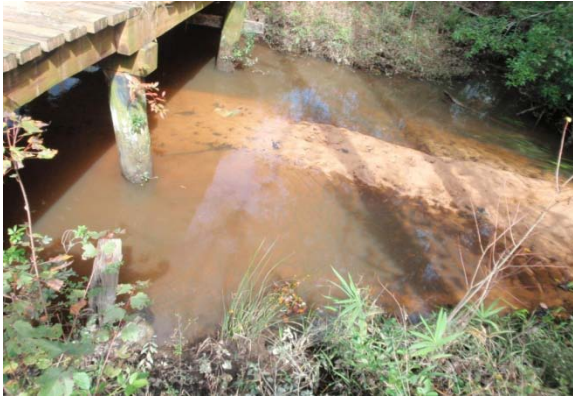
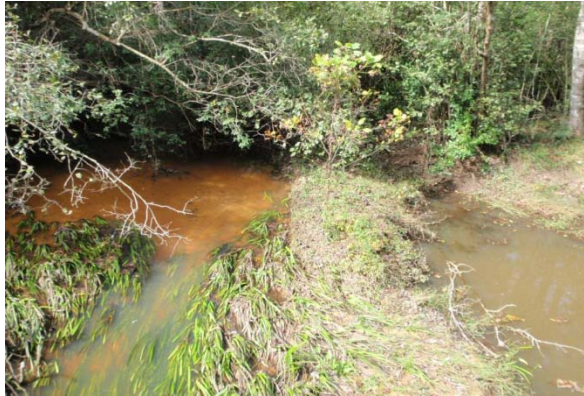
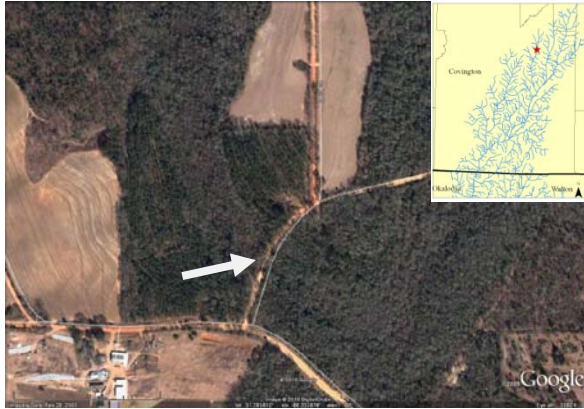
Crossing Structure: DS		US																																																																			
<table border="1"> <thead> <tr> <th>Risk Factor</th> <th>Ranking</th> <th>Score</th> </tr> </thead> <tbody> <tr><td>US Channel Morph</td><td>D</td><td>1</td></tr> <tr><td>DS Channel Morph</td><td>D</td><td>1</td></tr> <tr><td>DS Bank Alteration</td><td>MINOR/PARTIAL</td><td>3</td></tr> <tr><td>Upstream Skew Angle</td><td><5°</td><td>5</td></tr> <tr><td>Crossing fill condition</td><td>Good/Vegetated</td><td>5</td></tr> <tr><td>Inlet/Outlet Condition</td><td>Sed Islands/Scouring</td><td>3</td></tr> <tr><td>Road Approach Material</td><td>All Aggregate</td><td>5</td></tr> <tr><td>Potential Eroded Volume Mean</td><td><21 y³</td><td>5</td></tr> <tr><td>Approach Slope Mean</td><td>2.1-4%</td><td>3</td></tr> <tr><td>Soil K Factor</td><td><0.20</td><td>5</td></tr> <tr><td>Upstream Rt Outlet</td><td>Vegetated</td><td>1</td></tr> <tr><td>Upstream Lt Outlet</td><td>Vegetated</td><td>1</td></tr> <tr><td>Upstream Rt Ditch</td><td>Bare soil</td><td>0</td></tr> <tr><td>Upstream Lt Ditch</td><td>Bare soil</td><td>0</td></tr> <tr><td>Downstream Rt Outlet</td><td>Vegetated</td><td>1</td></tr> <tr><td>Downstream Lt Outlet</td><td>Vegetated</td><td>1</td></tr> <tr><td>Downstream Rt Ditch</td><td>Bare soil</td><td>0</td></tr> <tr><td>Downstream Lt Ditch</td><td>Bare soil</td><td>0</td></tr> <tr><td>Outlet Total</td><td>Improved Outlet System</td><td>5</td></tr> <tr><td>Ditches Total</td><td>Unimproved Drainage System</td><td>1</td></tr> <tr><td>SRI Total</td><td>Medium Risk</td><td>42</td></tr> </tbody> </table>		Risk Factor	Ranking	Score	US Channel Morph	D	1	DS Channel Morph	D	1	DS Bank Alteration	MINOR/PARTIAL	3	Upstream Skew Angle	<5°	5	Crossing fill condition	Good/Vegetated	5	Inlet/Outlet Condition	Sed Islands/Scouring	3	Road Approach Material	All Aggregate	5	Potential Eroded Volume Mean	<21 y ³	5	Approach Slope Mean	2.1-4%	3	Soil K Factor	<0.20	5	Upstream Rt Outlet	Vegetated	1	Upstream Lt Outlet	Vegetated	1	Upstream Rt Ditch	Bare soil	0	Upstream Lt Ditch	Bare soil	0	Downstream Rt Outlet	Vegetated	1	Downstream Lt Outlet	Vegetated	1	Downstream Rt Ditch	Bare soil	0	Downstream Lt Ditch	Bare soil	0	Outlet Total	Improved Outlet System	5	Ditches Total	Unimproved Drainage System	1	SRI Total	Medium Risk	42

Risk Factor	Ranking	Score																																																																			
US Channel Morph	D	1																																																																			
DS Channel Morph	D	1																																																																			
DS Bank Alteration	MINOR/PARTIAL	3																																																																			
Upstream Skew Angle	<5°	5																																																																			
Crossing fill condition	Good/Vegetated	5																																																																			
Inlet/Outlet Condition	Sed Islands/Scouring	3																																																																			
Road Approach Material	All Aggregate	5																																																																			
Potential Eroded Volume Mean	<21 y ³	5																																																																			
Approach Slope Mean	2.1-4%	3

Soil K Factor	<0.20	5																																																																			
Upstream Rt Outlet	Vegetated	1																																																																			
Upstream Lt Outlet	Vegetated	1																																																																			
Upstream Rt Ditch	Bare soil	0																																																																			
Upstream Lt Ditch	Bare soil	0																																																																			
Downstream Rt Outlet	Vegetated	1																																																																			
Downstream Lt Outlet	Vegetated	1																																																																			
Downstream Rt Ditch	Bare soil	0																																																																			
Downstream Lt Ditch	Bare soil	0																																																																			
Outlet Total	Improved Outlet System	5

Ditches Total	Unimproved Drainage System	1																																																																			
SRI Total	Medium Risk	42																																																																			
Additional Site Features <u>Crossing Type and Quantity:</u> Bridge, 1 <u>Crossing Materials:</u> Wood <u>Soil Types:</u> MBA, OrC, OrE, TrD <u>Rt Approach Prism Fill:</u> 0.1in <u>Lt Approach Prism Fill:</u> 0.1in		<table border="1"> <thead> <tr> <th>Feature</th> <th>Within Range</th> <th>Descriptive Field</th> </tr> </thead> <tbody> <tr> <td>303(d)</td> <td>No</td> <td>N/A</td> </tr> <tr> <td>Wetland Species</td> <td>No</td> <td>N/A</td> </tr> <tr> <td>Rare and Imperiled</td> <td>No</td> <td>N/A</td> </tr> <tr> <td>Land Use/Cover</td> <td>Yes</td> <td>N/A/ PASTURE/HAY, EAST GULF COASTAL PLAIN INTERIOR UPLAND LONGLEAF PINE WOODLAND-OFFSITE HARDWOOD MOD</td> </tr> <tr> <td>Candidate Mussels</td> <td>No</td> <td>N/A</td> </tr> <tr> <td>Sturgeon C.H.</td> <td>No</td> <td>N/A</td> </tr> </tbody> </table>		Feature	Within Range	Descriptive Field	303(d)	No	N/A	Wetland Species	No	N/A	Rare and Imperiled	No	N/A	Land Use/Cover	Yes	N/A/ PASTURE/HAY, EAST GULF COASTAL PLAIN INTERIOR UPLAND LONGLEAF PINE WOODLAND-OFFSITE HARDWOOD MOD	Candidate Mussels	No	N/A	Sturgeon C.H.	No	N/A

Notes: Close proximity to YR main stem.
