Unnamed tributary		co-0820-r-007	Sedimentation Risk Index 38																																																																		
<u>Common:</u> 6.1mi N of Florala <u>Drainage:</u> Clear Creek <u>GPS:</u> 31.093397595, -86.334589086 <u>Land owner:</u> Rayonier Forest Resources LP		<u>County:</u> Covington <u>PLSS (T-R-S):</u> 2N-17E-34 <u>Parcel No.:</u> 3 <u>Road Name:</u> Tram Rd	<u>State:</u> Alabama

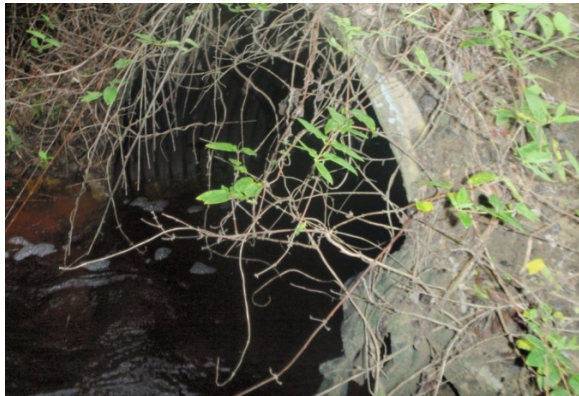
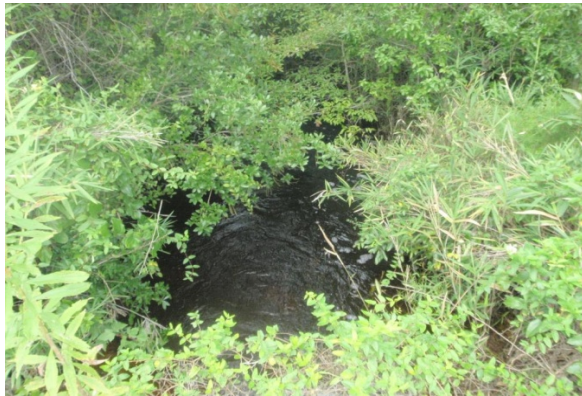
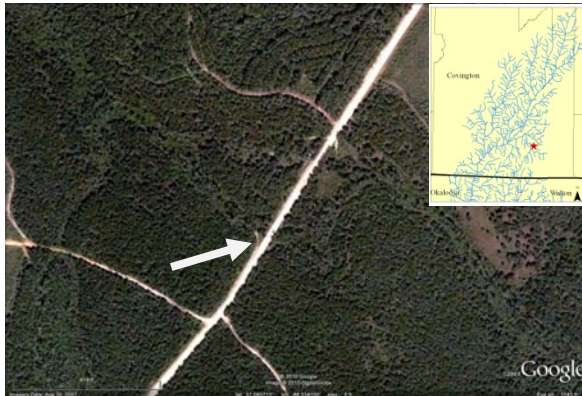
Crossing Structure: DS		DS																																																																			
<table border="1"> <thead> <tr> <th>Risk Factor</th> <th>Ranking</th> <th>Score</th> </tr> </thead> <tbody> <tr><td>US Channel Morph</td><td>DA</td><td>3</td></tr> <tr><td>DS Channel Morph</td><td>C</td><td>5</td></tr> <tr><td>DS Bank Alteration</td><td>MINOR/PARTIAL</td><td>3</td></tr> <tr><td>Upstream Skew Angle</td><td>5-30°</td><td>3</td></tr> <tr><td>Crossing fill condition</td><td>Poor/Bare soil</td><td>1</td></tr> <tr><td>Inlet/Outlet Condition</td><td>No Impairment</td><td>5</td></tr> <tr><td>Road Approach Material</td><td>All Sand/Clay</td><td>3</td></tr> <tr><td>Potential Eroded Volume Mean</td><td>>40 y³</td><td>1</td></tr> <tr><td>Approach Slope Mean</td><td><2%</td><td>5</td></tr> <tr><td>Soil K Factor</td><td><0.20</td><td>5</td></tr> <tr><td>Upstream Rt Outlet</td><td>Vegetated</td><td>1</td></tr> <tr><td>Upstream Lt Outlet</td><td>Vegetated</td><td>1</td></tr> <tr><td>Upstream Rt Ditch</td><td>Bare soil</td><td>0</td></tr> <tr><td>Upstream Lt Ditch</td><td>Bare soil</td><td>0</td></tr> <tr><td>Downstream Rt Outlet</td><td>Bare soil</td><td>0</td></tr> <tr><td>Downstream Lt Outlet</td><td>Vegetated</td><td>1</td></tr> <tr><td>Downstream Rt Ditch</td><td>Bare soil</td><td>0</td></tr> <tr><td>Downstream Lt Ditch</td><td>Bare soil</td><td>0</td></tr> <tr><td>Outlet Total</td><td>Partially Improved Outlet System</td><td>3</td></tr> <tr><td>Ditches Total</td><td>Unimproved Drainage System</td><td>1</td></tr> <tr><td>SRI Total</td><td>Medium Risk</td><td>38</td></tr> </tbody> </table>		Risk Factor	Ranking	Score	US Channel Morph	DA	3	DS Channel Morph	C	5	DS Bank Alteration	MINOR/PARTIAL	3	Upstream Skew Angle	5-30°	3	Crossing fill condition	Poor/Bare soil	1	Inlet/Outlet Condition	No Impairment	5	Road Approach Material	All Sand/Clay	3	Potential Eroded Volume Mean	>40 y ³	1	Approach Slope Mean	<2%	5	Soil K Factor	<0.20	5	Upstream Rt Outlet	Vegetated	1	Upstream Lt Outlet	Vegetated	1	Upstream Rt Ditch	Bare soil	0	Upstream Lt Ditch	Bare soil	0	Downstream Rt Outlet	Bare soil	0	Downstream Lt Outlet	Vegetated	1	Downstream Rt Ditch	Bare soil	0	Downstream Lt Ditch	Bare soil	0	Outlet Total	Partially Improved Outlet System	3	Ditches Total	Unimproved Drainage System	1	SRI Total	Medium Risk	38

Ditches Total	Unimproved Drainage System	1																																																																			
SRI Total	Medium Risk	38																																																																			
Additional Site Features <u>Crossing Type and Quantity:</u> Culvert, 1 <u>Crossing Materials:</u> Metal <u>Soil Types:</u> Bob,FuB,MBA,RaA <u>Rt Approach Prism Fill:</u> 1.0in <u>Lt Approach Prism Fill:</u> 0.1in		<table border="1"> <thead> <tr> <th>Feature</th> <th>Within Range</th> <th>Descriptive Field</th> </tr> </thead> <tbody> <tr><td>303(d)</td><td>No</td><td>N/A</td></tr> <tr><td>Wetland Species</td><td>No</td><td>N/A</td></tr> <tr><td>Rare and Imperiled</td><td>No</td><td>N/A</td></tr> <tr><td>Land Use/ Cover</td><td>Yes</td><td>N/A/ SUCCESSIONAL SHRUB/SCRUB (CLEAR CUT)</td></tr> <tr><td>Candidate Mussels</td><td>No</td><td>N/A</td></tr> <tr><td>Sturgeon C.H.</td><td>No</td><td>N/A</td></tr> </tbody> </table>		Feature	Within Range	Descriptive Field	303(d)	No	N/A	Wetland Species	No	N/A	Rare and Imperiled	No	N/A	Land Use/ Cover	Yes	N/A/ SUCCESSIONAL SHRUB/SCRUB (CLEAR CUT)	Candidate Mussels	No	N/A	Sturgeon C.H.	No	N/A
