Unnamed tributary		co-0831-r-008		Sedimentation Risk Index <b>40</b>																																																																			
<u>Common:</u> 6.8mi SW of Opp <u>Drainage:</u> Indian Creek <u>GPS:</u> 31.205856, -86.328747 <u>Land owner:</u> C&G LLC		<u>County:</u> Covington <u>PLSS (T-R-S):</u> 3N-17E-22/23 <u>Parcel No.:</u> 11 <u>Road Name:</u> Harrell Rd		<u>State:</u> Alabama

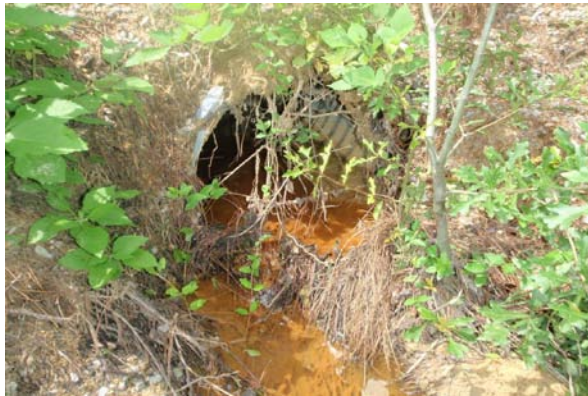
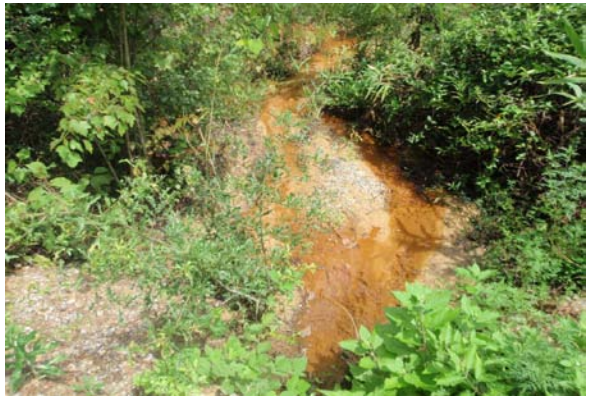
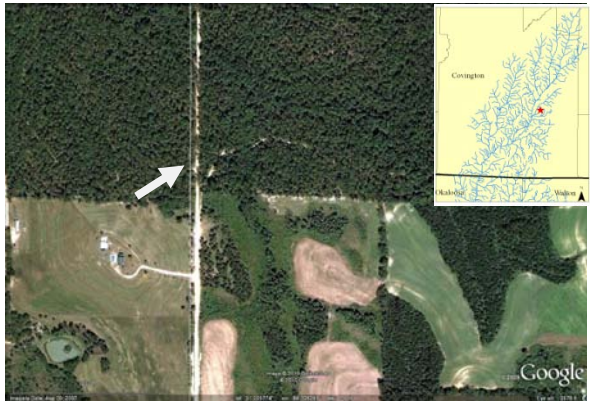
Crossing Structure: DS		US																																																																					
<table border="1"> <thead> <tr> <th>Risk Factor</th> <th>Ranking</th> <th>Score</th> </tr> </thead> <tbody> <tr><td>US Channel Morph</td><td>DA</td><td>3</td></tr> <tr><td>DS Channel Morph</td><td>B</td><td>5</td></tr> <tr><td>DS Bank Alteration</td><td>HIGH</td><td>1</td></tr> <tr><td>Upstream Skew Angle</td><td>5-30°</td><td>3</td></tr> <tr><td>Crossing fill condition</td><td>Poor/Bare soil</td><td>1</td></tr> <tr><td>Inlet/Outlet Condition</td><td>Sed Islands/Scouring</td><td>3</td></tr> <tr><td>Road Approach Material</td><td>All Aggregate</td><td>5</td></tr> <tr><td>Potential Eroded Volume Mean</td><td>&lt;21 y<sup>3</sup></td><td>5</td></tr> <tr><td>Approach Slope Mean</td><td>&lt;2%</td><td>5</td></tr> <tr><td>Soil K Factor</td><td>&lt;0.20</td><td>5</td></tr> <tr><td>Upstream Rt Outlet</td><td>Bare soil</td><td>0</td></tr> <tr><td>Upstream Lt Outlet</td><td>Bare soil</td><td>0</td></tr> <tr><td>Upstream Rt Ditch</td><td>Bare soil</td><td>0</td></tr> <tr><td>Upstream Lt Ditch</td><td>Bare soil</td><td>0</td></tr> <tr><td>Downstream Rt Outlet</td><td>Vegetated</td><td>1</td></tr> <tr><td>Downstream Lt Outlet</td><td>Vegetated</td><td>1</td></tr> <tr><td>Downstream Rt Ditch</td><td>Bare soil</td><td>0</td></tr> <tr><td>Downstream Lt Ditch</td><td>Bare soil</td><td>0</td></tr> <tr><td>Outlet Total</td><td>Partially Improved Outlet System</td><td>3</td></tr> <tr><td>Ditches Total</td><td>Unimproved Drainage System</td><td>1</td></tr> <tr><td><b>SRI Total</b></td><td><b>Medium Risk</b></td><td><b>40</b></td></tr> </tbody> </table>		Risk Factor	Ranking	Score	US Channel Morph	DA	3	DS Channel Morph	B	5	DS Bank Alteration	HIGH	1	Upstream Skew Angle	5-30°	3	Crossing fill condition	Poor/Bare soil	1	Inlet/Outlet Condition	Sed Islands/Scouring	3	Road Approach Material	All Aggregate	5	Potential Eroded Volume Mean	<21 y <sup>3</sup>	5	Approach Slope Mean	<2%	5	Soil K Factor	<0.20	5	Upstream Rt Outlet	Bare soil	0	Upstream Lt Outlet	Bare soil	0	Upstream Rt Ditch	Bare soil	0	Upstream Lt Ditch	Bare soil	0	Downstream Rt Outlet	Vegetated	1	Downstream Lt Outlet	Vegetated	1	Downstream Rt Ditch	Bare soil	0	Downstream Lt Ditch	Bare soil	0	Outlet Total	Partially Improved Outlet System	3	Ditches Total	Unimproved Drainage System	1	<b>SRI Total</b>	<b>Medium Risk</b>	<b>40</b>

Notes: Aggregate in stream bed.
