Unnamed tributary		wa-0714-r-006	Sedimentation Risk Index <b>40</b>																																																																		
<u>Common:</u> 10.4mi NW of DeFuniak Springs <u>Drainage:</u> Big Swamp Creek <u>GPS:</u> 30.853328, -86.197277 <u>Land owner:</u> John & Annie Coon-US, Pauline Price-DS		<u>County:</u> Walton <u>PLSS(T-R-S):</u> 4N-20-12 <u>Parcel No.:</u> 5; 4 <u>Road Name:</u> Price Rd	<u>State:</u> Florida

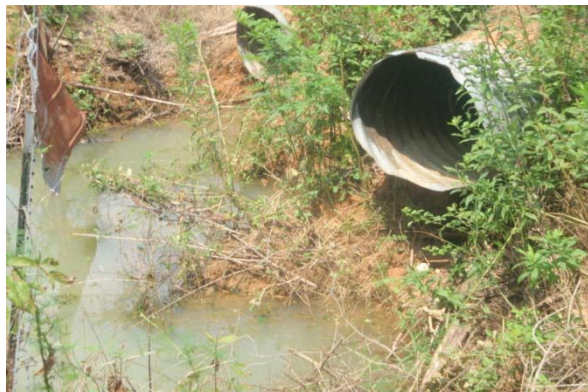
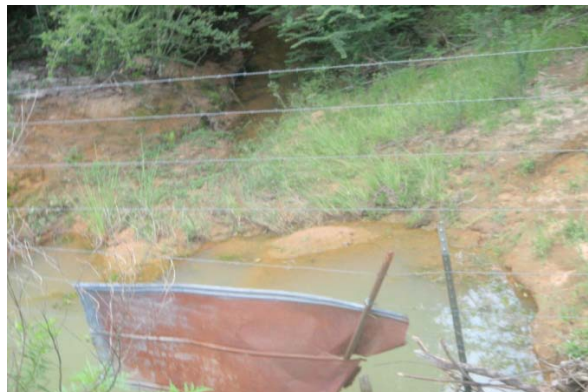
Crossing Structure: DS		US																																																																			
<table border="1"> <thead> <tr> <th>Risk Factor</th> <th>Ranking</th> <th>Score</th> </tr> </thead> <tbody> <tr><td>US Channel Morph</td><td>E</td><td>5</td></tr> <tr><td>DS Channel Morph</td><td>DA</td><td>3</td></tr> <tr><td>DS Bank Alteration</td><td>HIGH</td><td>1</td></tr> <tr><td>Upstream Skew Angle</td><td>5-30°</td><td>3</td></tr> <tr><td>Crossing fill condition</td><td>Good/Vegetated</td><td>5</td></tr> <tr><td>Inlet/Outlet Condition</td><td>Sed Islands/Scouring</td><td>3</td></tr> <tr><td>Road Approach Material</td><td>All Sand/Clay</td><td>3</td></tr> <tr><td>Potential Eroded Volume Mean</td><td>21-40 y<sup>3</sup></td><td>3</td></tr> <tr><td>Approach Slope Mean</td><td>2.1-4%</td><td>3</td></tr> <tr><td>Soil K Factor</td><td>&lt;0.20</td><td>5</td></tr> <tr><td>Upstream Rt Outlet</td><td>Vegetated</td><td>1</td></tr> <tr><td>Upstream Lt Outlet</td><td>Vegetated</td><td>1</td></tr> <tr><td>Upstream Rt Ditch</td><td>Bare soil</td><td>0</td></tr> <tr><td>Upstream Lt Ditch</td><td>Bare soil</td><td>0</td></tr> <tr><td>Downstream Rt Outlet</td><td>Vegetated</td><td>1</td></tr> <tr><td>Downstream Lt Outlet</td><td>Vegetated</td><td>1</td></tr> <tr><td>Downstream Rt Ditch</td><td>Bare soil</td><td>0</td></tr> <tr><td>Downstream Lt Ditch</td><td>Bare soil</td><td>0</td></tr> <tr><td>Outlet Total</td><td>Improved Outlet System</td><td>5</td></tr> <tr><td>Ditches Total</td><td>Unimproved Drainage System</td><td>1</td></tr> <tr><td><b>SRI Total</b></td><td><b>Medium Risk</b></td><td><b>40</b></td></tr> </tbody> </table>		Risk Factor	Ranking	Score	US Channel Morph	E	5	DS Channel Morph	DA	3	DS Bank Alteration	HIGH	1	Upstream Skew Angle	5-30°	3	Crossing fill condition	Good/Vegetated	5	Inlet/Outlet Condition	Sed Islands/Scouring	3	Road Approach Material	All Sand/Clay	3	Potential Eroded Volume Mean	21-40 y <sup>3</sup>	3	Approach Slope Mean	2.1-4%	3	Soil K Factor	<0.20	5	Upstream Rt Outlet	Vegetated	1	Upstream Lt Outlet	Vegetated	1	Upstream Rt Ditch	Bare soil	0	Upstream Lt Ditch	Bare soil	0	Downstream Rt Outlet	Vegetated	1	Downstream Lt Outlet	Vegetated	1	Downstream Rt Ditch	Bare soil	0	Downstream Lt Ditch	Bare soil	0	Outlet Total	Improved Outlet System	5	Ditches Total	Unimproved Drainage System	1	<b>SRI Total</b>	<b>Medium Risk</b>	<b>40</b>

Notes: DS drop off creating partial fish passage barrier.
