Unnamed tributary		co-0904-r-017	Sedimentation Risk Index <b>44</b>																																																																		
<u>Common:</u> 2.8mi SW of Opp <u>Drainage:</u> Indian Creek <u>GPS:</u> 31.253022205, -86.287154176 <u>Land owner:</u> Charles Jr & Renee Burgess		<u>County:</u> Covington <u>State:</u> Alabama <u>PLSS (T-R-S):</u> 3N-18E-6 <u>Parcel No.:</u> 8.02 <u>Road Name:</u> Substation Rd

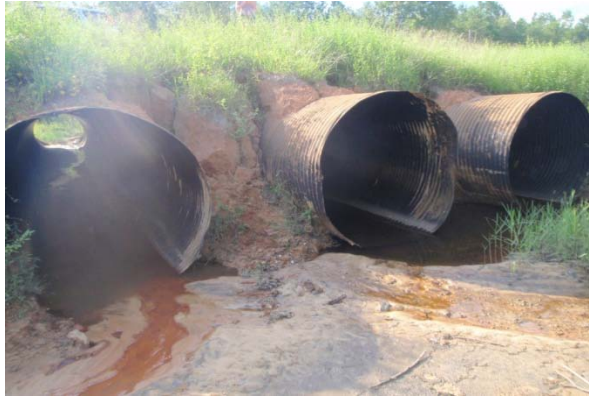
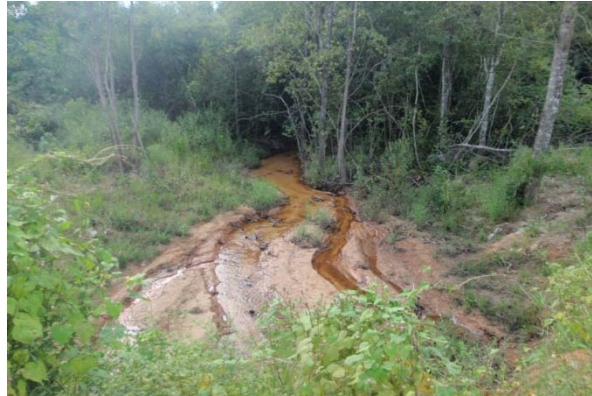
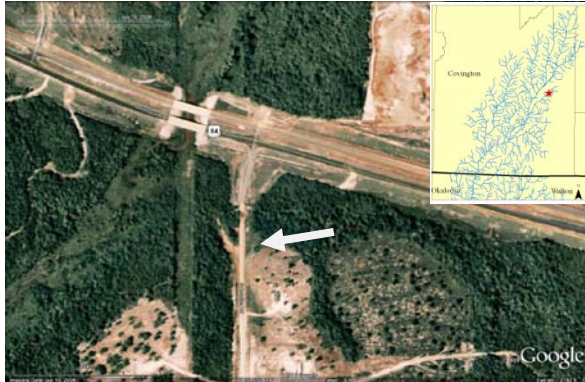
Crossing Structure: US		DS																																																																			
<table border="1"> <thead> <tr> <th>Risk Factor</th> <th>Ranking</th> <th>Score</th> </tr> </thead> <tbody> <tr><td>US Channel Morph</td><td>C</td><td>5</td></tr> <tr><td>DS Channel Morph</td><td>C</td><td>5</td></tr> <tr><td>DS Bank Alteration</td><td>HIGH</td><td>1</td></tr> <tr><td>Upstream Skew Angle</td><td>&gt;30°</td><td>1</td></tr> <tr><td>Crossing fill condition</td><td>Good/Vegetated</td><td>5</td></tr> <tr><td>Inlet/Outlet Condition</td><td>No Impairment</td><td>5</td></tr> <tr><td>Road Approach Material</td><td>All Sand/Clay</td><td>3</td></tr> <tr><td>Potential Eroded Volume Mean</td><td>&lt;21 y<sup>3</sup></td><td>5</td></tr> <tr><td>Approach Slope Mean</td><td>&gt;4%</td><td>1</td></tr> <tr><td>Soil K Factor</td><td>&lt;0.20</td><td>5</td></tr> <tr><td>Upstream Rt Outlet</td><td>Vegetated</td><td>1</td></tr> <tr><td>Upstream Lt Outlet</td><td>Bare soil</td><td>0</td></tr> <tr><td>Upstream Rt Ditch</td><td>Vegetated</td><td>1</td></tr> <tr><td>Upstream Lt Ditch</td><td>Vegetated</td><td>1</td></tr> <tr><td>Downstream Rt Outlet</td><td>Vegetated</td><td>1</td></tr> <tr><td>Downstream Lt Outlet</td><td>Vegetated</td><td>1</td></tr> <tr><td>Downstream Rt Ditch</td><td>Vegetated</td><td>1</td></tr> <tr><td>Downstream Lt Ditch</td><td>Vegetated</td><td>1</td></tr> <tr><td>Outlet Total</td><td>Partially Improved Outlet System</td><td>3</td></tr> <tr><td>Ditches Total</td><td>Improved Drainage System</td><td>5</td></tr> <tr><td><b>SRI Total</b></td><td><b>Medium Risk</b></td><td><b>44</b></td></tr> </tbody> </table>		Risk Factor	Ranking	Score	US Channel Morph	C	5	DS Channel Morph	C	5	DS Bank Alteration	HIGH	1	Upstream Skew Angle	>30°	1	Crossing fill condition	Good/Vegetated	5	Inlet/Outlet Condition	No Impairment	5	Road Approach Material	All Sand/Clay	3	Potential Eroded Volume Mean	<21 y <sup>3</sup>	5	Approach Slope Mean	>4%	1	Soil K Factor	<0.20	5	Upstream Rt Outlet	Vegetated	1	Upstream Lt Outlet	Bare soil	0	Upstream Rt Ditch	Vegetated	1	Upstream Lt Ditch	Vegetated	1	Downstream Rt Outlet	Vegetated	1	Downstream Lt Outlet	Vegetated	1	Downstream Rt Ditch	Vegetated	1	Downstream Lt Ditch	Vegetated	1	Outlet Total	Partially Improved Outlet System	3	Ditches Total	Improved Drainage System	5	<b>SRI Total</b>	<b>Medium Risk</b>	<b>44</b>

Notes: Most of Rt approach paved
