Unnamed tributary		co-0901-r-015	Sedimentation Risk Index 44																																																																		
<u>Common:</u> 11.6mi SE of Andalusia <u>Drainage:</u> Yellow River <u>GPS:</u> 31.158752073, -86.391583846 <u>Land owner:</u> Patricia Moody		<u>County:</u> Covington <u>State:</u> Alabama <u>PLSS (T-R-S):</u> 2N-17E-7 <u>Parcel No.:</u> 2 <u>Road Name:</u> Lake Rd

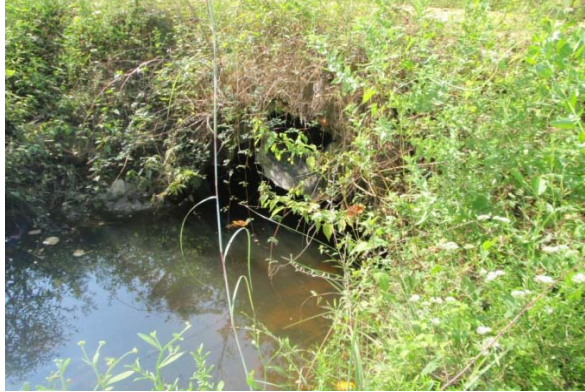
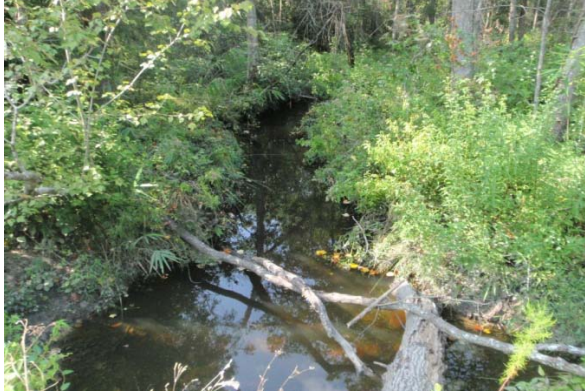
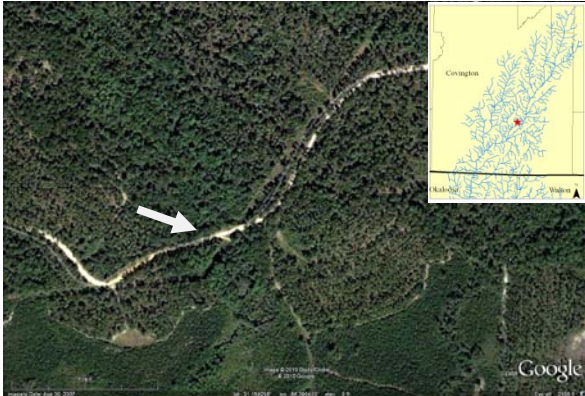
Crossing Structure: DS		US																																																																			
<table border="1"> <thead> <tr> <th>Risk Factor</th> <th>Ranking</th> <th>Score</th> </tr> </thead> <tbody> <tr><td>US Channel Morph</td><td>C</td><td>5</td></tr> <tr><td>DS Channel Morph</td><td>C</td><td>5</td></tr> <tr><td>DS Bank Alteration</td><td>MINOR/PARTIAL</td><td>3</td></tr> <tr><td>Upstream Skew Angle</td><td><5°</td><td>5</td></tr> <tr><td>Crossing fill condition</td><td>Good/Vegetated</td><td>5</td></tr> <tr><td>Inlet/Outlet Condition</td><td>Sed Islands/Scouring</td><td>3</td></tr> <tr><td>Road Approach Material</td><td>All Sand/Clay</td><td>3</td></tr> <tr><td>Potential Eroded Volume Mean</td><td>>40 y³</td><td>1</td></tr> <tr><td>Approach Slope Mean</td><td>2.1-4%</td><td>3</td></tr> <tr><td>Soil K Factor</td><td><0.20</td><td>5</td></tr> <tr><td>Upstream Rt Outlet</td><td>Vegetated</td><td>1</td></tr> <tr><td>Upstream Lt Outlet</td><td>Vegetated</td><td>1</td></tr> <tr><td>Upstream Rt Ditch</td><td>Bare soil</td><td>0</td></tr> <tr><td>Upstream Lt Ditch</td><td>Bare soil</td><td>0</td></tr> <tr><td>Downstream Rt Outlet</td><td>Vegetated</td><td>1</td></tr> <tr><td>Downstream Lt Outlet</td><td>Vegetated</td><td>1</td></tr> <tr><td>Downstream Rt Ditch</td><td>Bare soil</td><td>0</td></tr> <tr><td>Downstream Lt Ditch</td><td>Bare soil</td><td>0</td></tr> <tr><td>Outlet Total</td><td>Improved Outlet System</td><td>5</td></tr> <tr><td>Ditches Total</td><td>Unimproved Drainage System</td><td>1</td></tr> <tr><td>SRI Total</td><td>Medium Risk</td><td>44</td></tr> </tbody> </table>		Risk Factor	Ranking	Score	US Channel Morph	C	5	DS Channel Morph	C	5	DS Bank Alteration	MINOR/PARTIAL	3	Upstream Skew Angle	<5°	5	Crossing fill condition	Good/Vegetated	5	Inlet/Outlet Condition	Sed Islands/Scouring	3	Road Approach Material	All Sand/Clay	3	Potential Eroded Volume Mean	>40 y ³	1	Approach Slope Mean	2.1-4%	3	Soil K Factor	<0.20	5	Upstream Rt Outlet	Vegetated	1	Upstream Lt Outlet	Vegetated	1	Upstream Rt Ditch	Bare soil	0	Upstream Lt Ditch	Bare soil	0	Downstream Rt Outlet	Vegetated	1	Downstream Lt Outlet	Vegetated	1	Downstream Rt Ditch	Bare soil	0	Downstream Lt Ditch	Bare soil	0	Outlet Total	Improved Outlet System	5	Ditches Total	Unimproved Drainage System	1	SRI Total	Medium Risk	44

Notes: Highly vegetated
