Unnamed tributary		wa-0716-r-003a	Sedimentation Risk Index 38																																																																		
<u>Common:</u> 3.8mi NE of Mossy Head <u>Drainage:</u> Shoal River GPS: 30.756112, -86.252238 <u>Land owner:</u> Helen Bright-US, James & Diane Love-DS		<u>County:</u> Walton <u>State:</u> Florida <u>PLSS(T-R-S):</u> 3N-20-16-28060 <u>Parcel No.:</u> 9.0150; 25.0150 <u>Road Name:</u> Trout Rd

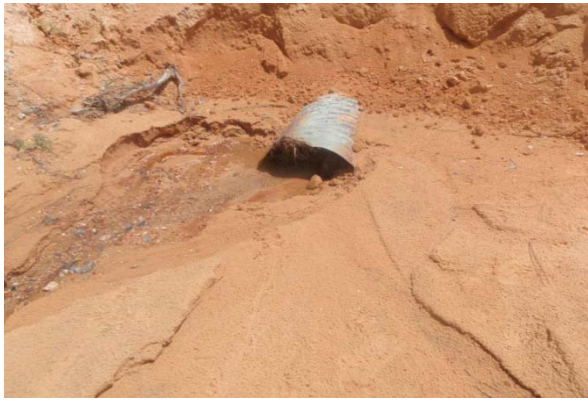
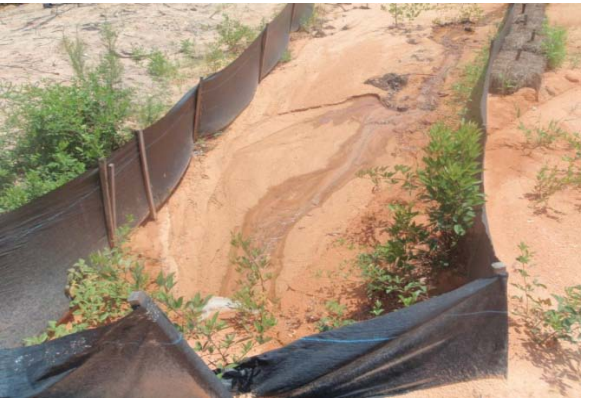
Crossing Structure: US		DS																																																																			
<table border="1"> <thead> <tr> <th>Risk Factor</th> <th>Ranking</th> <th>Score</th> </tr> </thead> <tbody> <tr><td>US Channel Morph</td><td>E</td><td>5</td></tr> <tr><td>DS Channel Morph</td><td>E</td><td>5</td></tr> <tr><td>DS Bank Alteration</td><td>HIGH</td><td>1</td></tr> <tr><td>Upstream Skew Angle</td><td><5°</td><td>5</td></tr> <tr><td>Crossing fill condition</td><td>Poor/Bare soil</td><td>1</td></tr> <tr><td>Inlet/Outlet Condition</td><td>Sed Islands/Scouring</td><td>3</td></tr> <tr><td>Road Approach Material</td><td>All Sand/Clay</td><td>3</td></tr> <tr><td>Potential Eroded Volume Mean</td><td><21 y³</td><td>5</td></tr> <tr><td>Approach Slope Mean</td><td>2.1-4%</td><td>3</td></tr> <tr><td>Soil K Factor</td><td><0.20</td><td>5</td></tr> <tr><td>Upstream Rt Outlet</td><td>Bare soil</td><td>0</td></tr> <tr><td>Upstream Lt Outlet</td><td>Bare soil</td><td>0</td></tr> <tr><td>Upstream Rt Ditch</td><td>Bare soil</td><td>0</td></tr> <tr><td>Upstream Lt Ditch</td><td>Bare soil</td><td>0</td></tr> <tr><td>Downstream Rt Outlet</td><td>Bare soil</td><td>0</td></tr> <tr><td>Downstream Lt Outlet</td><td>Other</td><td>0</td></tr> <tr><td>Downstream Rt Ditch</td><td>Bare soil</td><td>0</td></tr> <tr><td>Downstream Lt Ditch</td><td>Bare soil</td><td>0</td></tr> <tr><td>Outlet Total</td><td>Unimproved Outlet System</td><td>1</td></tr> <tr><td>Ditches Total</td><td>Unimproved Drainage System</td><td>1</td></tr> <tr><td>SRI Total</td><td>Medium Risk</td><td>38</td></tr> </tbody> </table>		Risk Factor	Ranking	Score	US Channel Morph	E	5	DS Channel Morph	E	5	DS Bank Alteration	HIGH	1	Upstream Skew Angle	<5°	5	Crossing fill condition	Poor/Bare soil	1	Inlet/Outlet Condition	Sed Islands/Scouring	3	Road Approach Material	All Sand/Clay	3	Potential Eroded Volume Mean	<21 y ³	5	Approach Slope Mean	2.1-4%	3	Soil K Factor	<0.20	5	Upstream Rt Outlet	Bare soil	0	Upstream Lt Outlet	Bare soil	0	Upstream Rt Ditch	Bare soil	0	Upstream Lt Ditch	Bare soil	0	Downstream Rt Outlet	Bare soil	0	Downstream Lt Outlet	Other	0	Downstream Rt Ditch	Bare soil	0	Downstream Lt Ditch	Bare soil	0	Outlet Total	Unimproved Outlet System	1	Ditches Total	Unimproved Drainage System	1	SRI Total	Medium Risk	38

Notes: BMPs installed

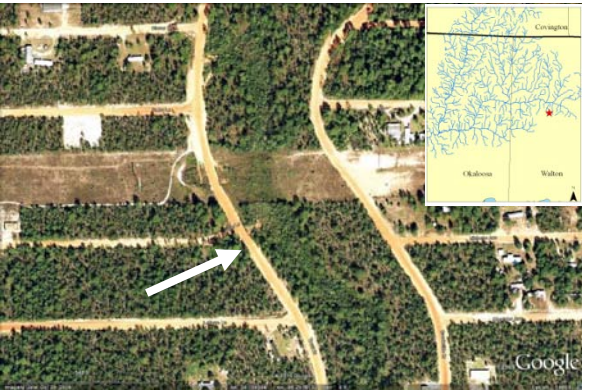
Risk Factor	Ranking	Score																																																																			
US Channel Morph	E	5																																																																			
DS Channel Morph	E	5																																																																			
DS Bank Alteration	HIGH	1																																																																			
Upstream Skew Angle	<5°	5																																																																			
Crossing fill condition	Poor/Bare soil	1																																																																			
Inlet/Outlet Condition	Sed Islands/Scouring	3																																																																			
Road Approach Material	All Sand/Clay	3																																																																			
Potential Eroded Volume Mean	<21 y ³	5																																																																			
Approach Slope Mean	2.1-4%	3

Soil K Factor	<0.20	5																																																																			
Upstream Rt Outlet	Bare soil	0																																																																			
Upstream Lt Outlet	Bare soil	0																																																																			
Upstream Rt Ditch	Bare soil	0																																																																			
Upstream Lt Ditch	Bare soil	0																																																																			
Downstream Rt Outlet	Bare soil	0																																																																			
Downstream Lt Outlet	Other	0																																																																			
Downstream Rt Ditch	Bare soil	0																																																																			
Downstream Lt Ditch	Bare soil	0																																																																			
Outlet Total	Unimproved Outlet System	1
