Unnamed tributary		co-0810-r-014b		Sedimentation Risk Index <b>38</b>																																																																			
<u>Common:</u> 7.4mi S of Andalusia <u>Drainage:</u> Five Runs Creek <u>GPS:</u> 31.200686, -86.480097 <u>Land owner:</u> C&G LLC		<u>County:</u> Covington <u>PLSS (T-R-S):</u> 3N-16E-29 <u>Parcel No.:</u> 1 <u>Road Name:</u> Bass Bridge Rd		<u>State:</u> Alabama

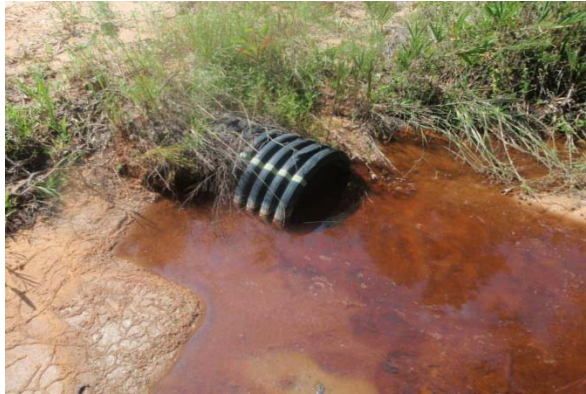
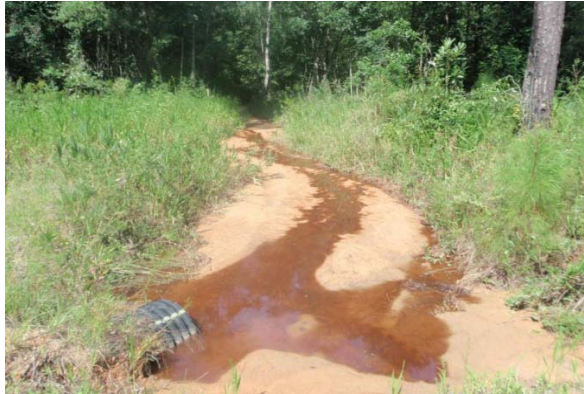
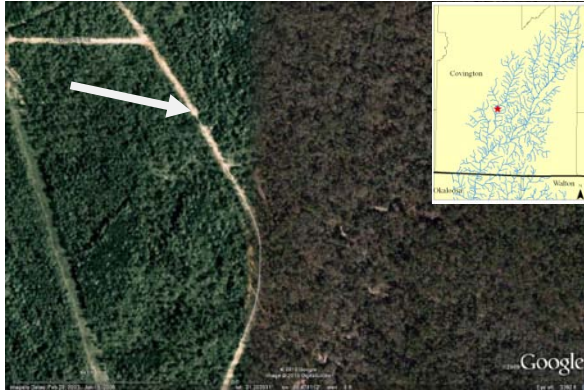
Risk Factor	Ranking	Score																																																																					
US Channel Morph	E	5																																																																					
DS Channel Morph	E	5																																																																					
DS Bank Alteration	HIGH	1																																																																					
Upstream Skew Angle	>30°	1																																																																					
Crossing fill condition	Poor/Bare soil	1																																																																					
Inlet/Outlet Condition	No Impairment	5																																																																					
Road Approach Material	All Sand/Clay	3																																																																					
Potential Eroded Volume Mean	>40 y <sup>3</sup>	1

Approach Slope Mean	<2%	5																																																																					
Soil K Factor	<0.20	5																																																																					
Upstream Rt Outlet	Vegetated	1																																																																					
Upstream Lt Outlet	Vegetated	1																																																																					
Upstream Rt Ditch	Bare soil	0																																																																					
Upstream Lt Ditch	Bare soil	0																																																																					
Downstream Rt Outlet	Vegetated	1																																																																					
Downstream Lt Outlet	Vegetated	1																																																																					
Downstream Rt Ditch	Bare soil	0																																																																					
Downstream Lt Ditch	Bare soil	0

Outlet Total	Improved Outlet System	5																																																																					
Ditches Total	Unimproved Drainage System	1																																																																					
<b>SRI Total</b>	<b>Medium Risk</b>	<b>38</b>																																																																					
<b>Additional Site Features</b> <u>Crossing Type and Quantity:</u> Culvert, 1 <u>Crossing Materials:</u> PVC <u>Soil Types:</u> BoB,FoA,FuB,IbA <u>Rt Approach Prism Fill:</u> 0.25in <u>Lt Approach Prism Fill:</u> 0.2in		<table border="1"> <thead> <tr> <th>Feature</th> <th>Within Range</th> <th>Descriptive Field</th> </tr> </thead> <tbody> <tr> <td>303(d)</td> <td>No</td> <td>N/A</td> </tr> <tr> <td>Wetland Species</td> <td>No</td> <td>N/A</td> </tr> <tr> <td>Rare and Imperiled</td> <td>No</td> <td>N/A</td> </tr> <tr> <td>Land Use/Cover</td> <td>Yes</td> <td>N/A / EVERGREEN PLANTATIONS</td> </tr> <tr> <td>Candidate Mussels</td> <td>No</td> <td>N/A</td> </tr> <tr> <td>Sturgeon C.H.</td> <td>No</td> <td>N/A</td> </tr> </tbody> </table>				Feature	Within Range	Descriptive Field	303(d)	No	N/A	Wetland Species	No	N/A	Rare and Imperiled	No	N/A	Land Use/Cover	Yes	N/A / EVERGREEN PLANTATIONS	Candidate Mussels	No	N/A	Sturgeon C.H.	No	N/A

Notes: US channelized ditch.
