Unnamed tributary		co-0812-r-010	Sedimentation Risk Index <b>46</b>																																																																		
<u>Common:</u> 8.3mi N of Florala <u>Drainage:</u> Clear Creek <i>GPS:</i> 31.126136, -86.330511 <u>Land owner:</u> Rayonier Forest Resources LP		<u>County:</u> Covington <u>PLSS (T-R-S):</u> 2N-17E-22 <u>Parcel No.:</u> 1 <u>Road Name:</u> Booker Rd

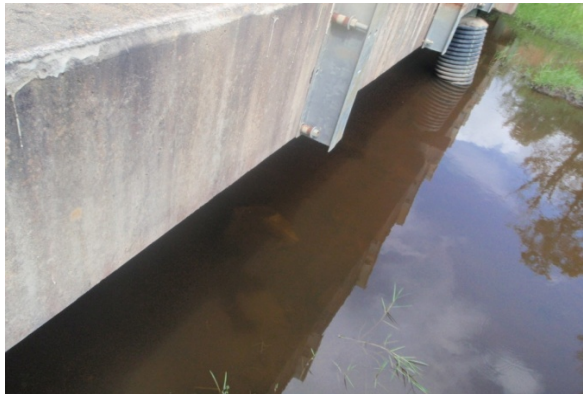
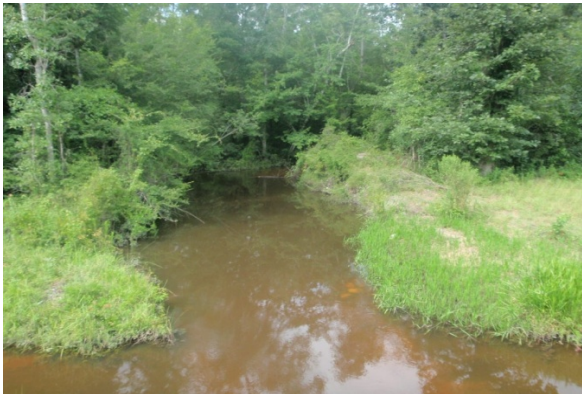
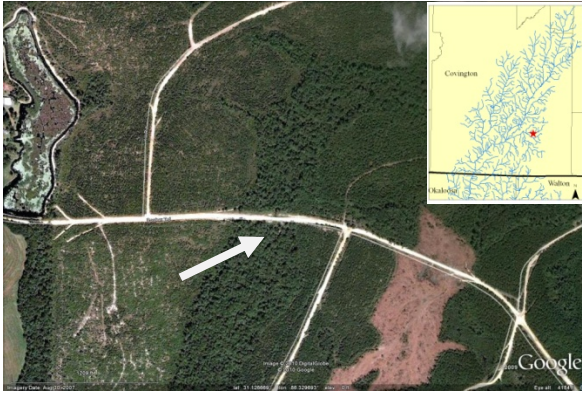
Crossing Structure: DS		US																																																																			
<table border="1"> <thead> <tr> <th>Risk Factor</th> <th>Ranking</th> <th>Score</th> </tr> </thead> <tbody> <tr><td>US Channel Morph</td><td>C</td><td>5</td></tr> <tr><td>DS Channel Morph</td><td>C</td><td>5</td></tr> <tr><td>DS Bank Alteration</td><td>MINOR/PARTIAL</td><td>3</td></tr> <tr><td>Upstream Skew Angle</td><td>5-30°</td><td>3</td></tr> <tr><td>Crossing fill condition</td><td>Fair/Rip Rap</td><td>3</td></tr> <tr><td>Inlet/Outlet Condition</td><td>No Impairment</td><td>5</td></tr> <tr><td>Road Approach Material</td><td>All Aggregate</td><td>5</td></tr> <tr><td>Potential Eroded Volume Mean</td><td>&lt;21 y<sup>3</sup></td><td>5</td></tr> <tr><td>Approach Slope Mean</td><td>2.1-4%</td><td>3</td></tr> <tr><td>Soil K Factor</td><td>&lt;0.20</td><td>5</td></tr> <tr><td>Upstream Rt Outlet</td><td>Vegetated</td><td>1</td></tr> <tr><td>Upstream Lt Outlet</td><td>Vegetated</td><td>1</td></tr> <tr><td>Upstream Rt Ditch</td><td>Bare soil</td><td>0</td></tr> <tr><td>Upstream Lt Ditch</td><td>Bare soil</td><td>0</td></tr> <tr><td>Downstream Rt Outlet</td><td>Bare soil</td><td>0</td></tr> <tr><td>Downstream Lt Outlet</td><td>Vegetated</td><td>1</td></tr> <tr><td>Downstream Rt Ditch</td><td>Bare soil</td><td>0</td></tr> <tr><td>Downstream Lt Ditch</td><td>Bare soil</td><td>0</td></tr> <tr><td>Outlet Total</td><td>Partially Improved Outlet System</td><td>3</td></tr> <tr><td>Ditches Total</td><td>Unimproved Drainage System</td><td>1</td></tr> <tr><td><b>SRI Total</b></td><td><b>Low Risk</b></td><td><b>46</b></td></tr> </tbody> </table>		Risk Factor	Ranking	Score	US Channel Morph	C	5	DS Channel Morph	C	5	DS Bank Alteration	MINOR/PARTIAL	3	Upstream Skew Angle	5-30°	3	Crossing fill condition	Fair/Rip Rap	3	Inlet/Outlet Condition	No Impairment	5	Road Approach Material	All Aggregate	5	Potential Eroded Volume Mean	<21 y <sup>3</sup>	5	Approach Slope Mean	2.1-4%	3	Soil K Factor	<0.20	5	Upstream Rt Outlet	Vegetated	1	Upstream Lt Outlet	Vegetated	1	Upstream Rt Ditch	Bare soil	0	Upstream Lt Ditch	Bare soil	0	Downstream Rt Outlet	Bare soil	0	Downstream Lt Outlet	Vegetated	1	Downstream Rt Ditch	Bare soil	0	Downstream Lt Ditch	Bare soil	0	Outlet Total	Partially Improved Outlet System	3	Ditches Total	Unimproved Drainage System	1	<b>SRI Total</b>	<b>Low Risk</b>	<b>46</b>

Risk Factor	Ranking	Score																																																																			
US Channel Morph	C	5																																																																			
DS Channel Morph	C	5																																																																			
DS Bank Alteration	MINOR/PARTIAL	3																																																																			
Upstream Skew Angle	5-30°	3																																																																			
Crossing fill condition	Fair/Rip Rap	3																																																																			
Inlet/Outlet Condition	No Impairment	5																																																																			
Road Approach Material	All Aggregate	5																																																																			
Potential Eroded Volume Mean	<21 y <sup>3</sup>	5																																																																			
Approach Slope Mean	2.1-4%	3

Soil K Factor	<0.20	5																																																																			
Upstream Rt Outlet	Vegetated	1																																																																			
Upstream Lt Outlet	Vegetated	1																																																																			
Upstream Rt Ditch	Bare soil	0																																																																			
Upstream Lt Ditch	Bare soil	0																																																																			
Downstream Rt Outlet	Bare soil	0																																																																			
Downstream Lt Outlet	Vegetated	1																																																																			
Downstream Rt Ditch	Bare soil	0																																																																			
Downstream Lt Ditch	Bare soil	0																																																																			
Outlet Total	Partially Improved Outlet System	3

Ditches Total	Unimproved Drainage System	1																																																																			
<b>SRI Total</b>	<b>Low Risk</b>	<b>46</b>																																																																			
<b>Additional Site Features</b> <u>Crossing Type and Quantity:</u> Bridge, 1 <u>Crossing Materials:</u> Reinforced Concrete <u>Soil Types:</u> BoB,BoC,DmB,EsC,GrA,MBA,OrA,OrB <u>Rt Approach Prism Fill:</u> 0.1in <u>Lt Approach Prism Fill:</u> 0.15in		<table border="1"> <thead> <tr> <th>Feature</th> <th>Within Range</th> <th>Descriptive Field</th> </tr> </thead> <tbody> <tr><td>303(d)</td><td>No</td><td>N/A</td></tr> <tr><td>Wetland Species</td><td>No</td><td>N/A</td></tr> <tr><td>Rare and Imperiled</td><td>No</td><td>N/A</td></tr> <tr><td>Land Use/Cover</td><td>Yes</td><td>N/A/ DEVELOPED OPEN SPACE</td></tr> <tr><td>Candidate Mussels</td><td>No</td><td>N/A</td></tr> <tr><td>Sturgeon C.H.</td><td>No</td><td>N/A</td></tr> </tbody> </table>		Feature	Within Range	Descriptive Field	303(d)	No	N/A	Wetland Species	No	N/A	Rare and Imperiled	No	N/A	Land Use/Cover	Yes	N/A/ DEVELOPED OPEN SPACE	Candidate Mussels	No	N/A	Sturgeon C.H.	No	N/A
