Unnamed tributary		wa-0727-r-004a	Sedimentation Risk Index 34																																																																		
<u>Common:</u> 4.5mi E of Mossy Head <u>Drainage:</u> Gum Creek <i>GPS:</i> 30.755967537, -86.240822602 <u>Land owner:</u> Roland & Judith Joachim-US, Ramon Trelles-DS		<u>County:</u> Walton <u>State:</u> Florida <u>PLSS (T-R-S):</u> 3N-20-16-28060 <u>Parcel No.:</u> 7.20030; 6.80940 <u>Road Name:</u> Blue Ridge Blvd

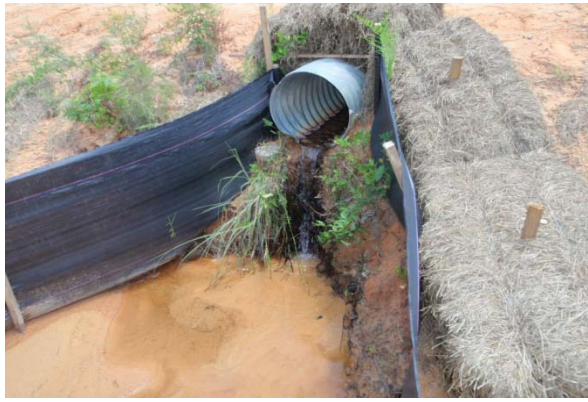
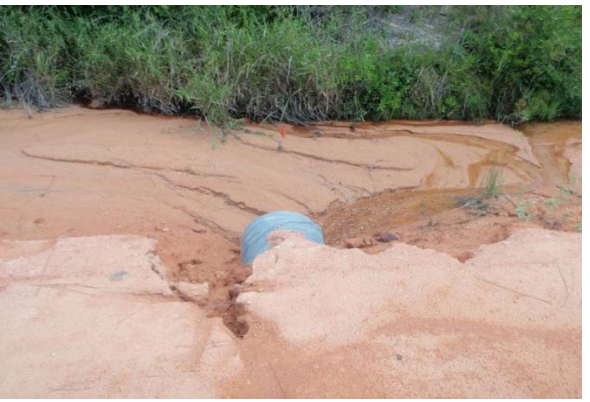
Crossing Structure: DS		US																																																																			
<table border="1"> <thead> <tr> <th>Risk Factor</th> <th>Ranking</th> <th>Score</th> </tr> </thead> <tbody> <tr><td>US Channel Morph</td><td>DA</td><td>3</td></tr> <tr><td>DS Channel Morph</td><td>E</td><td>5</td></tr> <tr><td>DS Bank Alteration</td><td>HIGH</td><td>1</td></tr> <tr><td>Upstream Skew Angle</td><td>>30°</td><td>1</td></tr> <tr><td>Crossing fill condition</td><td>Poor/Bare soil</td><td>1</td></tr> <tr><td>Inlet/Outlet Condition</td><td>No Impairment</td><td>5</td></tr> <tr><td>Road Approach Material</td><td>All Sand/Clay</td><td>3</td></tr> <tr><td>Potential Eroded Volume Mean</td><td><21 y³</td><td>5</td></tr> <tr><td>Approach Slope Mean</td><td>2.1-4%</td><td>3</td></tr> <tr><td>Soil K Factor</td><td><0.20</td><td>5</td></tr> <tr><td>Upstream Rt Outlet</td><td>Bare soil</td><td>0</td></tr> <tr><td>Upstream Lt Outlet</td><td>Bare soil</td><td>0</td></tr> <tr><td>Upstream Rt Ditch</td><td>Bare soil</td><td>0</td></tr> <tr><td>Upstream Lt Ditch</td><td>Bare soil</td><td>0</td></tr> <tr><td>Downstream Rt Outlet</td><td>Other</td><td>0</td></tr> <tr><td>Downstream Lt Outlet</td><td>Other</td><td>0</td></tr> <tr><td>Downstream Rt Ditch</td><td>Bare soil</td><td>0</td></tr> <tr><td>Downstream Lt Ditch</td><td>Bare soil</td><td>0</td></tr> <tr><td>Outlet Total</td><td>Unimproved Outlet System</td><td>1</td></tr> <tr><td>Ditches Total</td><td>Unimproved Drainage System</td><td>1</td></tr> <tr><td>SRI Total</td><td>High Risk</td><td>34</td></tr> </tbody> </table>		Risk Factor	Ranking	Score	US Channel Morph	DA	3	DS Channel Morph	E	5	DS Bank Alteration	HIGH	1	Upstream Skew Angle	>30°	1	Crossing fill condition	Poor/Bare soil	1	Inlet/Outlet Condition	No Impairment	5	Road Approach Material	All Sand/Clay	3	Potential Eroded Volume Mean	<21 y ³	5	Approach Slope Mean	2.1-4%	3	Soil K Factor	<0.20	5	Upstream Rt Outlet	Bare soil	0	Upstream Lt Outlet	Bare soil	0	Upstream Rt Ditch	Bare soil	0	Upstream Lt Ditch	Bare soil	0	Downstream Rt Outlet	Other	0	Downstream Lt Outlet	Other	0	Downstream Rt Ditch	Bare soil	0	Downstream Lt Ditch	Bare soil	0	Outlet Total	Unimproved Outlet System	1	Ditches Total	Unimproved Drainage System	1	SRI Total	High Risk	34

Notes: DS drop off. BMPs installed.
