Unnamed tributary		ok-0429-r-010	Sedimentation Risk Index 26																																																																		
<u>Common:</u> 6.2mi SW of Laurel Hill <u>Drainage:</u> Murder Creek <u>GPS:</u> 30.895197686, -86.525778507 <u>Land owner:</u> James & Joyce Arnette-US, Rose in Bloom Inc- DS East, Swampland Inc-DS West		<u>County:</u> Okaloosa <u>State:</u> Florida <u>PLSS(T-R-S):</u> 5N-23-34 <u>Parcel No.:</u> 1.002, 1.004 <u>Road Name:</u> Jack Rd

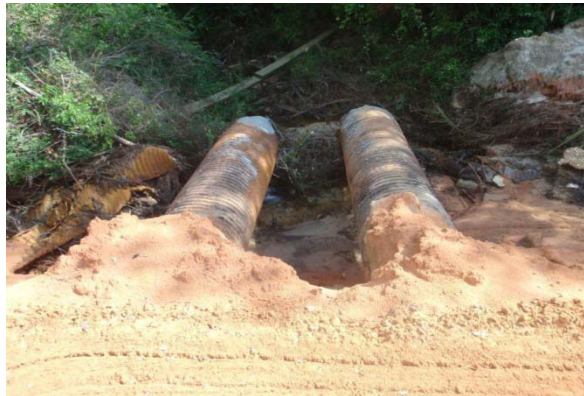
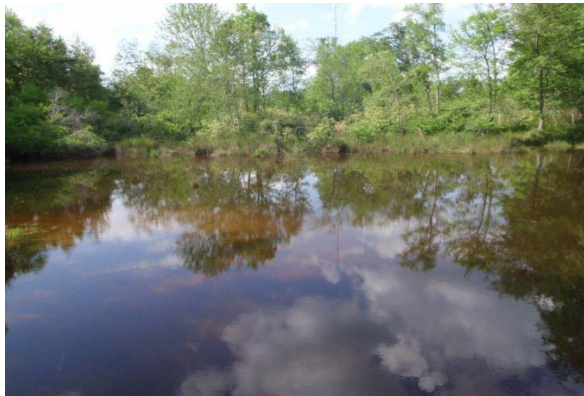
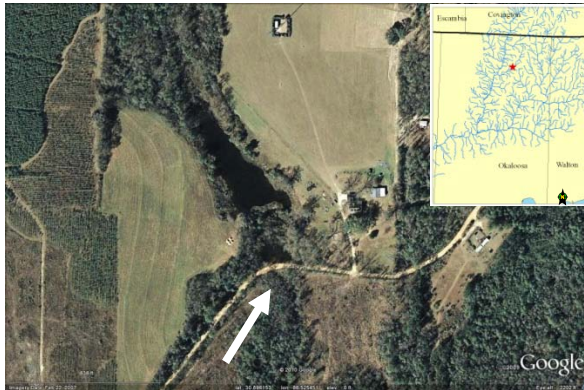
Crossing Structure: DS		US																																																																			
<table border="1"> <thead> <tr> <th>Risk Factor</th> <th>Ranking</th> <th>Score</th> </tr> </thead> <tbody> <tr><td>US Channel Morph</td><td>PONDED</td><td>1</td></tr> <tr><td>DS Channel Morph</td><td>DA</td><td>3</td></tr> <tr><td>DS Bank Alteration</td><td>HIGH</td><td>1</td></tr> <tr><td>Upstream Skew Angle</td><td>5-30°</td><td>3</td></tr> <tr><td>Crossing fill condition</td><td>Poor/Bare soil</td><td>1</td></tr> <tr><td>Inlet/Outlet Condition</td><td>Sed Islands/Scouring</td><td>3</td></tr> <tr><td>Road Approach Material</td><td>All Sand/Clay</td><td>3</td></tr> <tr><td>Potential Eroded Volume Mean</td><td>>40 y³</td><td>1</td></tr> <tr><td>Approach Slope Mean</td><td>2.1-4%</td><td>3</td></tr> <tr><td>Soil K Factor</td><td><0.20</td><td>5</td></tr> <tr><td>Upstream Rt Outlet</td><td>Bare soil</td><td>0</td></tr> <tr><td>Upstream Lt Outlet</td><td>Bare soil</td><td>0</td></tr> <tr><td>Upstream Rt Ditch</td><td>Bare soil</td><td>0</td></tr> <tr><td>Upstream Lt Ditch</td><td>Bare soil</td><td>0</td></tr> <tr><td>Downstream Rt Outlet</td><td>Bare soil</td><td>0</td></tr> <tr><td>Downstream Lt Outlet</td><td>Bare soil</td><td>0</td></tr> <tr><td>Downstream Rt Ditch</td><td>Bare soil</td><td>0</td></tr> <tr><td>Downstream Lt Ditch</td><td>Bare soil</td><td>0</td></tr> <tr><td>Outlet Total</td><td>Unimproved Outlet System</td><td>1</td></tr> <tr><td>Ditches Total</td><td>Unimproved Drainage System</td><td>1</td></tr> <tr><td>SRI Total</td><td>High Risk</td><td>26</td></tr> </tbody> </table>		Risk Factor	Ranking	Score	US Channel Morph	PONDED	1	DS Channel Morph	DA	3	DS Bank Alteration	HIGH	1	Upstream Skew Angle	5-30°	3	Crossing fill condition	Poor/Bare soil	1	Inlet/Outlet Condition	Sed Islands/Scouring	3	Road Approach Material	All Sand/Clay	3	Potential Eroded Volume Mean	>40 y ³	1	Approach Slope Mean	2.1-4%	3	Soil K Factor	<0.20	5	Upstream Rt Outlet	Bare soil	0	Upstream Lt Outlet	Bare soil	0	Upstream Rt Ditch	Bare soil	0	Upstream Lt Ditch	Bare soil	0	Downstream Rt Outlet	Bare soil	0	Downstream Lt Outlet	Bare soil	0	Downstream Rt Ditch	Bare soil	0	Downstream Lt Ditch	Bare soil	0	Outlet Total	Unimproved Outlet System	1	Ditches Total	Unimproved Drainage System	1	SRI Total	High Risk	26

Notes: 12ft of each culvert exposed due to road erosion. US openings covered by fencing.
