Lightwood Knot Creek		co-1103-r-018	Sedimentation Risk Index 44																																																																		
<u>Common:</u> 3.5mi SW of Friendship <u>Drainage:</u> Yellow River <i>GPS:</i> 31.372027985,-86.253615927 <u>Land owner:</u> Emily Carr -US, James Carr -DS		<u>County:</u> Covington <i>State:</i> Alabama <u>PLSS (T-R-S):</u> 5N-18E-28 <u>Parcel No.:</u> 1.04, 1 <u>Road Name:</u> Union Grove Rd

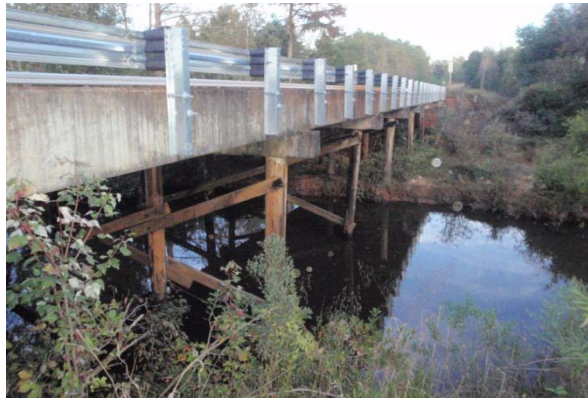
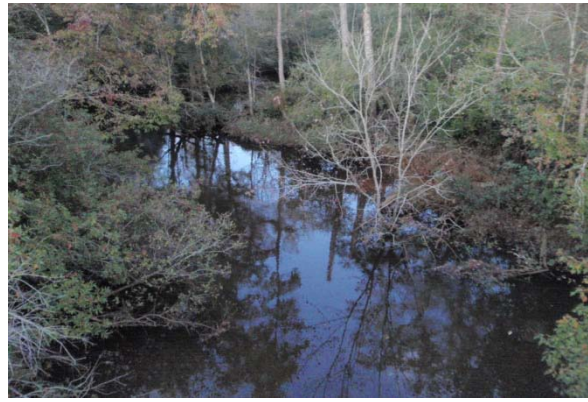
Crossing Structure: DS		US																																																																			
<table border="1"> <thead> <tr> <th>Risk Factor</th> <th>Ranking</th> <th>Score</th> </tr> </thead> <tbody> <tr><td>US Channel Morph</td><td>C</td><td>5</td></tr> <tr><td>DS Channel Morph</td><td>C</td><td>5</td></tr> <tr><td>DS Bank Alteration</td><td>NATURAL</td><td>5</td></tr> <tr><td>Upstream Skew Angle</td><td><5°</td><td>5</td></tr> <tr><td>Crossing fill condition</td><td>Good/Vegetated</td><td>5</td></tr> <tr><td>Inlet/Outlet Condition</td><td>No Impairment</td><td>5</td></tr> <tr><td>Road Approach Material</td><td>All Aggregate</td><td>5</td></tr> <tr><td>Potential Eroded Volume Mean</td><td>>40 y³</td><td>1</td></tr> <tr><td>Approach Slope Mean</td><td>>4%</td><td>1</td></tr> <tr><td>Soil K Factor</td><td>0.21-0.40</td><td>3</td></tr> <tr><td>Upstream Rt Outlet</td><td>Vegetated</td><td>1</td></tr> <tr><td>Upstream Lt Outlet</td><td>Vegetated</td><td>1</td></tr> <tr><td>Upstream Rt Ditch</td><td>Bare soil</td><td>0</td></tr> <tr><td>Upstream Lt Ditch</td><td>Bare soil</td><td>0</td></tr> <tr><td>Downstream Rt Outlet</td><td>Vegetated</td><td>1</td></tr> <tr><td>Downstream Lt Outlet</td><td>Bare soil</td><td>0</td></tr> <tr><td>Downstream Rt Ditch</td><td>Bare soil</td><td>0</td></tr> <tr><td>Downstream Lt Ditch</td><td>Bare soil</td><td>0</td></tr> <tr><td>Outlet Total</td><td>Partially Improved Outlet System</td><td>3</td></tr> <tr><td>Ditches Total</td><td>Unimproved Drainage System</td><td>1</td></tr> <tr><td>SRI Total</td><td>Medium Risk</td><td>44</td></tr> </tbody> </table>				Risk Factor	Ranking	Score	US Channel Morph	C	5	DS Channel Morph	C	5	DS Bank Alteration	NATURAL	5	Upstream Skew Angle	<5°	5	Crossing fill condition	Good/Vegetated	5	Inlet/Outlet Condition	No Impairment	5	Road Approach Material	All Aggregate	5	Potential Eroded Volume Mean	>40 y ³	1	Approach Slope Mean	>4%	1	Soil K Factor	0.21-0.40	3	Upstream Rt Outlet	Vegetated	1	Upstream Lt Outlet	Vegetated	1	Upstream Rt Ditch	Bare soil	0	Upstream Lt Ditch	Bare soil	0	Downstream Rt Outlet	Vegetated	1	Downstream Lt Outlet	Bare soil	0	Downstream Rt Ditch	Bare soil	0	Downstream Lt Ditch	Bare soil	0	Outlet Total	Partially Improved Outlet System	3	Ditches Total	Unimproved Drainage System	1	SRI Total	Medium Risk	44
