Unnamed tributary		co-0812-r-002	Sedimentation Risk Index 28																																																																		
<u>Common:</u> 8.3mi NW of Florala <u>Drainage:</u> North Creek <u>GPS:</u> 31.095561, -86.418078 <u>Land owner:</u> Walter & Martha Spears		<u>County:</u> Covington <u>State:</u> Alabama <u>PLSS (T-R-S):</u> 2N-16E-35 <u>Parcel No.:</u> 6 <u>Road Name:</u> Laird Rd

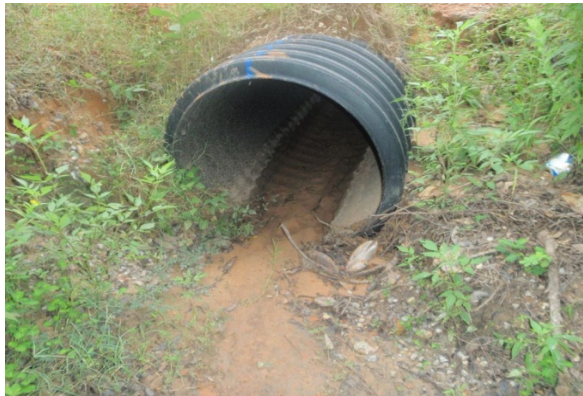
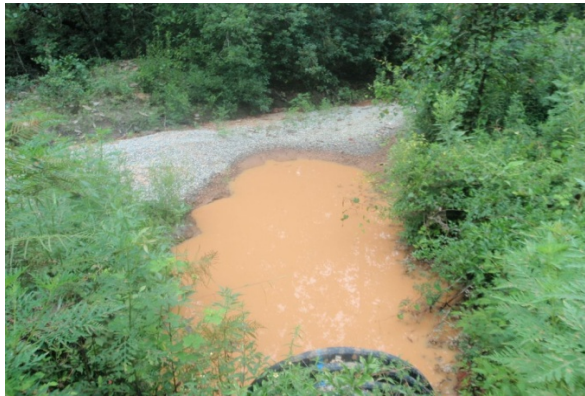
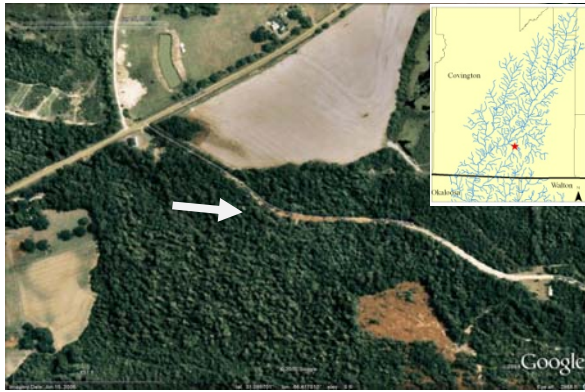
Crossing Structure: US		DS																																																																			
<table border="1"> <thead> <tr> <th>Risk Factor</th> <th>Ranking</th> <th>Score</th> </tr> </thead> <tbody> <tr><td>US Channel Morph</td><td>DA</td><td>3</td></tr> <tr><td>DS Channel Morph</td><td>PONDED</td><td>1</td></tr> <tr><td>DS Bank Alteration</td><td>HIGH</td><td>1</td></tr> <tr><td>Upstream Skew Angle</td><td>5-30°</td><td>3</td></tr> <tr><td>Crossing fill condition</td><td>Poor/Bare soil</td><td>1</td></tr> <tr><td>Inlet/Outlet Condition</td><td>Sed Islands/Scouring</td><td>3</td></tr> <tr><td>Road Approach Material</td><td>All Sand/Clay</td><td>3</td></tr> <tr><td>Potential Eroded Volume Mean</td><td>>40 y³</td><td>1</td></tr> <tr><td>Approach Slope Mean</td><td><2%</td><td>5</td></tr> <tr><td>Soil K Factor</td><td><0.20</td><td>5</td></tr> <tr><td>Upstream Rt Outlet</td><td>Bare soil</td><td>0</td></tr> <tr><td>Upstream Lt Outlet</td><td>Bare soil</td><td>0</td></tr> <tr><td>Upstream Rt Ditch</td><td>Bare soil</td><td>0</td></tr> <tr><td>Upstream Lt Ditch</td><td>Bare soil</td><td>0</td></tr> <tr><td>Downstream Rt Outlet</td><td>Bare soil</td><td>0</td></tr> <tr><td>Downstream Lt Outlet</td><td>Other</td><td>0</td></tr> <tr><td>Downstream Rt Ditch</td><td>Bare soil</td><td>0</td></tr> <tr><td>Downstream Lt Ditch</td><td>Bare soil</td><td>0</td></tr> <tr><td>Outlet Total</td><td>Unimproved Outlet System</td><td>1</td></tr> <tr><td>Ditches Total</td><td>Unimproved Drainage System</td><td>1</td></tr> <tr><td>SRI Total</td><td>High Risk</td><td>28</td></tr> </tbody> </table>		Risk Factor	Ranking	Score	US Channel Morph	DA	3	DS Channel Morph	PONDED	1	DS Bank Alteration	HIGH	1	Upstream Skew Angle	5-30°	3	Crossing fill condition	Poor/Bare soil	1	Inlet/Outlet Condition	Sed Islands/Scouring	3	Road Approach Material	All Sand/Clay	3	Potential Eroded Volume Mean	>40 y ³	1	Approach Slope Mean	<2%	5	Soil K Factor	<0.20	5	Upstream Rt Outlet	Bare soil	0	Upstream Lt Outlet	Bare soil	0	Upstream Rt Ditch	Bare soil	0	Upstream Lt Ditch	Bare soil	0	Downstream Rt Outlet	Bare soil	0	Downstream Lt Outlet	Other	0	Downstream Rt Ditch	Bare soil	0	Downstream Lt Ditch	Bare soil	0	Outlet Total	Unimproved Outlet System	1	Ditches Total	Unimproved Drainage System	1	SRI Total	High Risk	28

Notes: Rock DS holding back the water flow.
