Unnamed tributary		co-0812-r-003		Sedimentation Risk Index 54																																																																			
<u>Common:</u> 8.0mi NW of Florala <u>Drainage:</u> Clear Creek <u>GPS:</u> 31.110944, -86.378897 <u>Land owner:</u> Rayonier Forest Resources LP		<u>County:</u> Covington <u>PLSS (T-R-S):</u> 2N-17E-30 <u>Parcel No.:</u> 8 <u>Road Name:</u> Camp Eleven Rd		<u>State:</u> Alabama

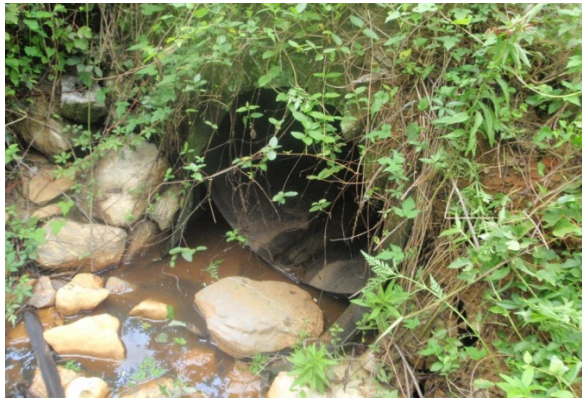
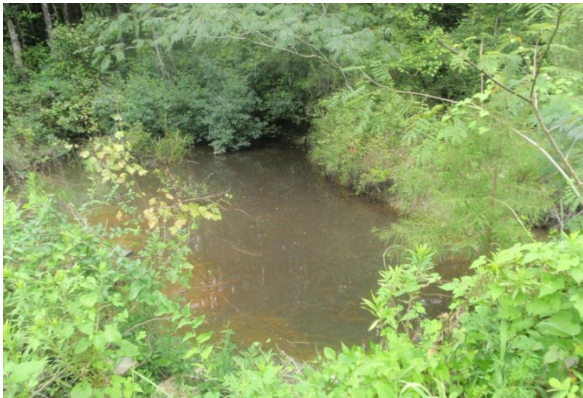
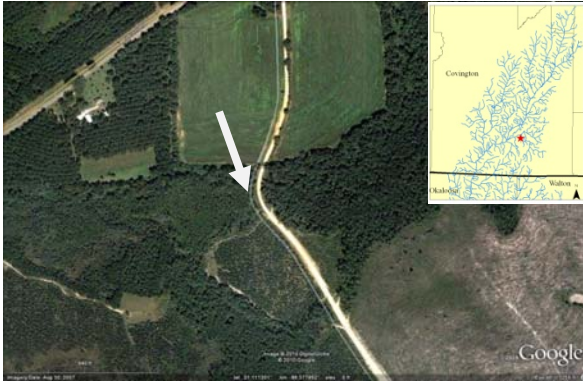
Crossing Structure: DS		US																																																																					
<table border="1"> <thead> <tr> <th>Risk Factor</th> <th>Ranking</th> <th>Score</th> </tr> </thead> <tbody> <tr><td>US Channel Morph</td><td>E</td><td>5</td></tr> <tr><td>DS Channel Morph</td><td>E</td><td>5</td></tr> <tr><td>DS Bank Alteration</td><td>MINOR/PARTIAL</td><td>3</td></tr> <tr><td>Upstream Skew Angle</td><td><5°</td><td>5</td></tr> <tr><td>Crossing fill condition</td><td>Good/Vegetated</td><td>5</td></tr> <tr><td>Inlet/Outlet Condition</td><td>No Impairment</td><td>5</td></tr> <tr><td>Road Approach Material</td><td>All Sand/Clay</td><td>3</td></tr> <tr><td>Potential Eroded Volume Mean</td><td><21 y³</td><td>5</td></tr> <tr><td>Approach Slope Mean</td><td><2%</td><td>5</td></tr> <tr><td>Soil K Factor</td><td><0.20</td><td>5</td></tr> <tr><td>Upstream Rt Outlet</td><td>Vegetated</td><td>1</td></tr> <tr><td>Upstream Lt Outlet</td><td>Vegetated</td><td>1</td></tr> <tr><td>Upstream Rt Ditch</td><td>Vegetated</td><td>1</td></tr> <tr><td>Upstream Lt Ditch</td><td>Bare soil</td><td>0</td></tr> <tr><td>Downstream Rt Outlet</td><td>Vegetated</td><td>1</td></tr> <tr><td>Downstream Lt Outlet</td><td>Vegetated</td><td>1</td></tr> <tr><td>Downstream Rt Ditch</td><td>Bare soil</td><td>0</td></tr> <tr><td>Downstream Lt Ditch</td><td>Bare soil</td><td>0</td></tr> <tr><td>Outlet Total</td><td>Improved Outlet System</td><td>5</td></tr> <tr><td>Ditches Total</td><td>Partially Improved Drainage System</td><td>3</td></tr> <tr><td>SRI Total</td><td>Low Risk</td><td>54</td></tr> </tbody> </table>		Risk Factor	Ranking	Score	US Channel Morph	E	5	DS Channel Morph	E	5	DS Bank Alteration	MINOR/PARTIAL	3	Upstream Skew Angle	<5°	5	Crossing fill condition	Good/Vegetated	5	Inlet/Outlet Condition	No Impairment	5	Road Approach Material	All Sand/Clay	3	Potential Eroded Volume Mean	<21 y ³	5	Approach Slope Mean	<2%	5	Soil K Factor	<0.20	5	Upstream Rt Outlet	Vegetated	1	Upstream Lt Outlet	Vegetated	1	Upstream Rt Ditch	Vegetated	1	Upstream Lt Ditch	Bare soil	0	Downstream Rt Outlet	Vegetated	1	Downstream Lt Outlet	Vegetated	1	Downstream Rt Ditch	Bare soil	0	Downstream Lt Ditch	Bare soil	0	Outlet Total	Improved Outlet System	5	Ditches Total	Partially Improved Drainage System	3	SRI Total	Low Risk	54

Notes: Highly vegetated.
